**Re: 9608 Eighth Line, Halton Hills
Request to Remove from the Heritage Register
Halton Hills Investment (III) Corp.**

BUILDING CONDITION ASSESSMENT

9608 Eighth Line
Halton Hills, Ontario

LANHACK STEELCON INC.

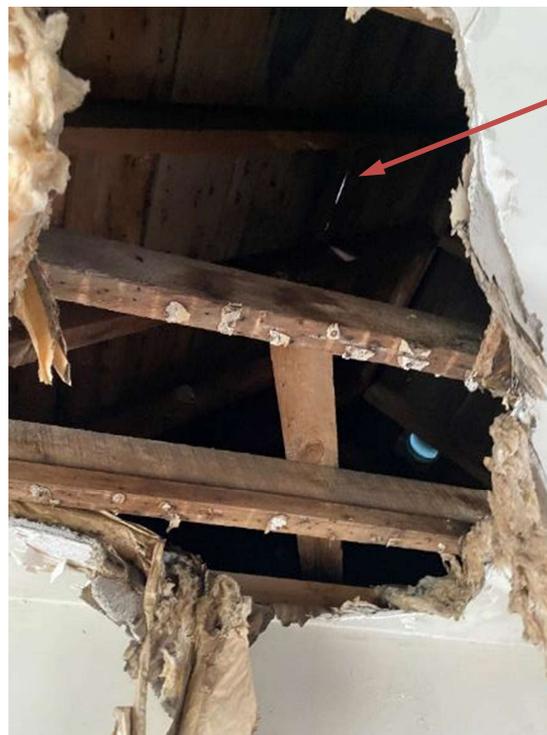
Figure 2.0

Original Farmhouse
– Collapsed Ceiling

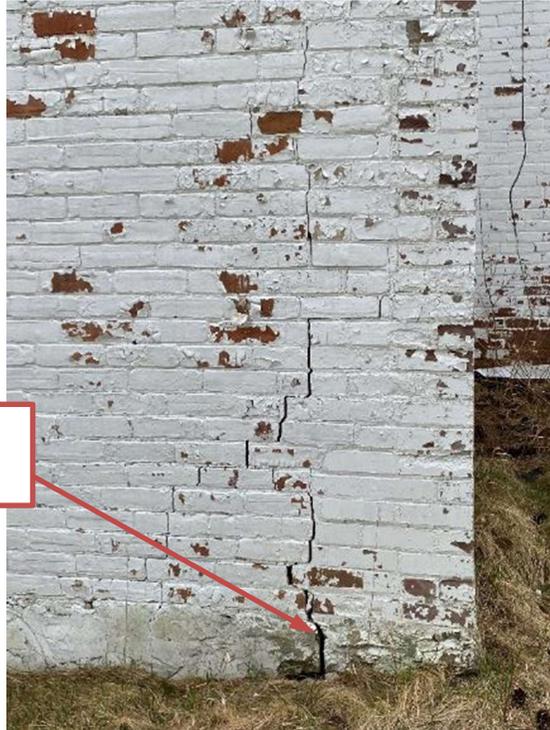
Figure 11.0

Original Farmhouse
– Cracked Wall

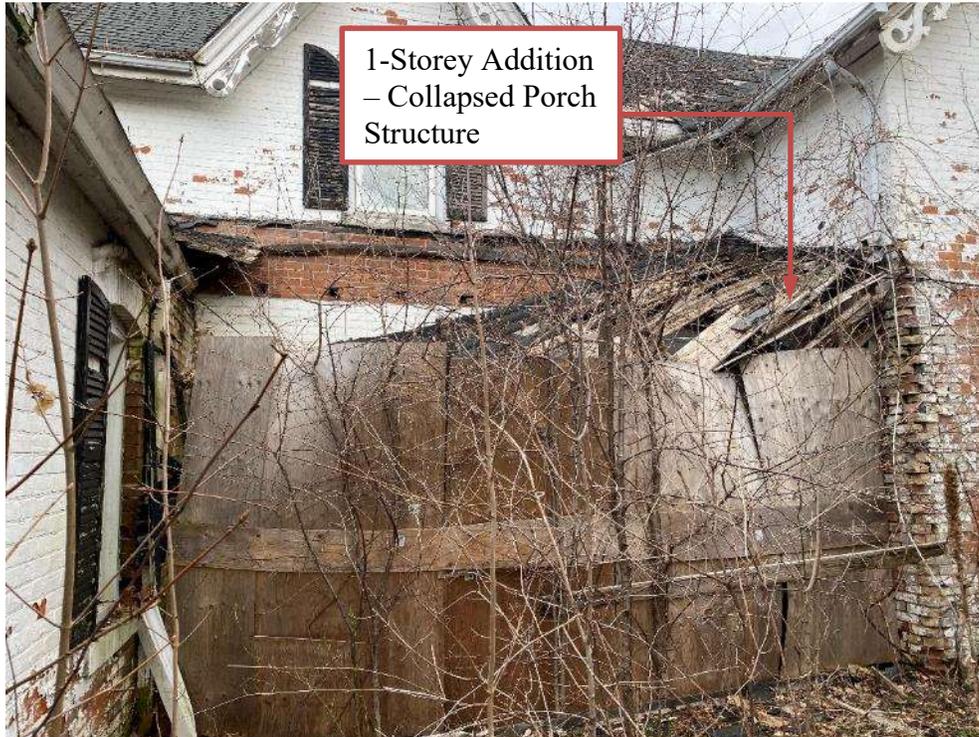
Figure 31.0

The one-storey additions were all found to be in poor condition and structurally compromised. The porch enclosure on the side of the dwelling, adjacent to the one-storey family room, had collapsed due to the deterioration of the wood framing (see fig. 31.0). The family room revealed severe water infiltration, evident by the collapsed ceiling and collapse of the veneer finish on the fireplace. On the exterior, this section was in poor condition and the roof shingles and wood, roof overhangs were completely deteriorated. The attached chimney in this area revealed signs of extensive deterioration, especially at the base, where there were extensive damaged bricks.
