LES SALLAY
PROJECT NUMBER: 221-07745-00

HERITAGE IMPACT ASSESSMENT 152 CONFEDERATION STREET, TOWN OF HALTON HILLS

SEPTEMBER 07, 2022

FINAL

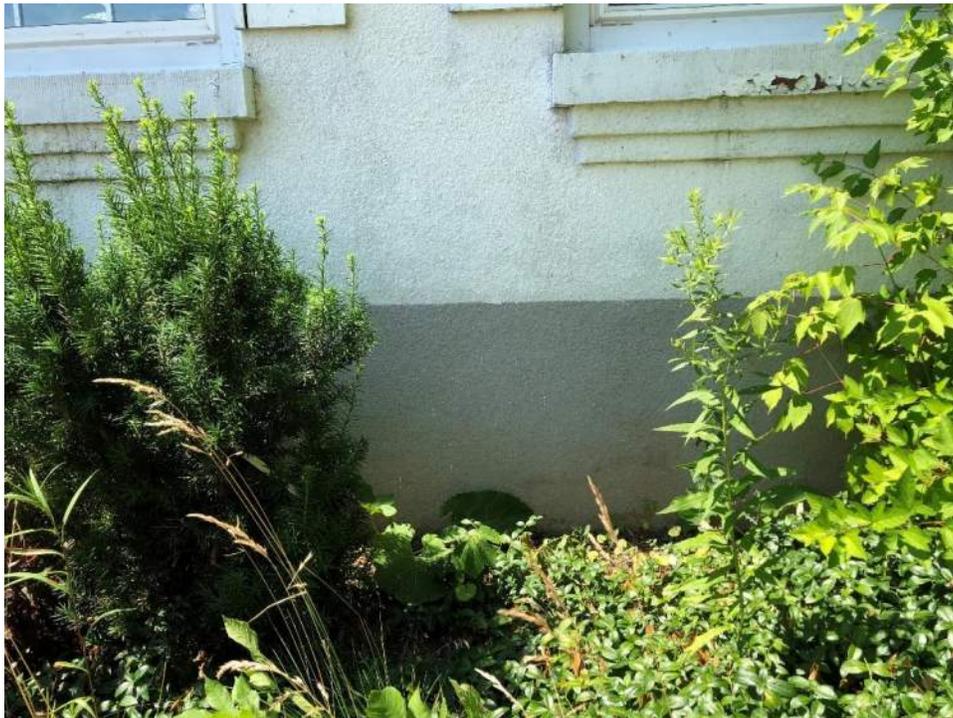
Image 12: Detail of the stuccoed foundation that is painted grey (this is consistent with the foundation treatment on all elevations).

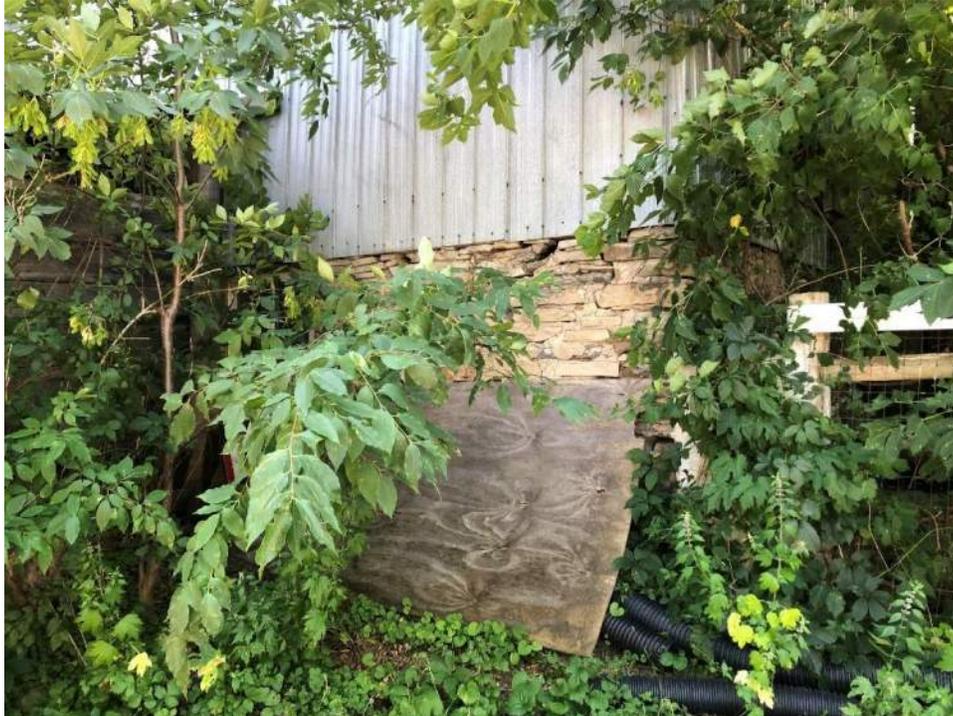
The north elevation of the barn also displays the original stone foundation and areas where it has been replaced with concrete as well as corrugated metal cladding on the upper storey (Image 69-Image 72). The upper storey includes two windows and three rectangular openings/doors. A shed roof structure is also located on this side of the barn protecting some bails of hay.

Image 72: View of the stone foundation on the north elevation of the barn.

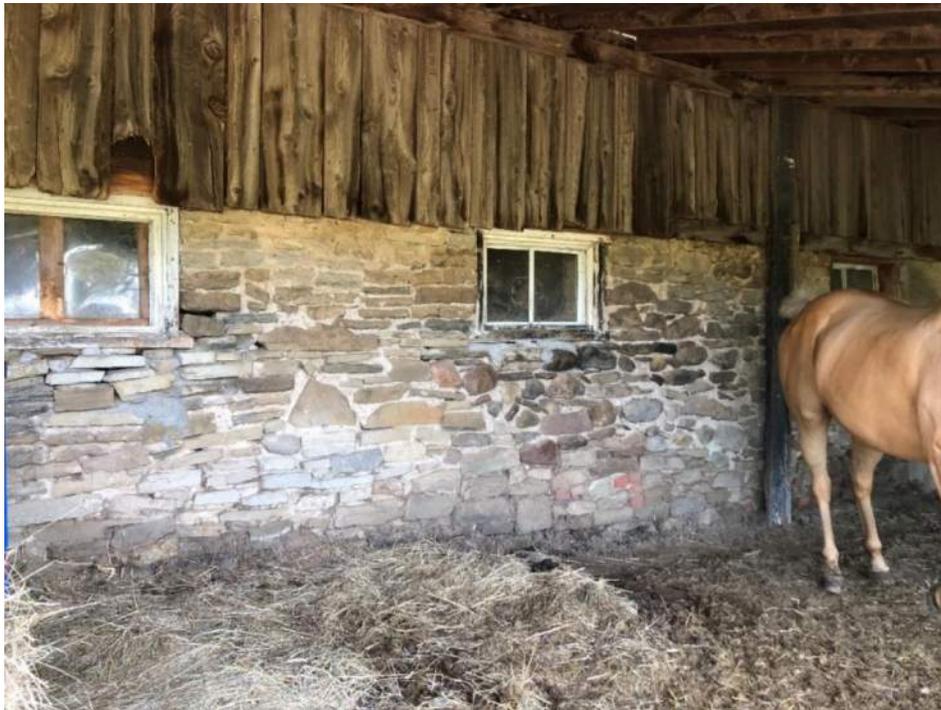
Image 76: View of the foundation along the south elevation of the barn.

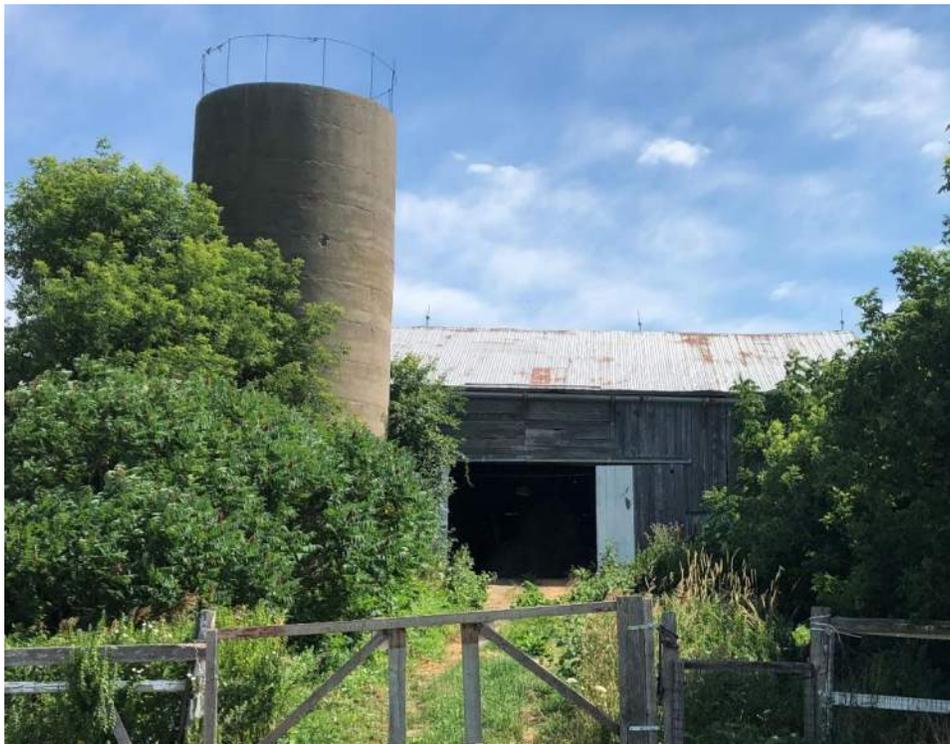
The concrete silo is located on the west side of the barn and consists of poured concrete construction with steel reinforcing rods. The top of the structure is missing, revealing the steel reinforcing rods.

Image 77: View of the concrete silo.

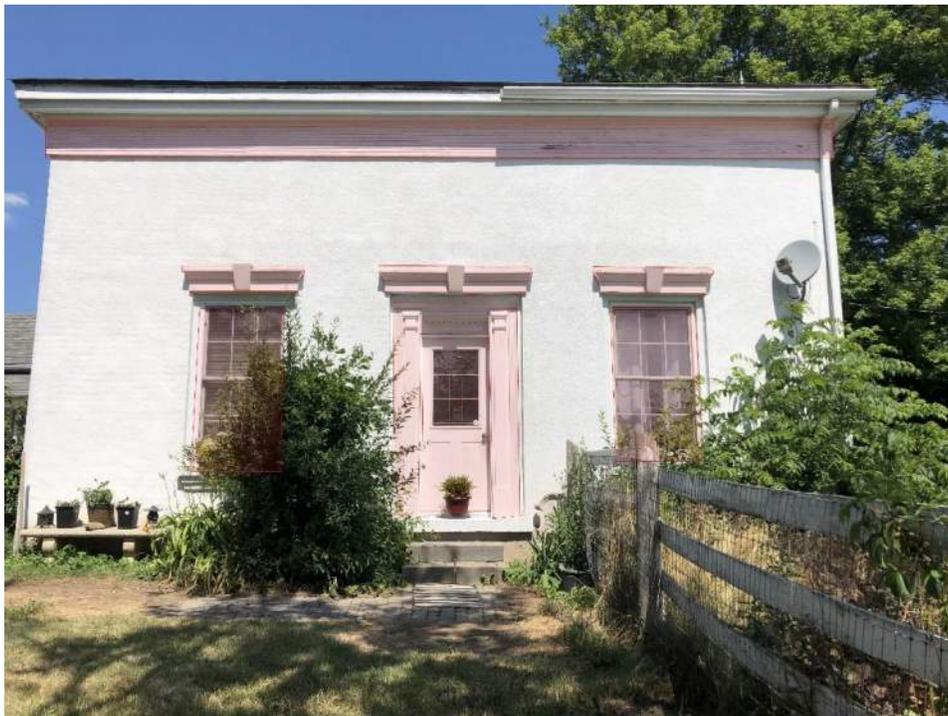
Image 95: Annotated photograph of the south elevation of the original part of the house (pink shaded areas depict alterations completed since 1983)

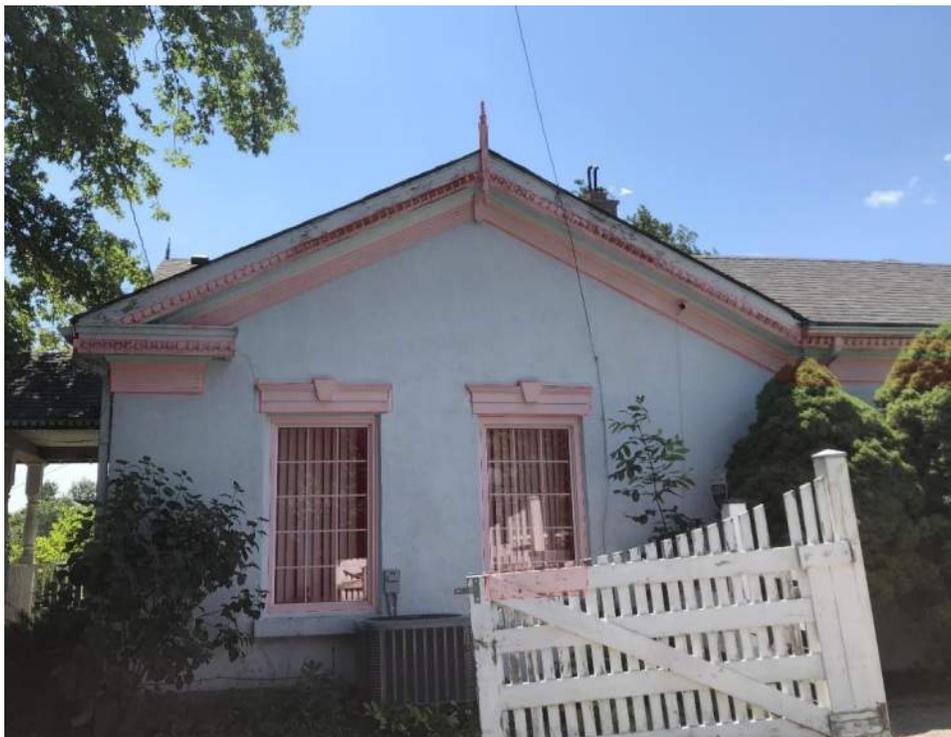
Image 98: Annotated photograph of the north elevation of the north wing (pink shaded areas depict alterations completed since 1983).

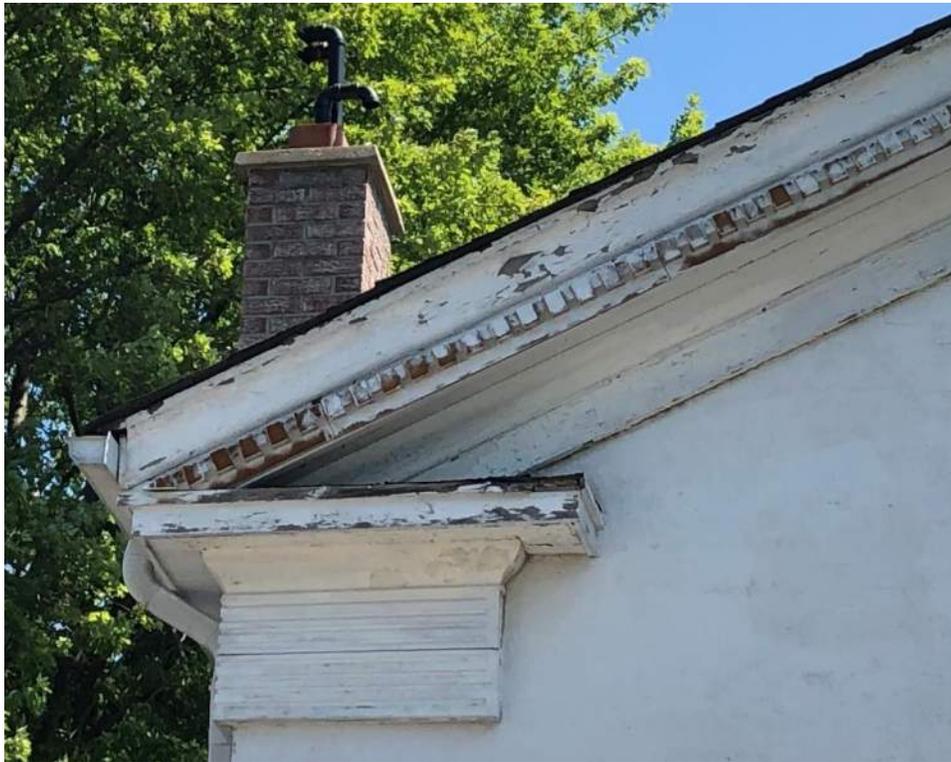
Photographs of the farmhouse have been annotated to visually identify the most recent changes to the structure (Image 95-Image 98). Samples of the exterior moulding were also provided and upon close inspection the cornice and dentil detailing do not display the typical deterioration one would expect from wood details dating to 1857 and some areas reveal the polyurethane material where the coating has worn away

Image 101: Detail view of the dentil detailing, revealing the polyurethane material where the exterior coating has worn away.

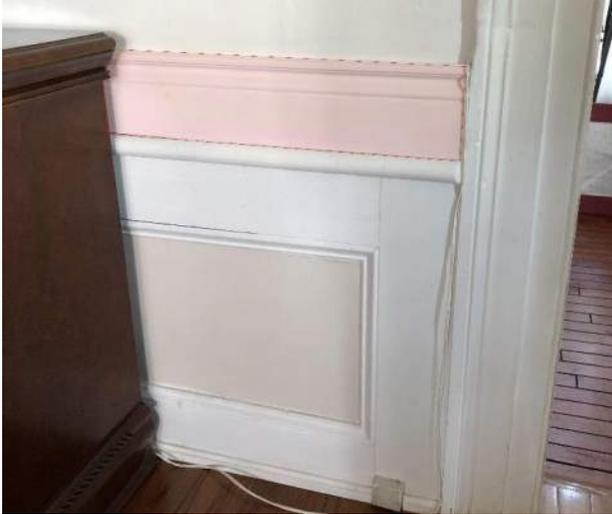
Image 102: Annotated photograph of the woodwork in the large room of the north wing (pink shaded areas depict alterations completed since 1983).
