Cultural Heritage Evaluation Report

9259 Fifth Line
Town of Halton Hills, Ontario

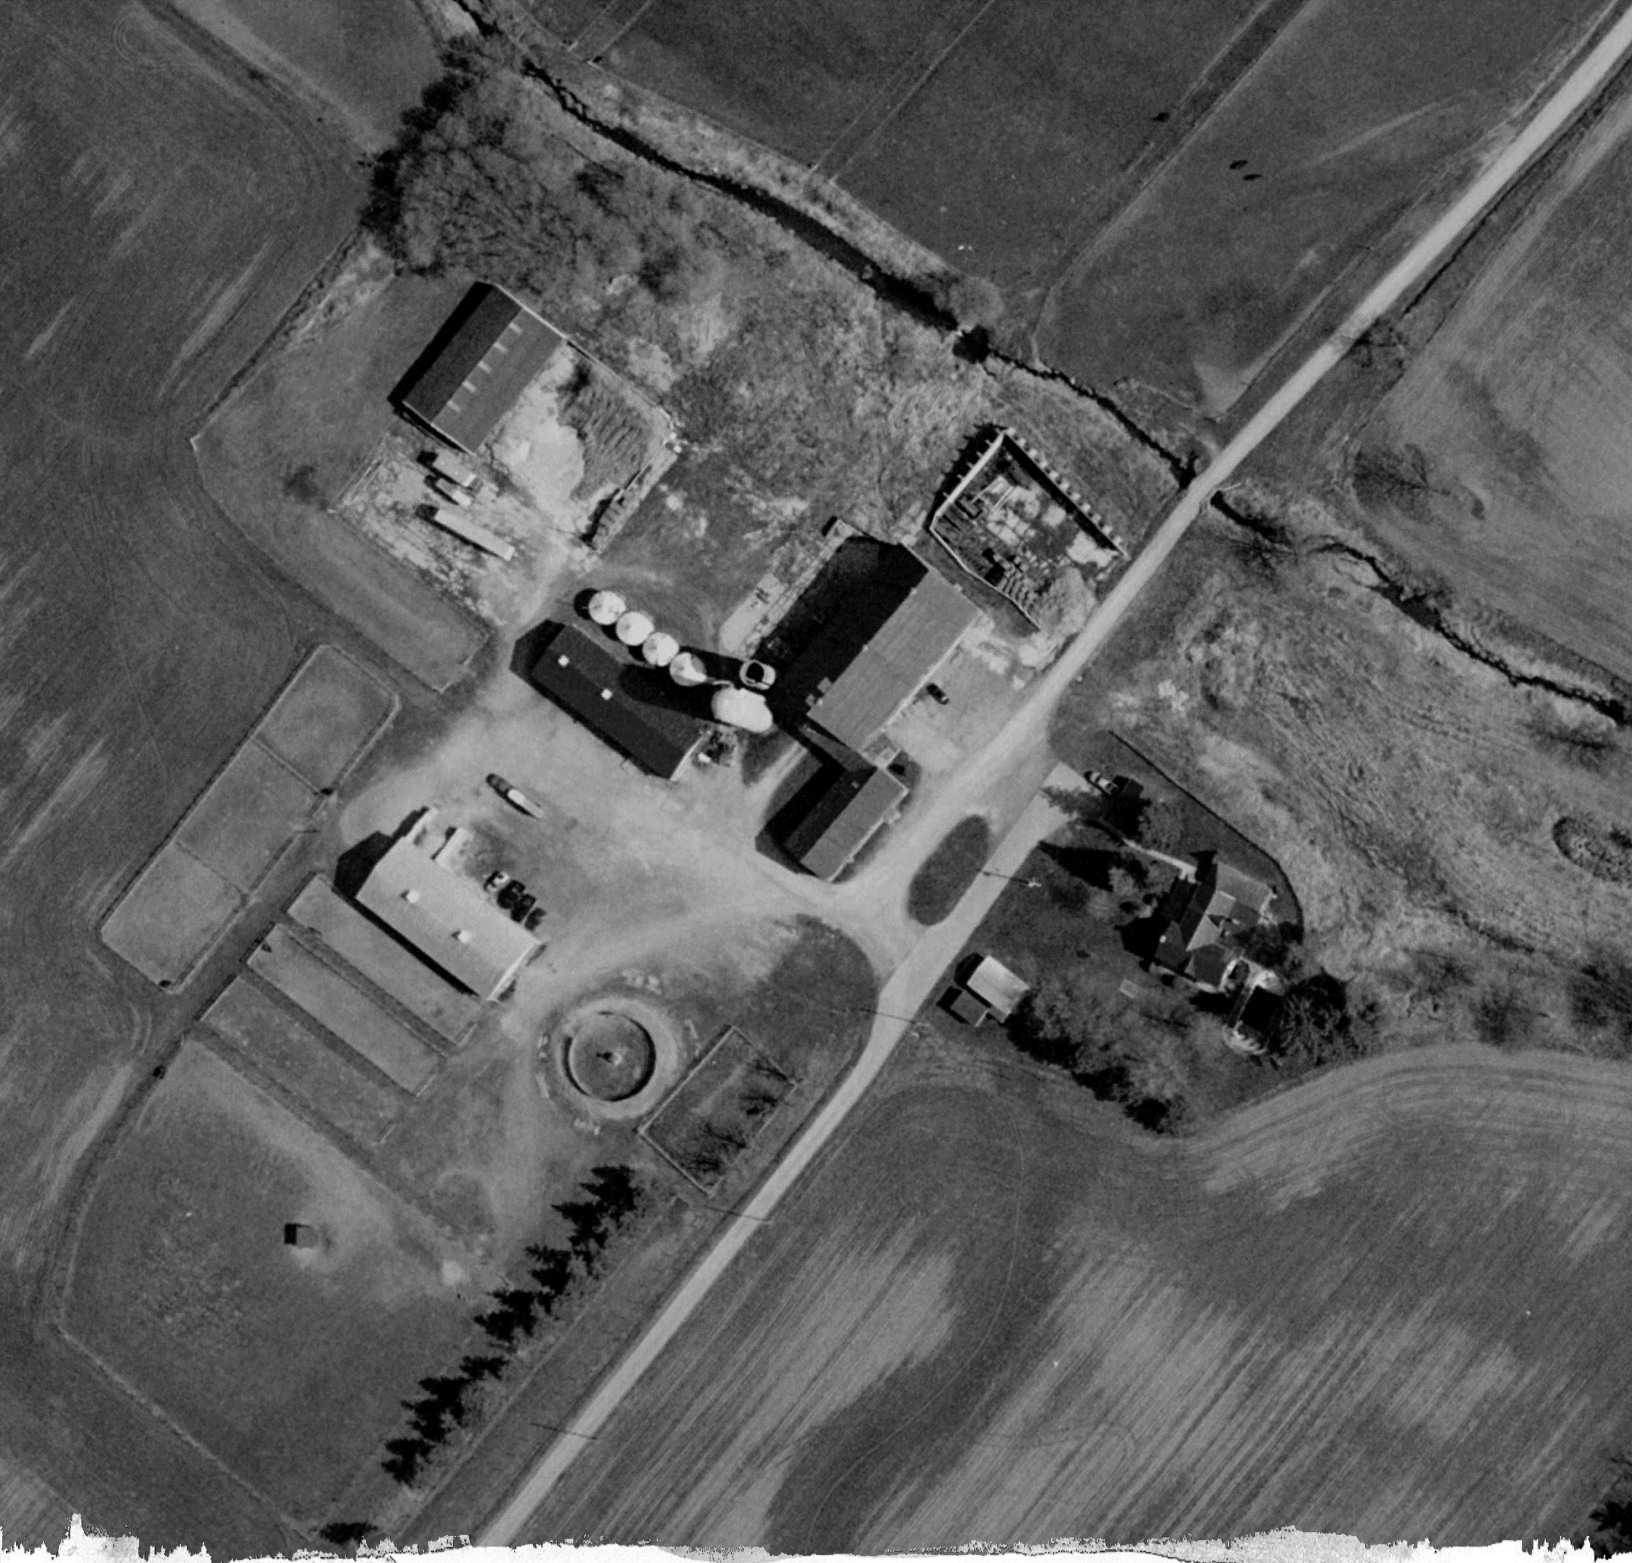
2.0 Site & Surroundings

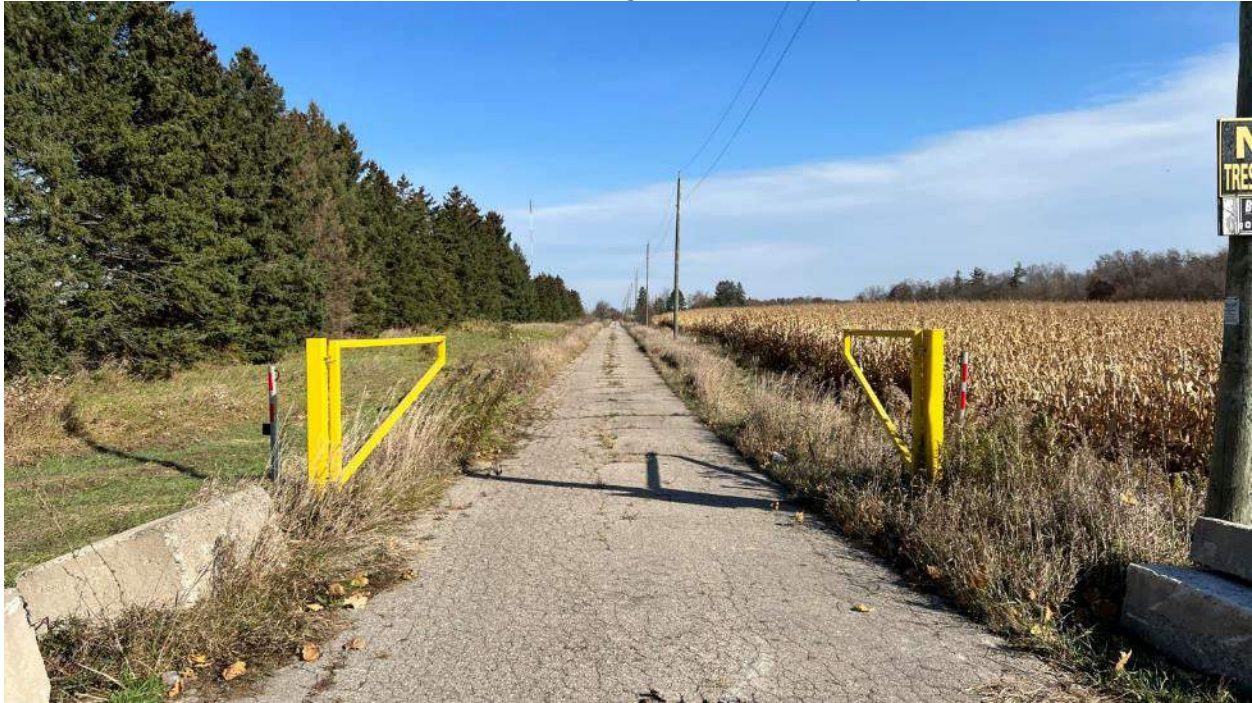
Source: Original Photo

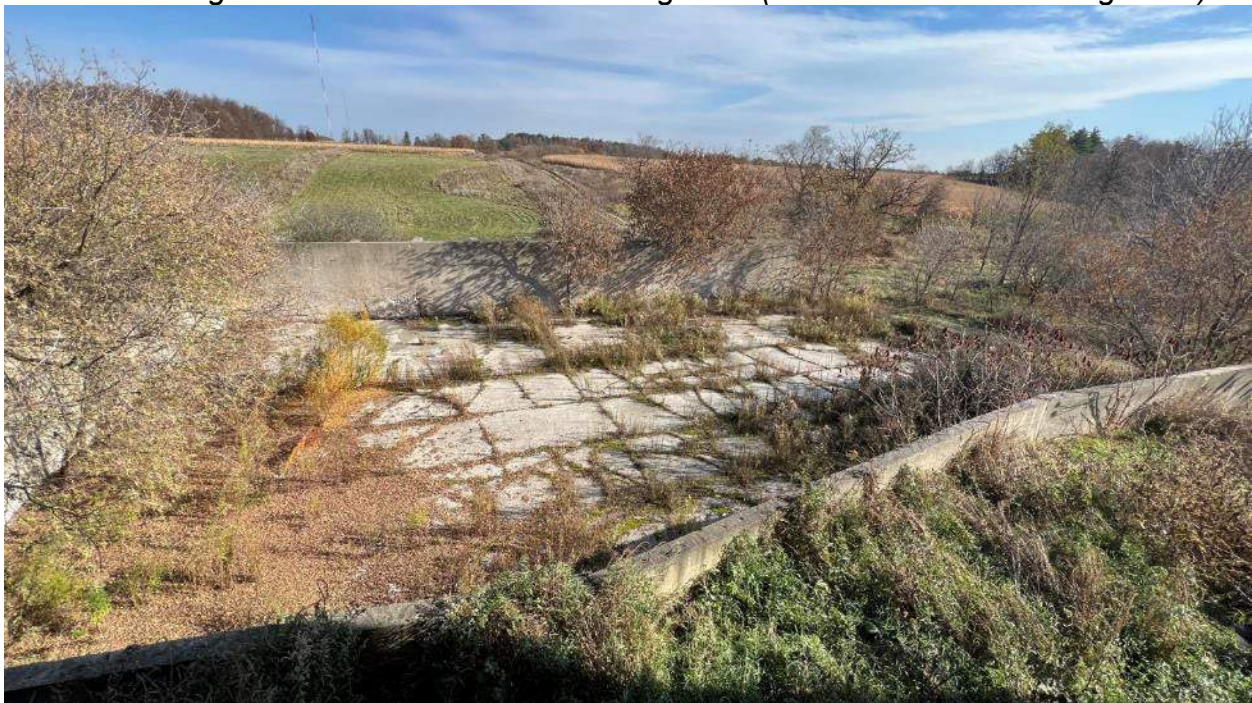
Source: Original Photo

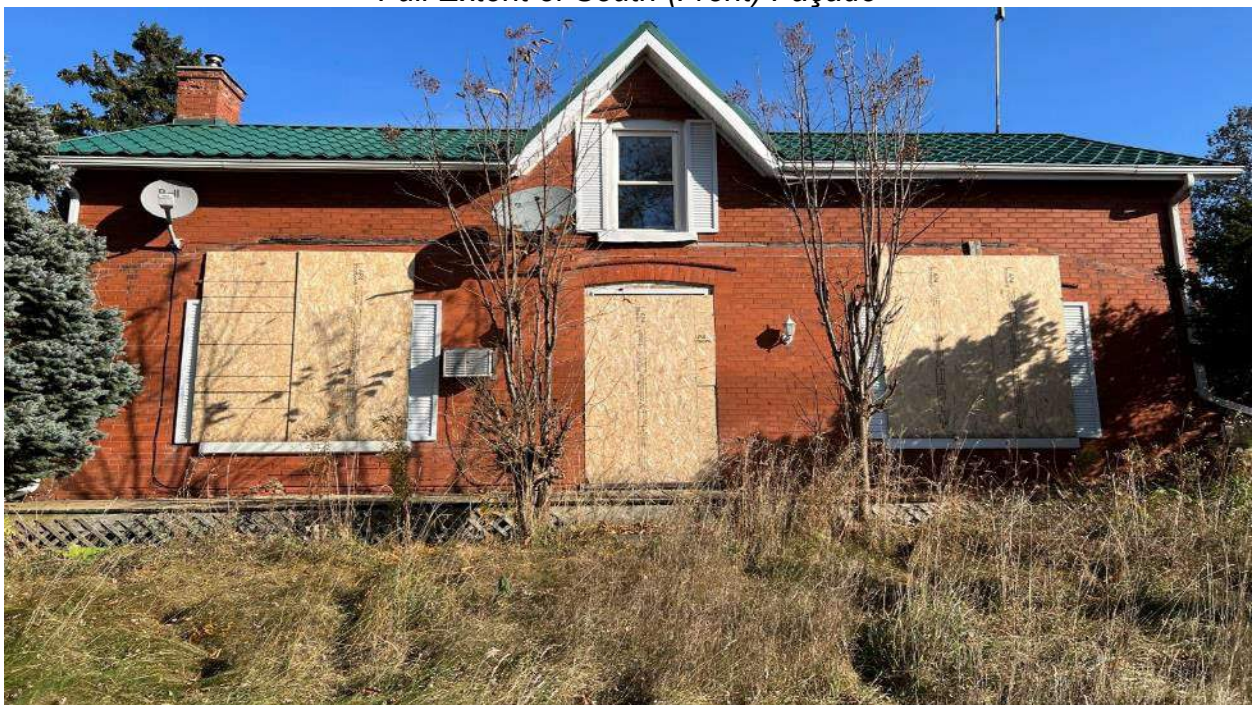
Source: Original Photo

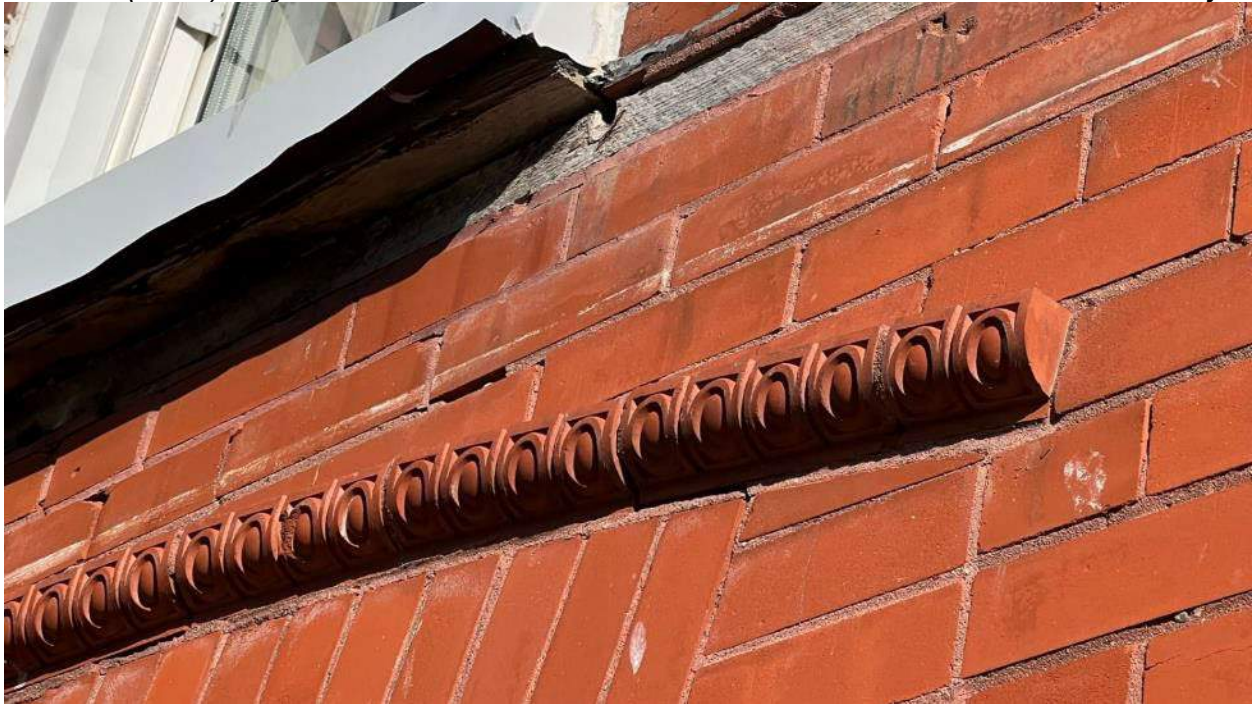
Source: Original Photo

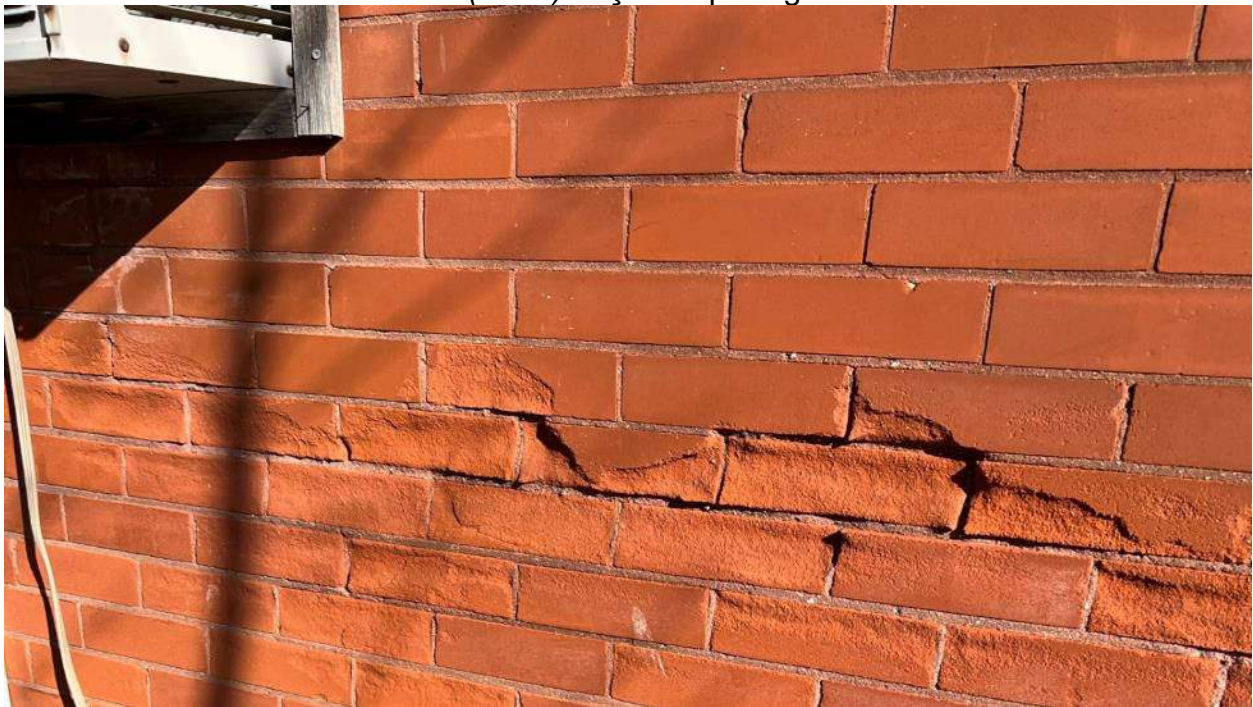
Source: Original Photo

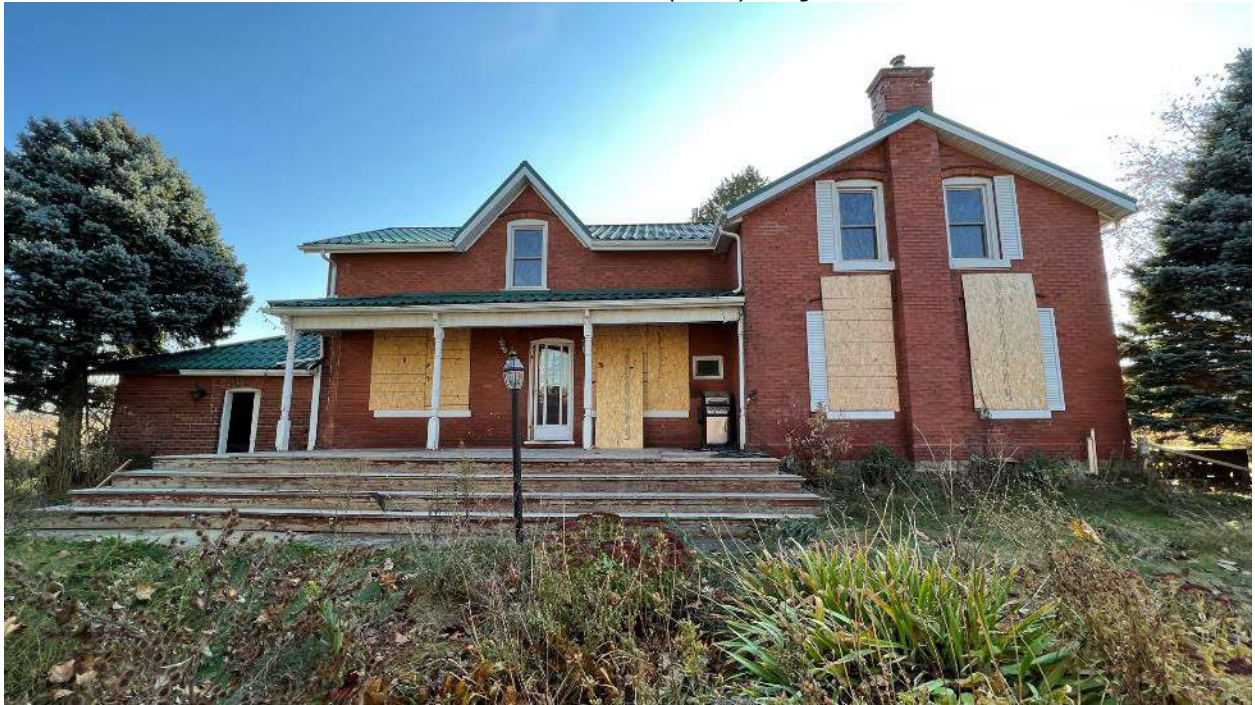
Source: Original Photo

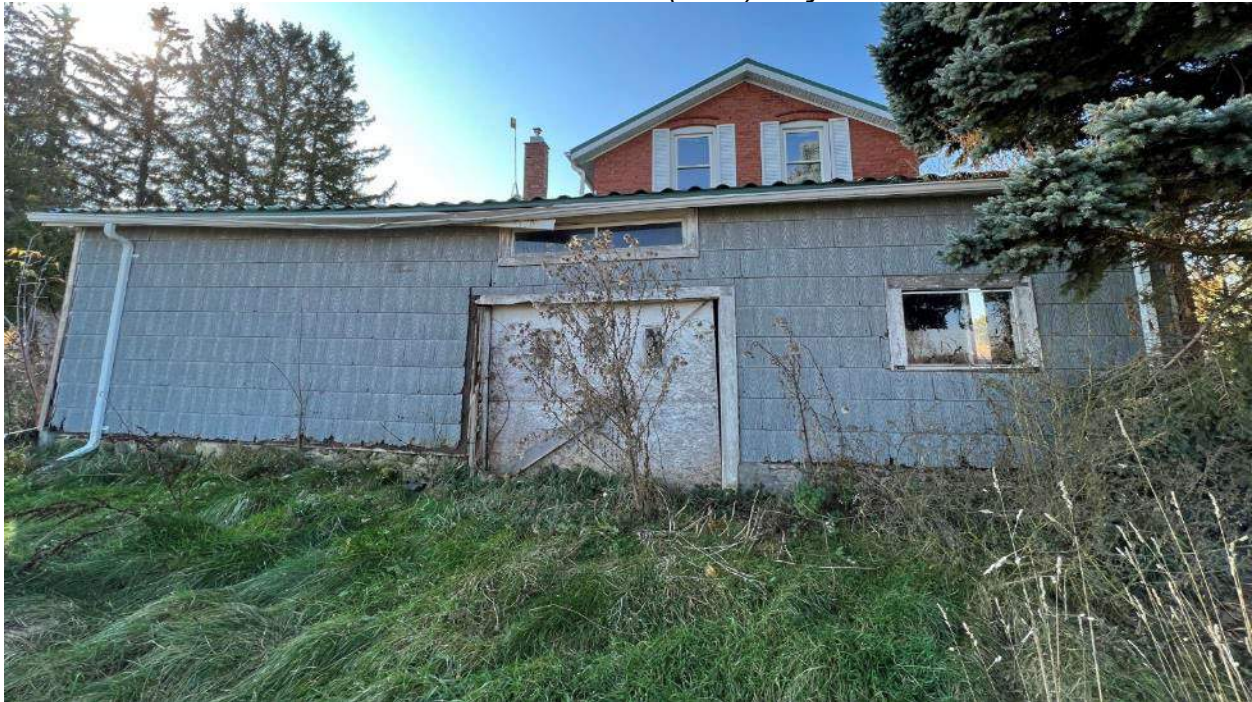
Source: Original Photo

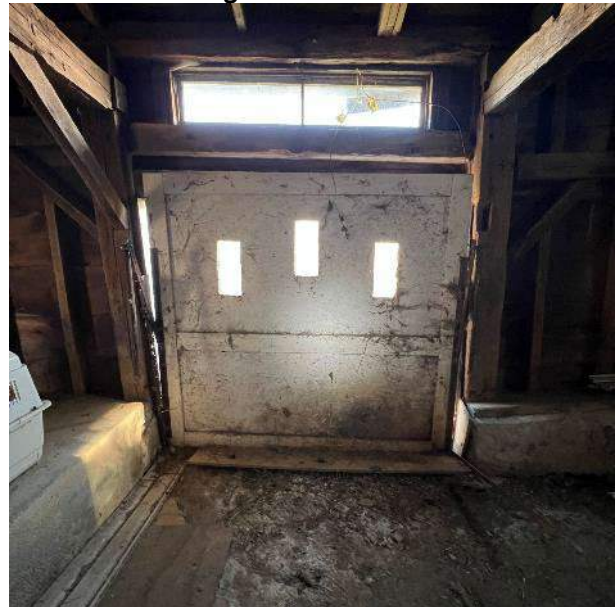
*Garage Addition Concrete Block
Foundation Walls*

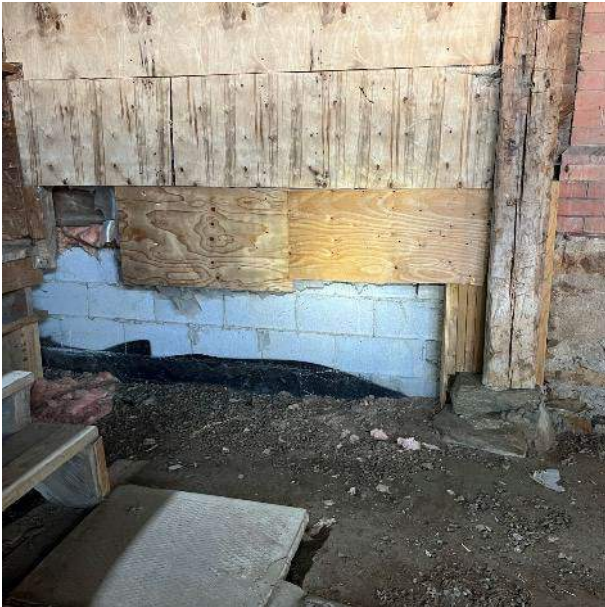
Garage Addition Sliding Door

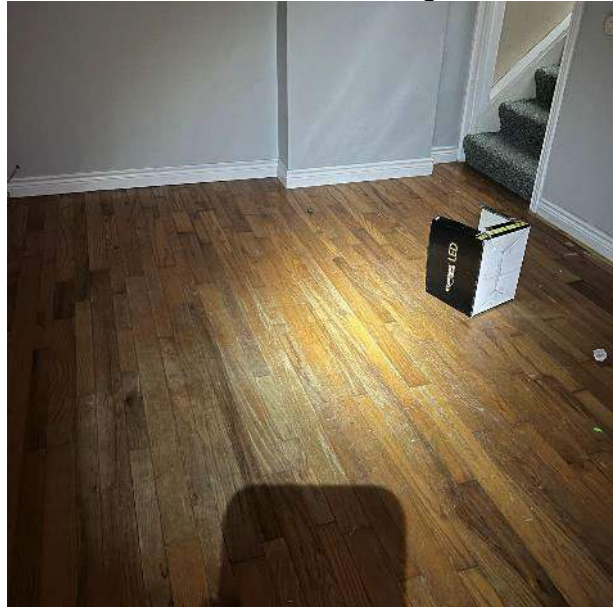
Stained Glass Windows

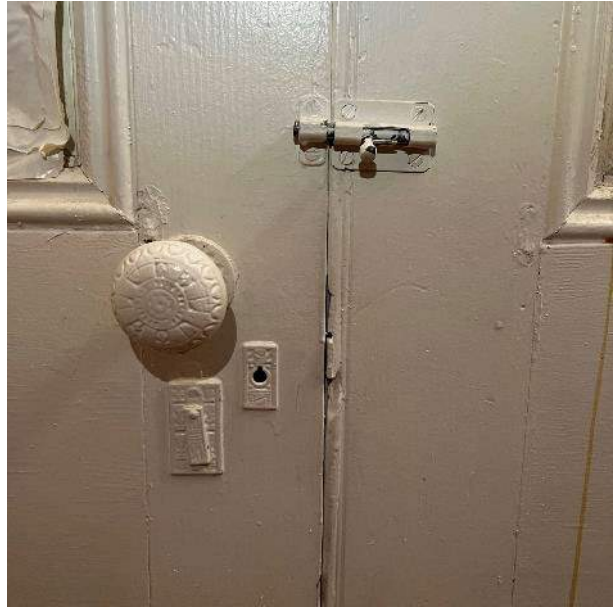
Pot Light with Water Damage

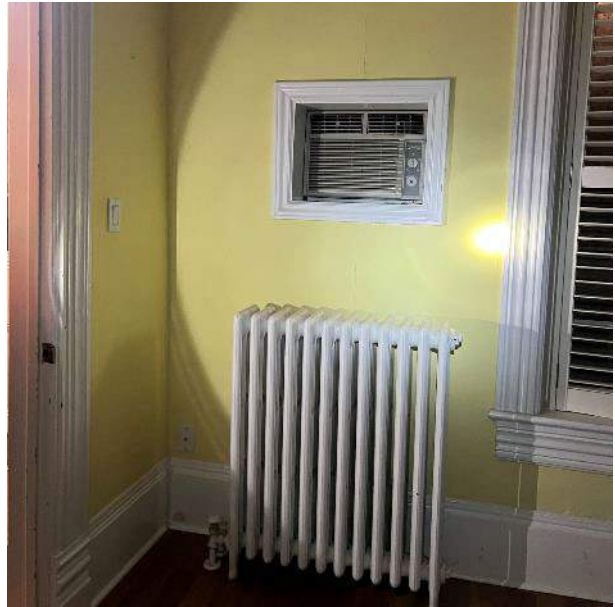
Closet - Green Checkered Floor

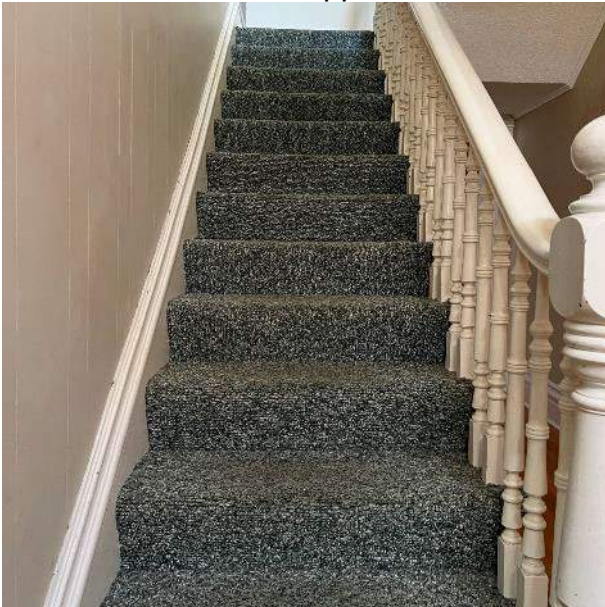
Damaged Wall Covering

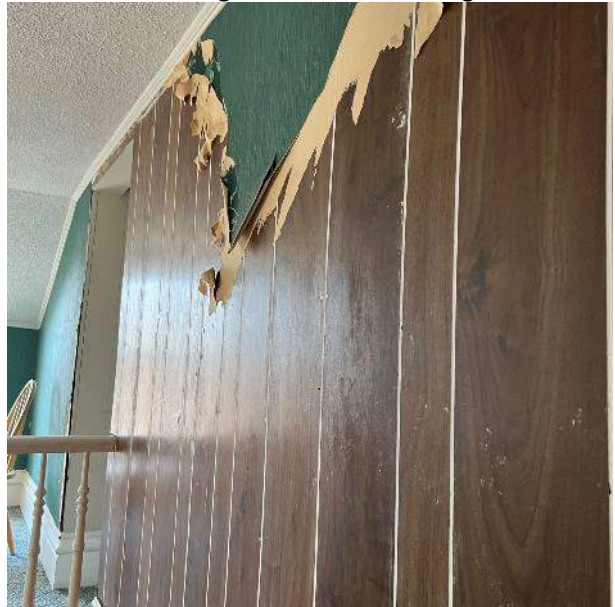
*Up Stairs Landing and Wall with Wood
Panelling*

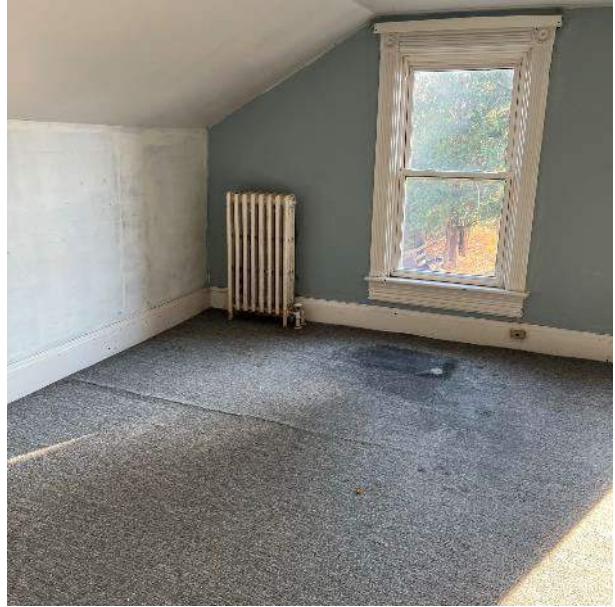
Upstairs Ceiling Water Damage

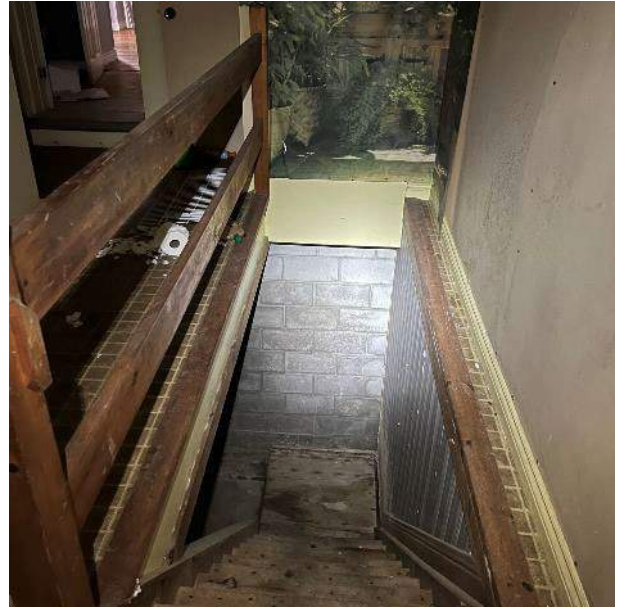
Basement Storage Room with Buckling Concrete Block Foundation

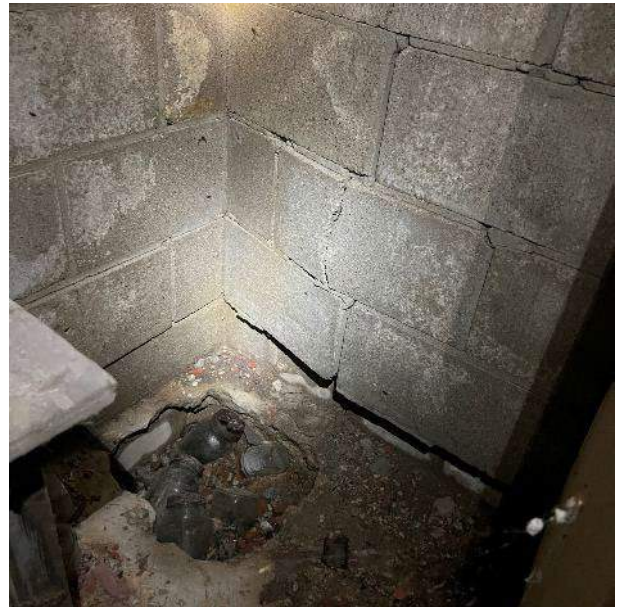
Transition between Concrete Block and Rubble Stone Foundations

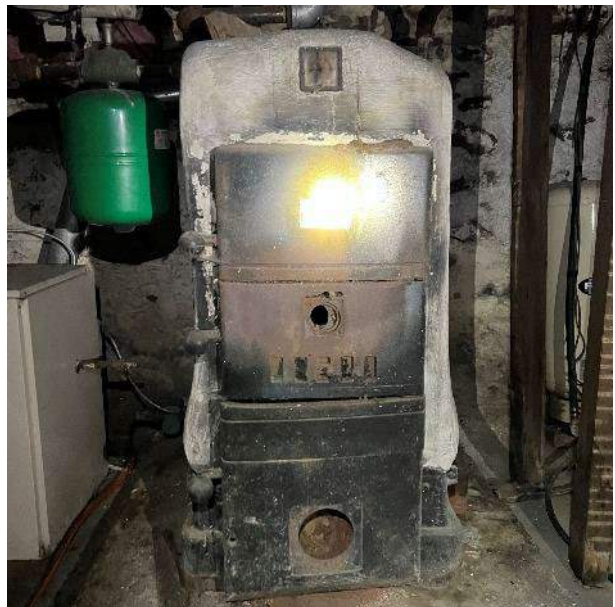
Floor Joists at Rubblestone Foundation

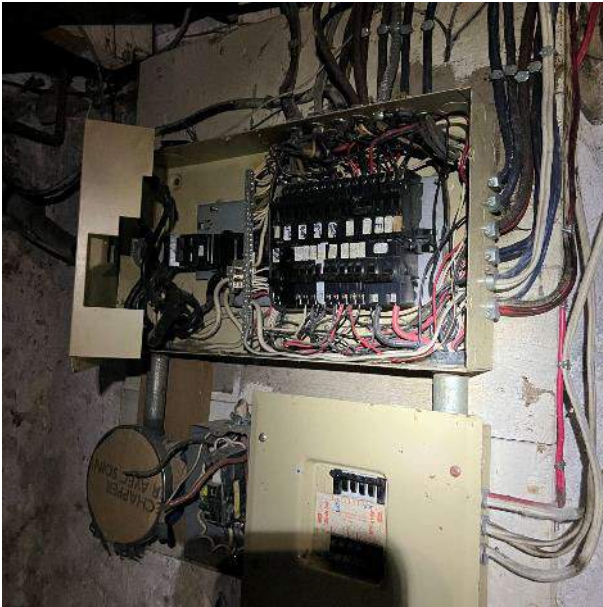
Rubblestone Foundation

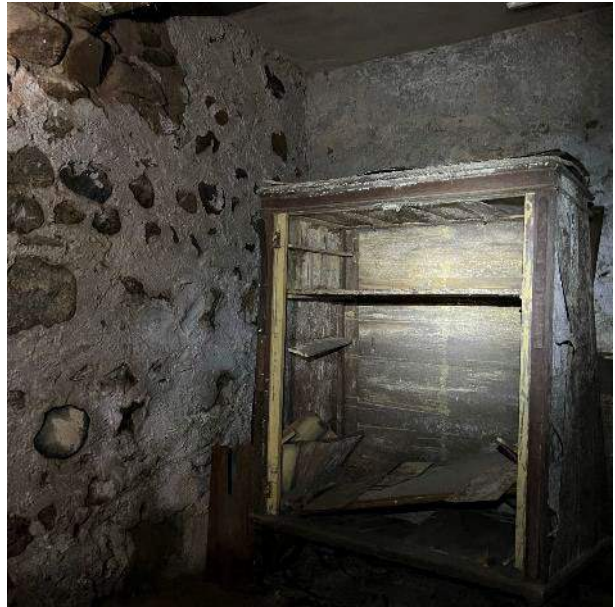
Electrical Equipment

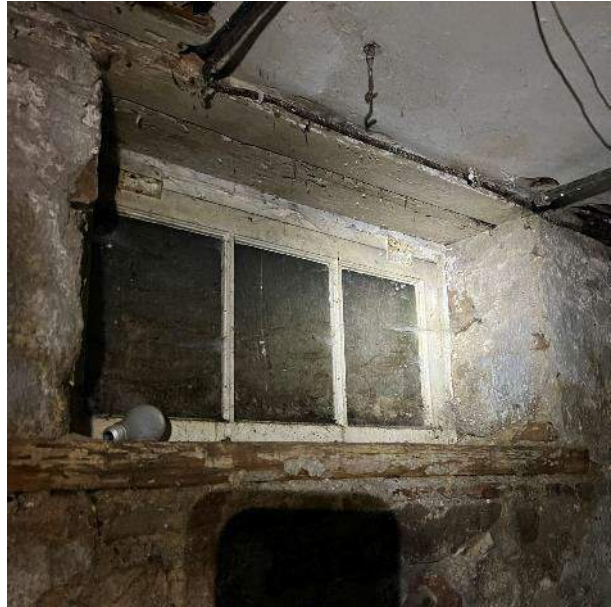
Basement Water Damage

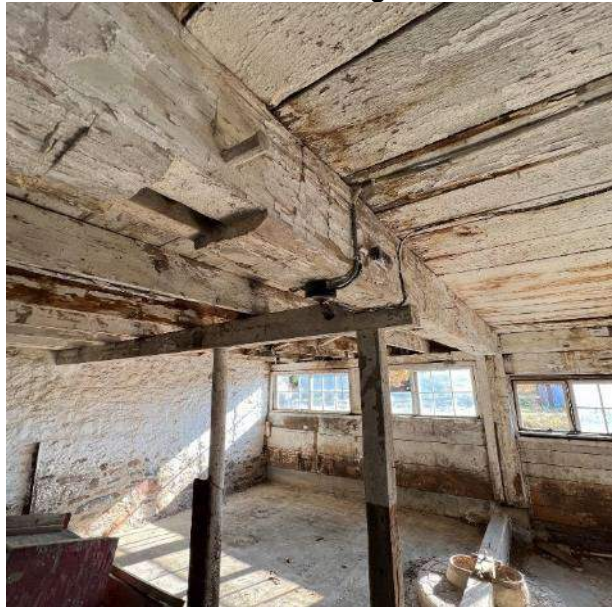
Interior Doorway and Foundation Walls

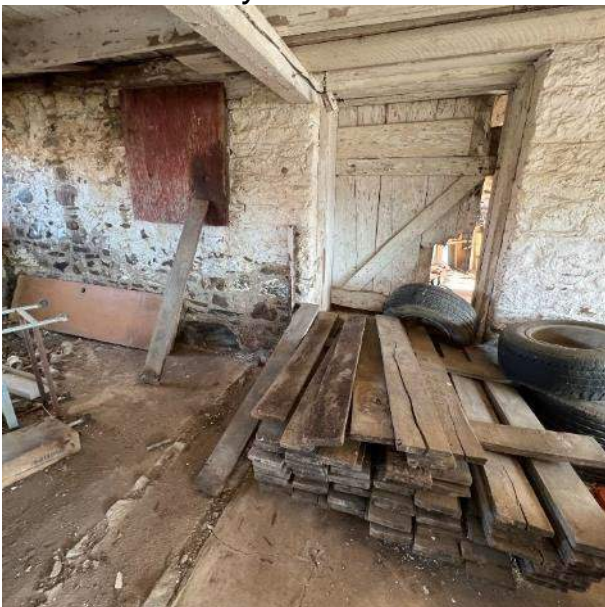
Animal Pen and Timber Construction

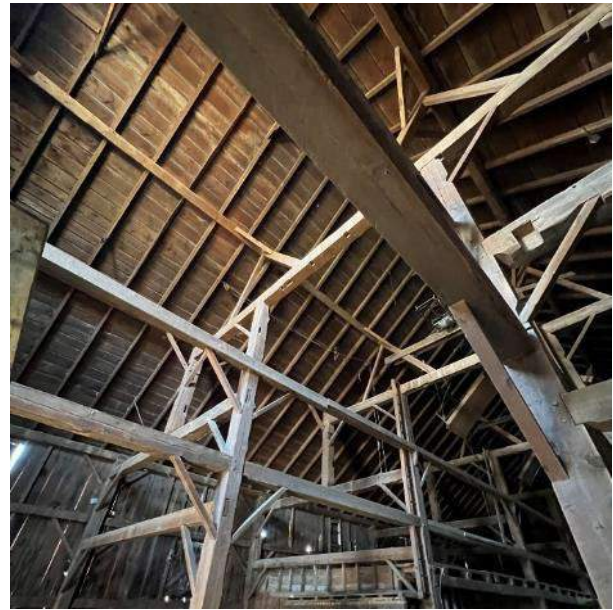
Rubble Stone Foundation

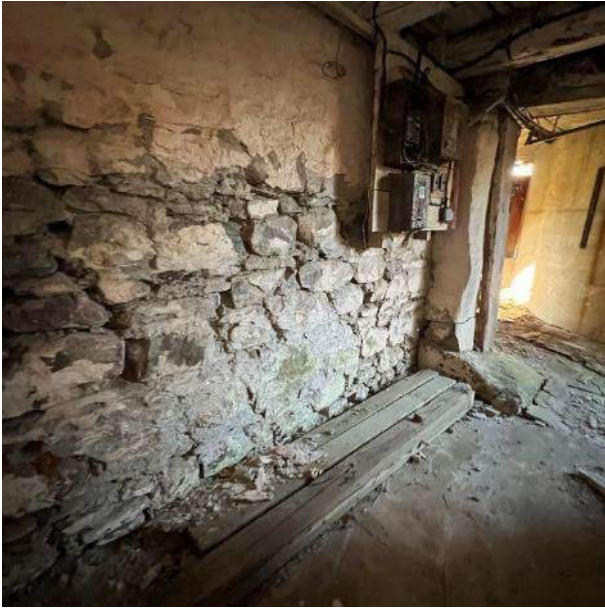
Connection with Concrete Silo

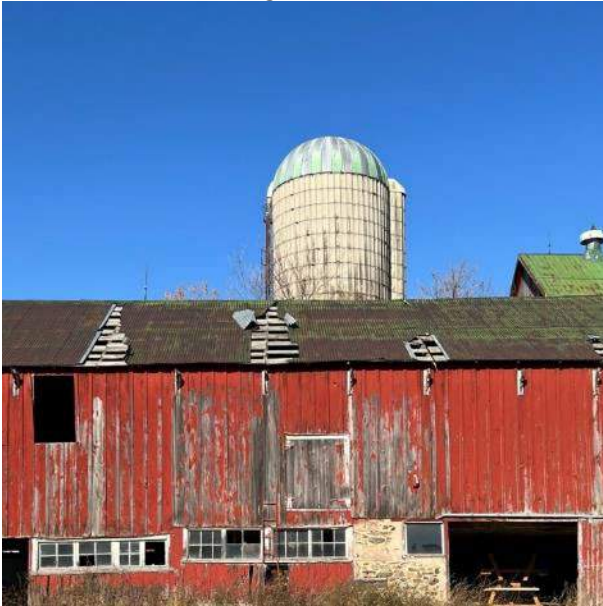
Two Tallest Silos One without Top

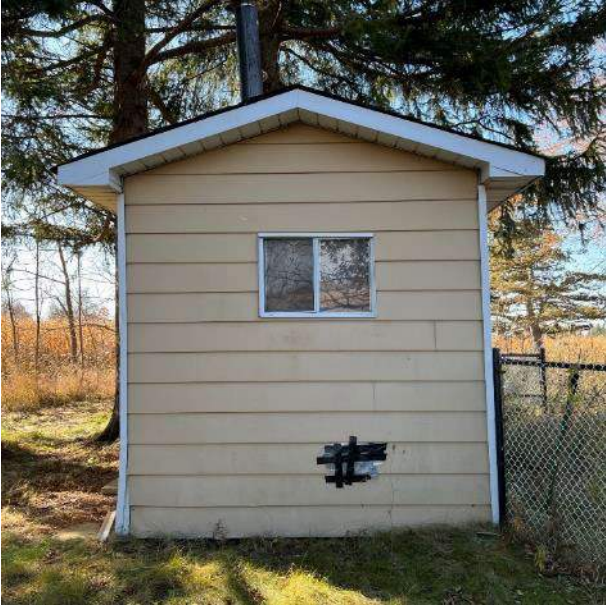
East Façade of Pool Shed

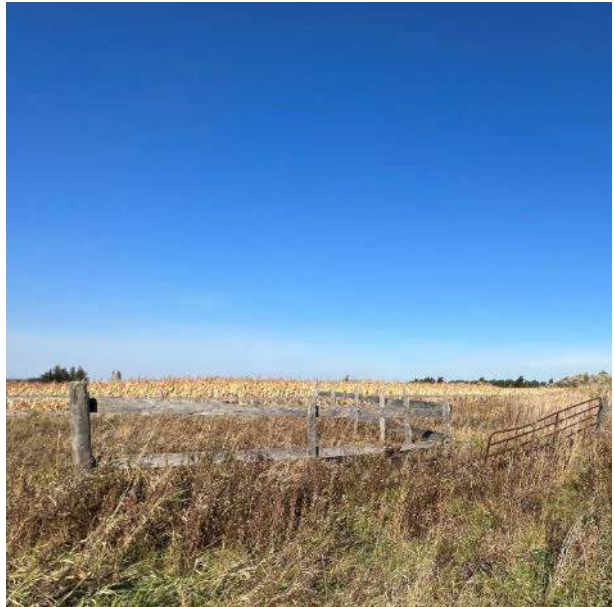
Old Concrete Foundation Northeast of Larger Barn

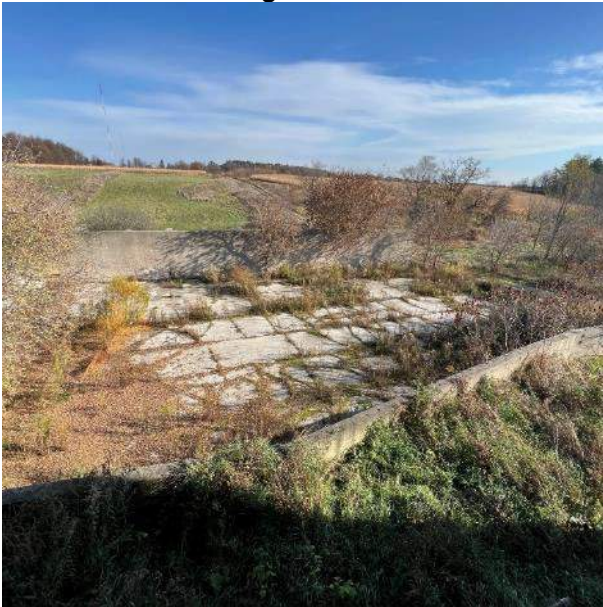
Old Concrete Foundation Northeast of Larger Barn

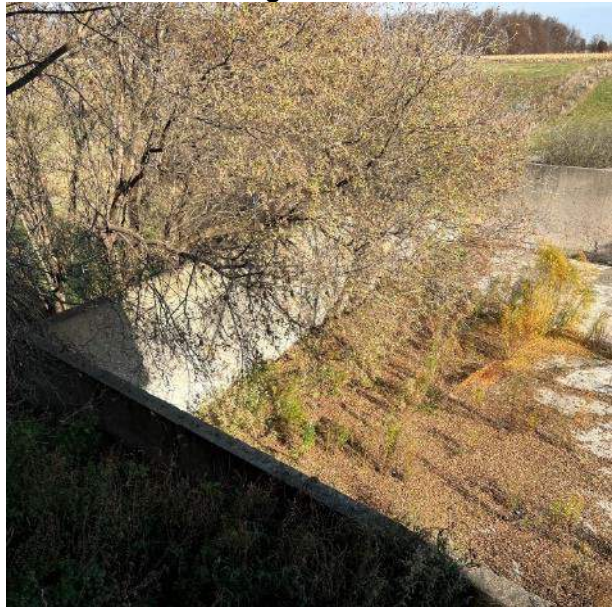
The following figure summarizes the existing site context in broader detail (images are not necessarily to scale).

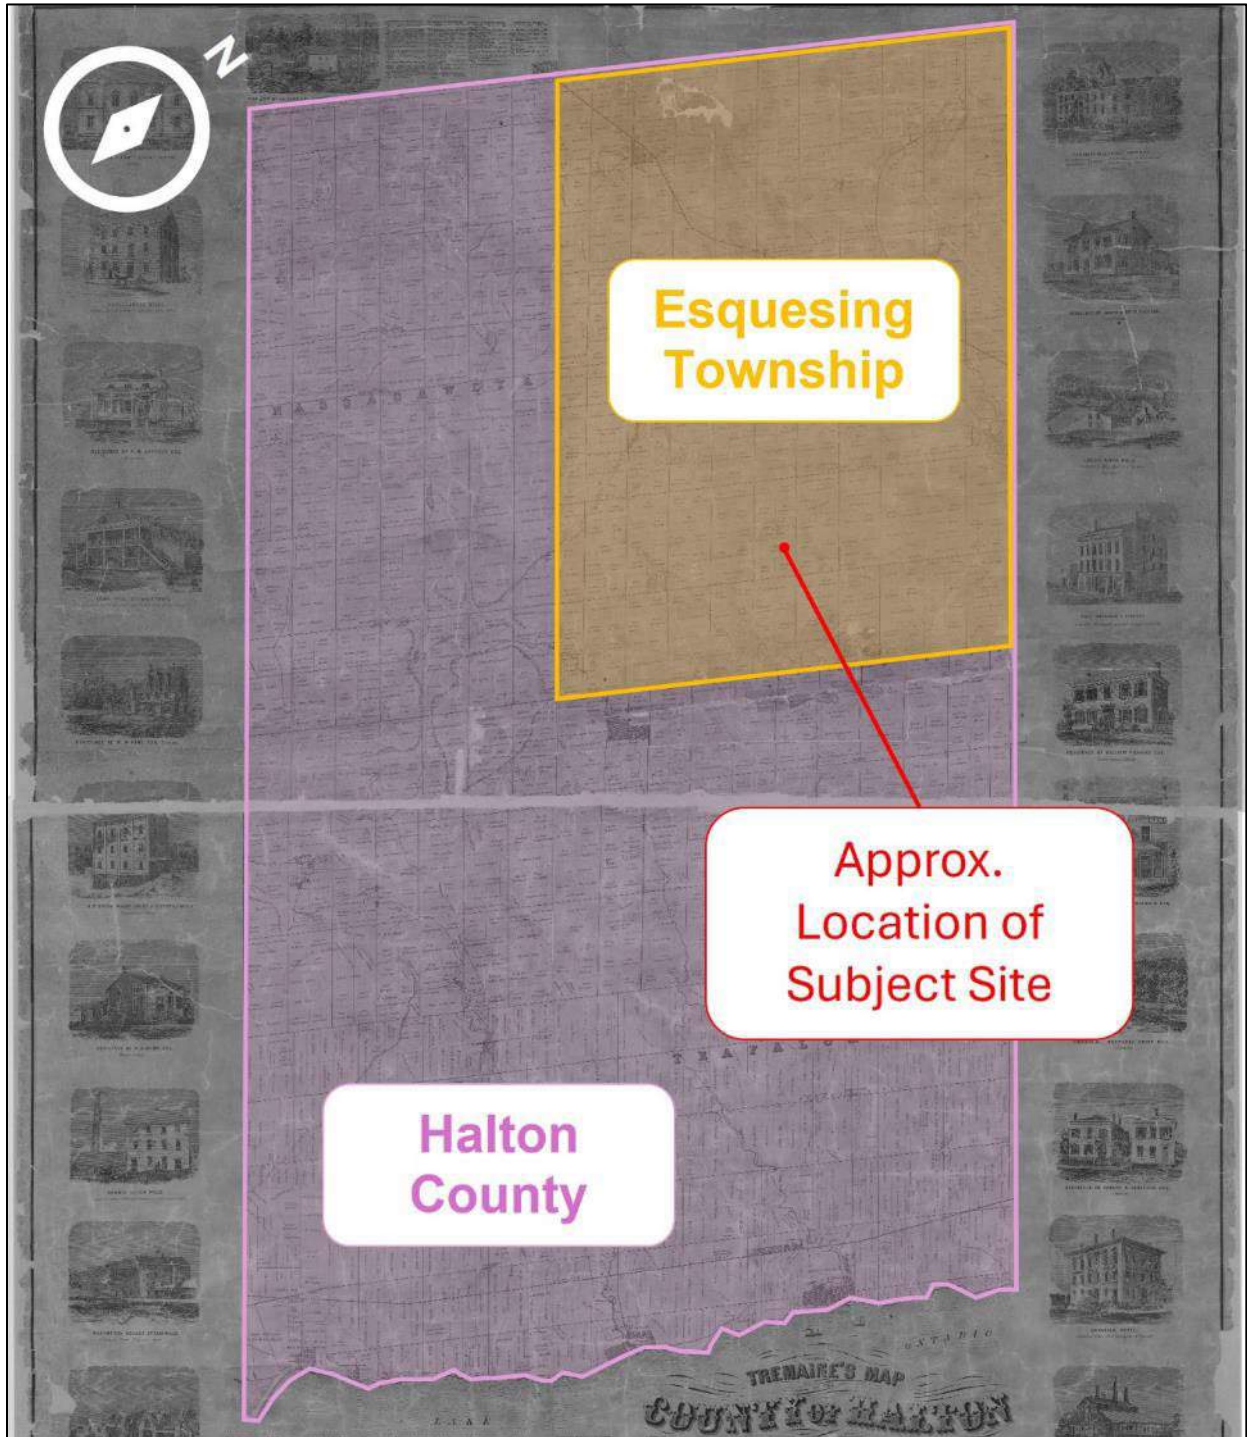
Source: Tremaine, 1858

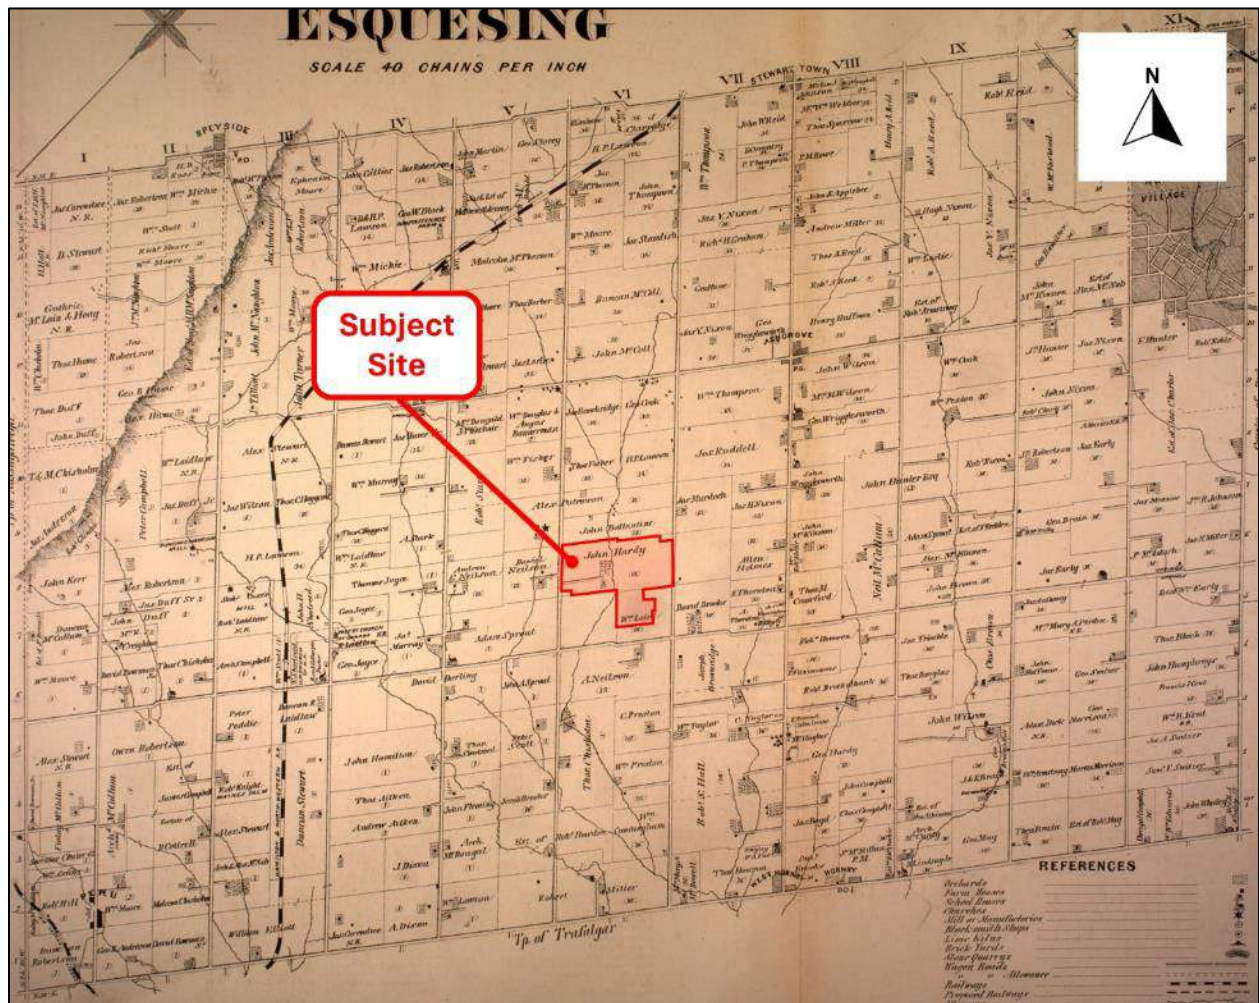
Source: Walker & Miles, 1877

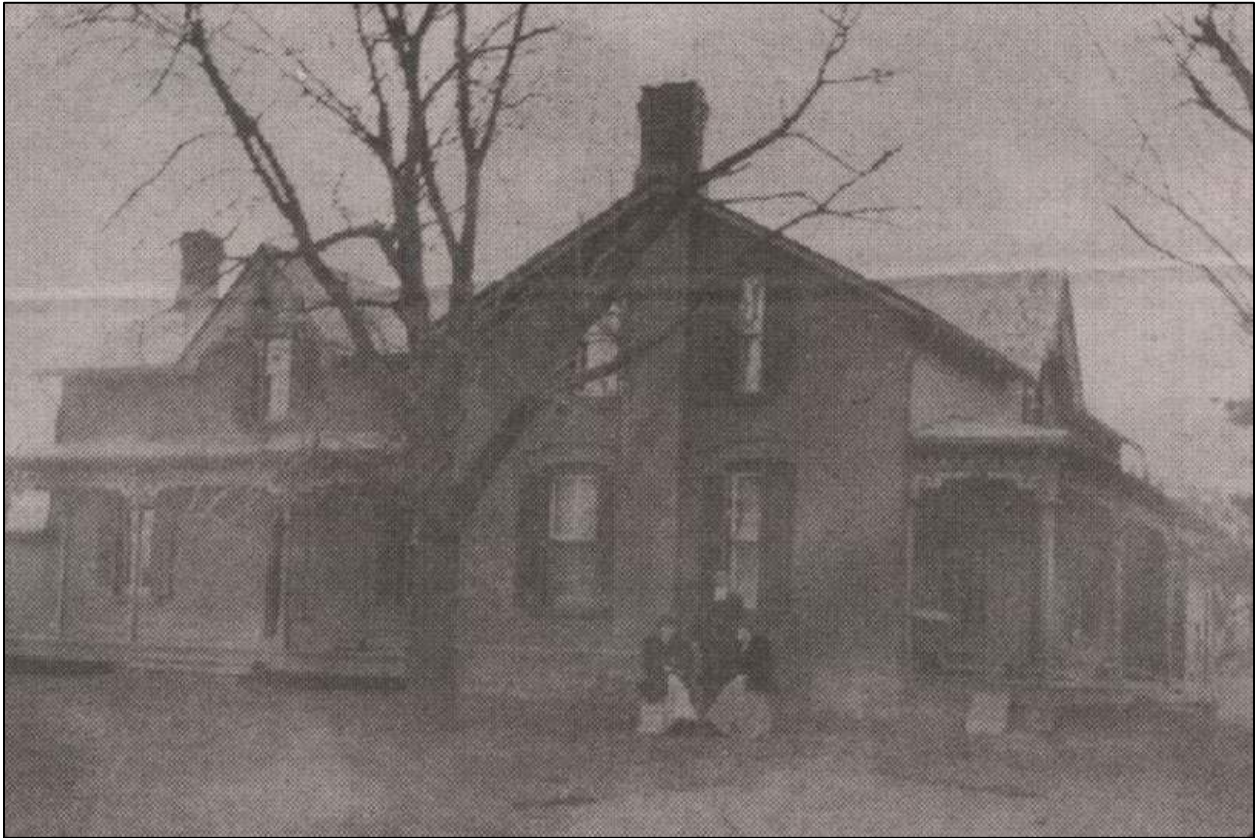
Source: North Halton Compass, 2000

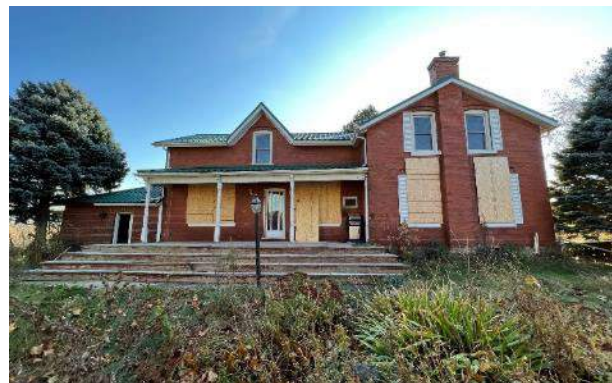
Source: Original Photo
