Cultural Heritage Evaluation Report

9259 Fifth Line
Town of Halton Hills, Ontario

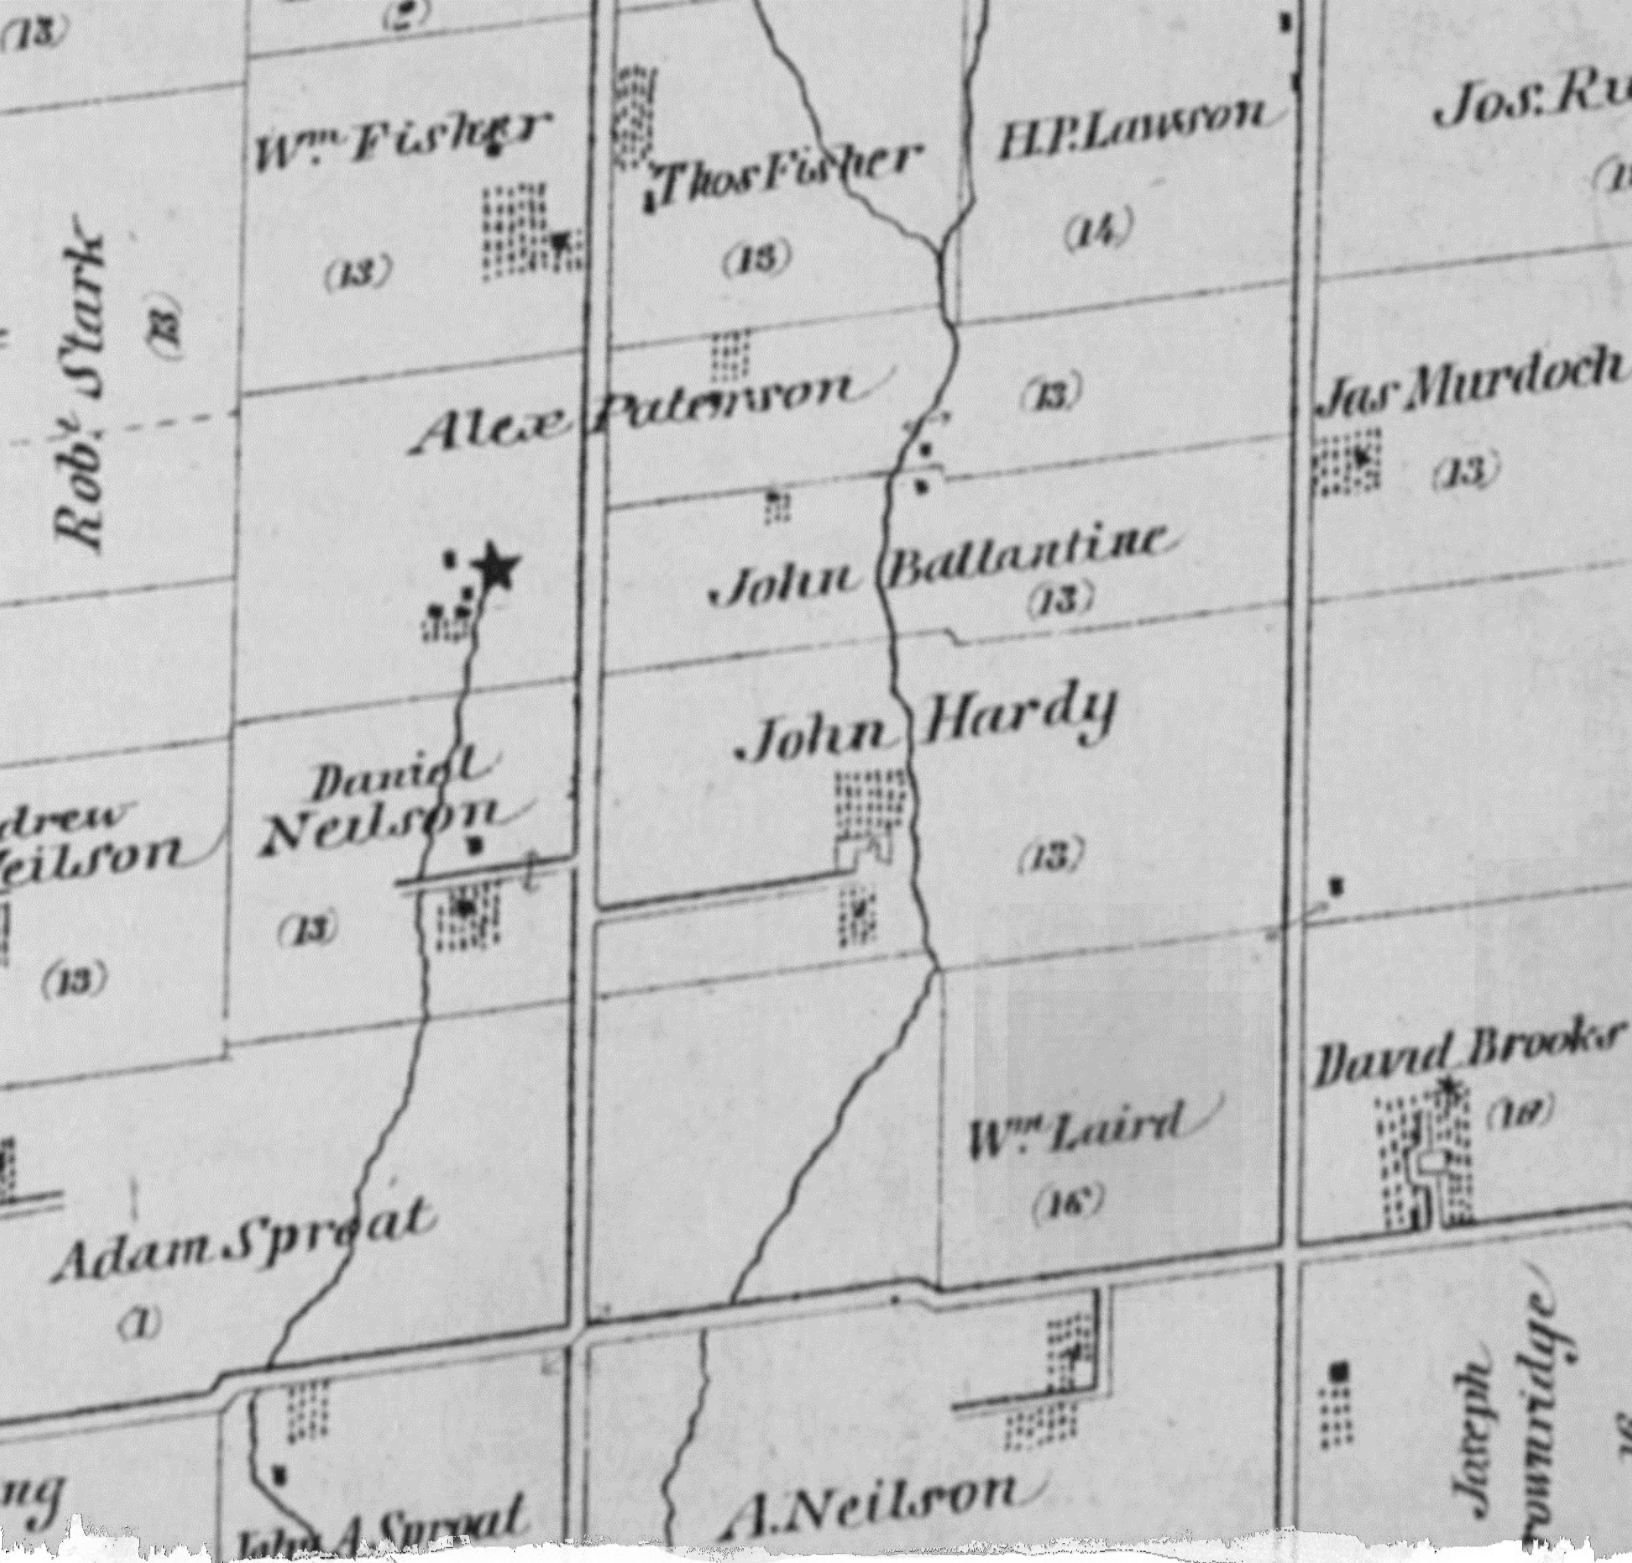
Accordingly, we recommend removing the subject site from the Register.

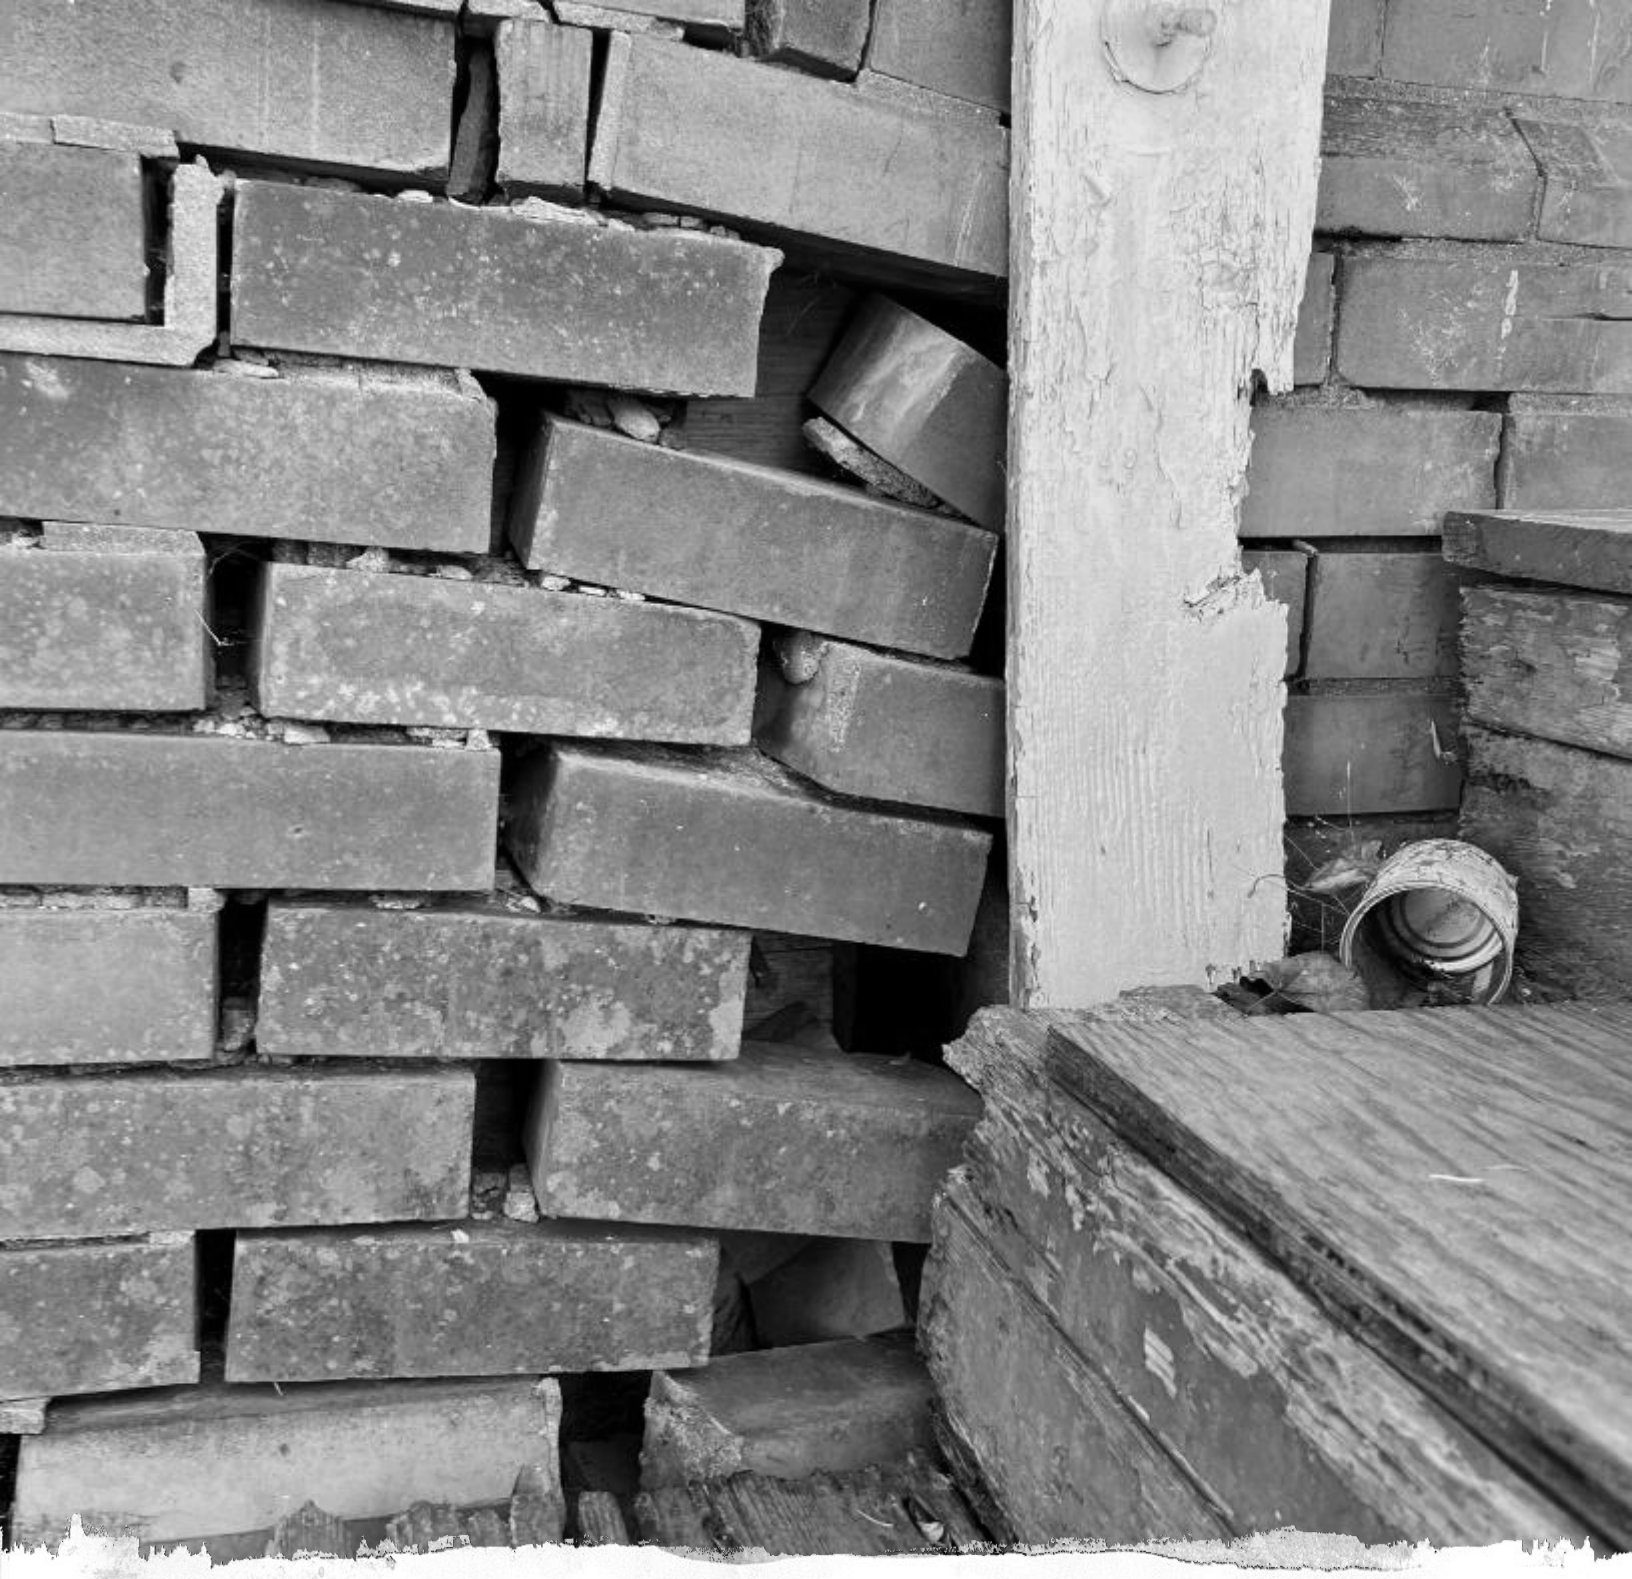
Appendix A - Tacoma Engineers Inc. Structural Condition Assessment

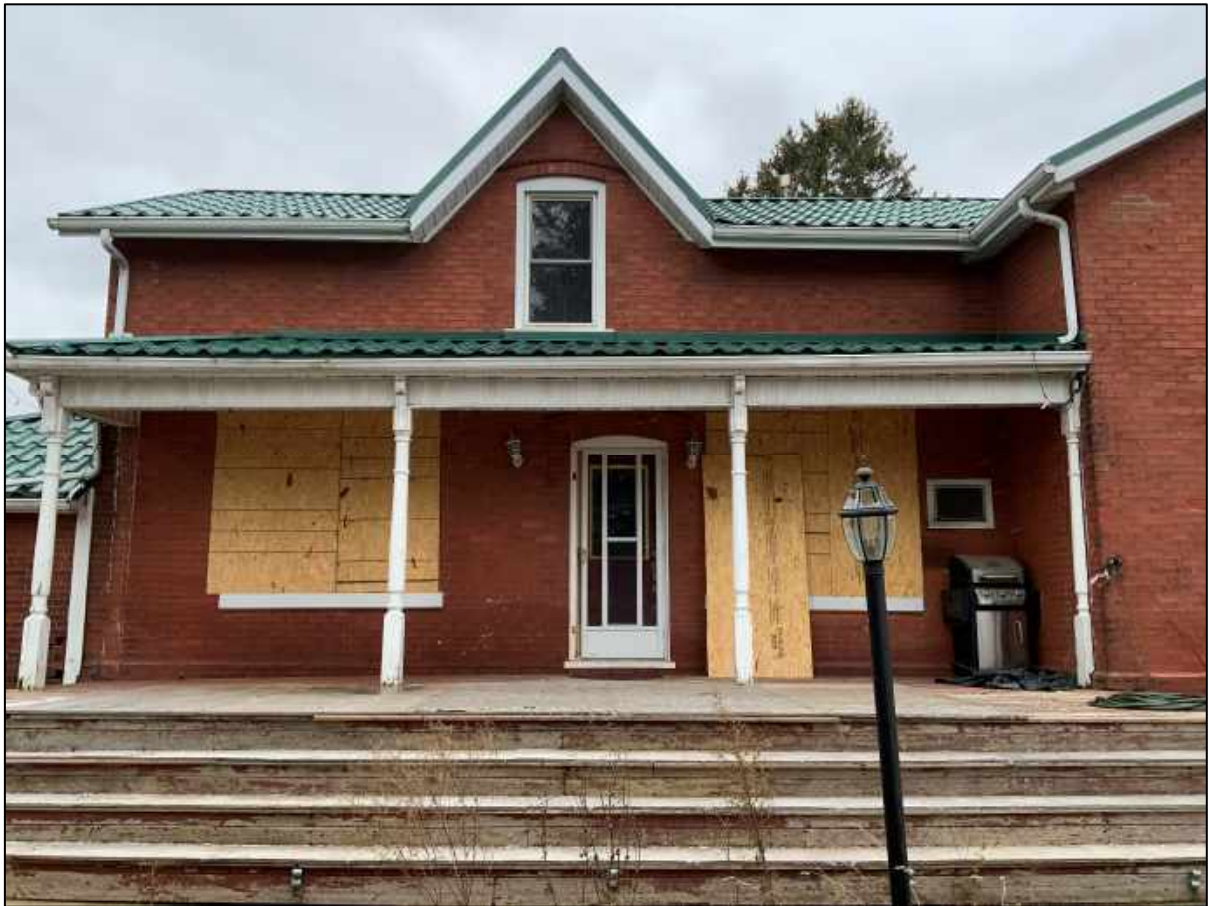
9259 Fifth Line
Georgetown Ontario

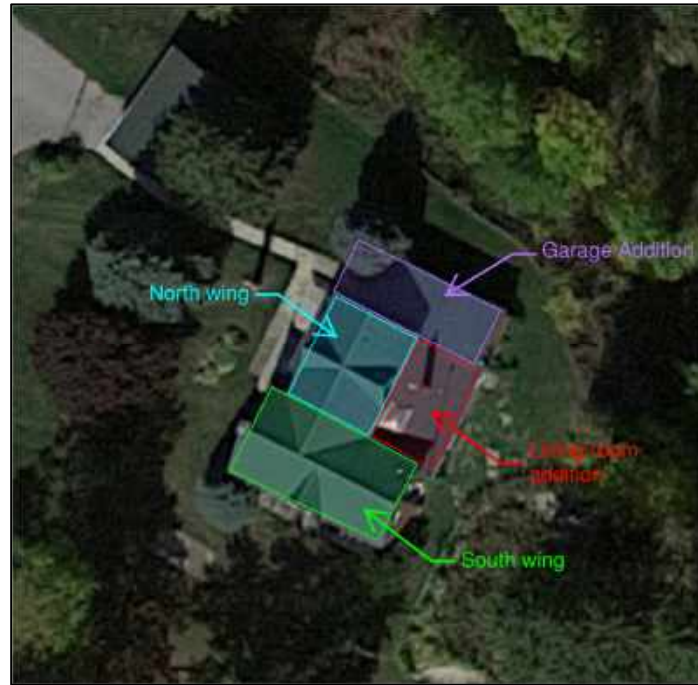
Photograph 1: Overview of the Hardy Farm residence.

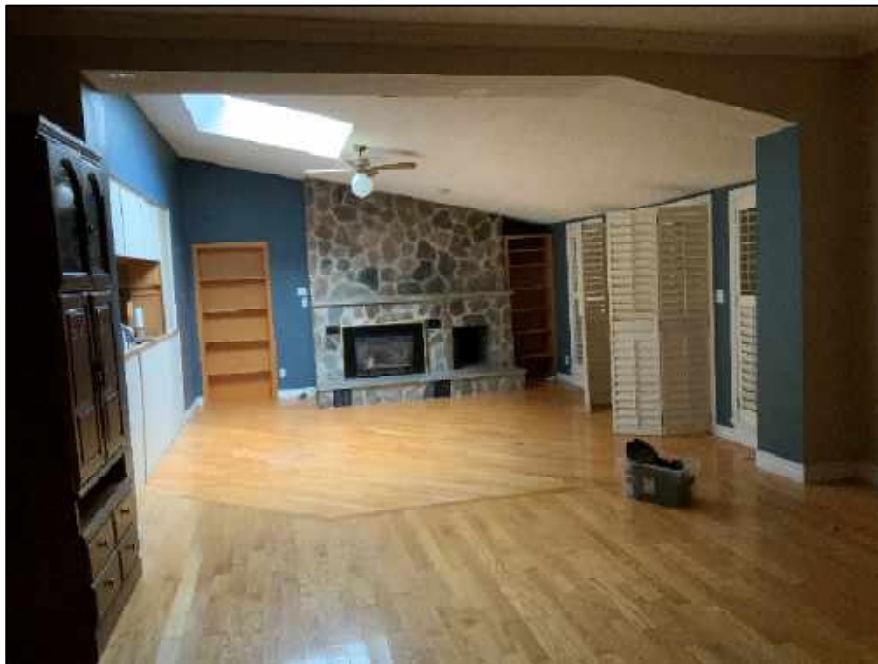
Photograph 3: Overview of living room addition.

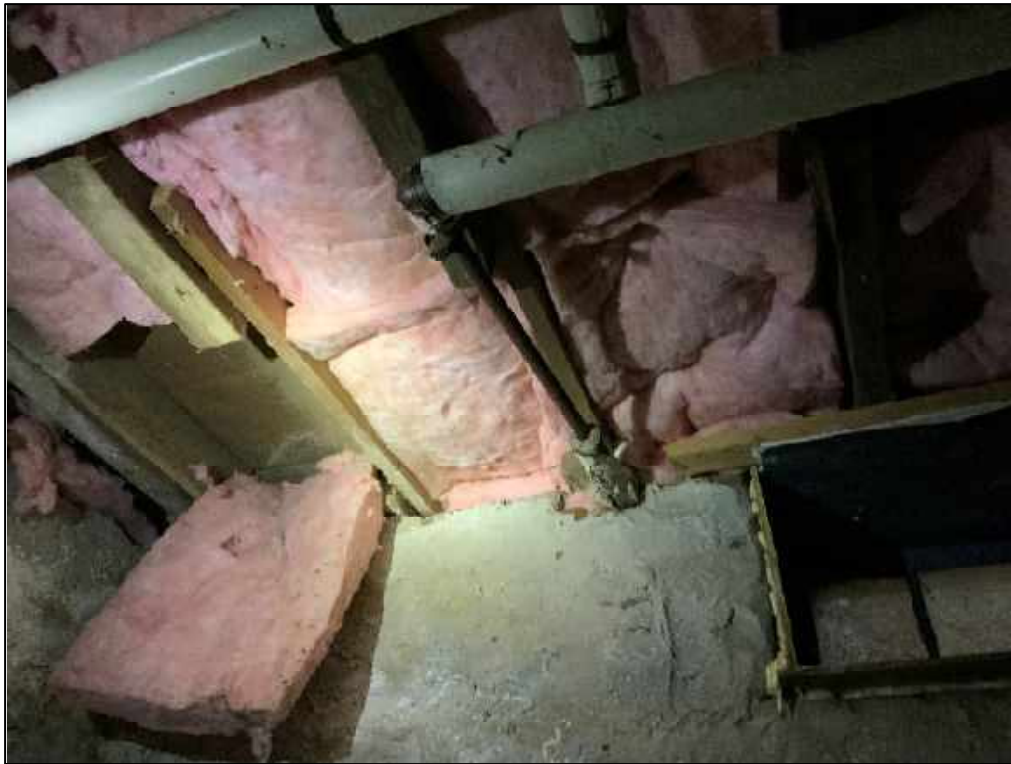
Photograph 4: Cut joists.

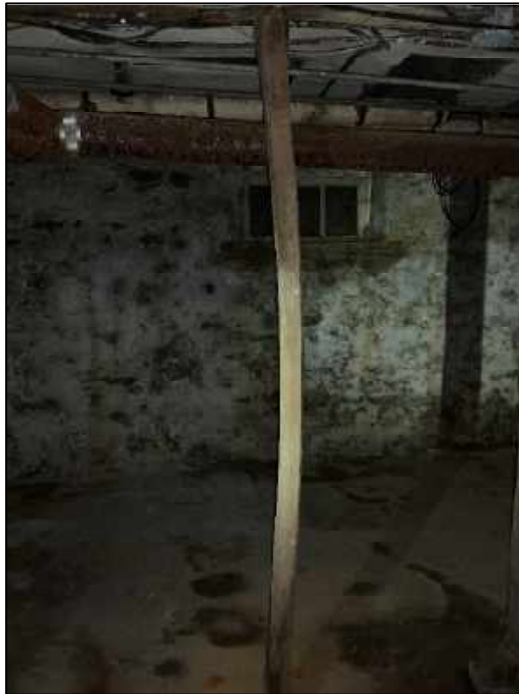
Photograph 6: Buckled prop in the intermediate bearing line.

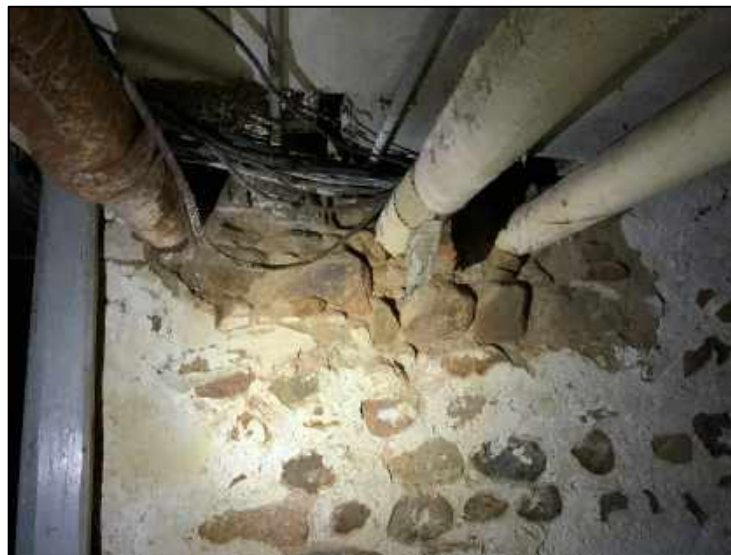
Photograph 10: Deteriorated area of foundation wall.

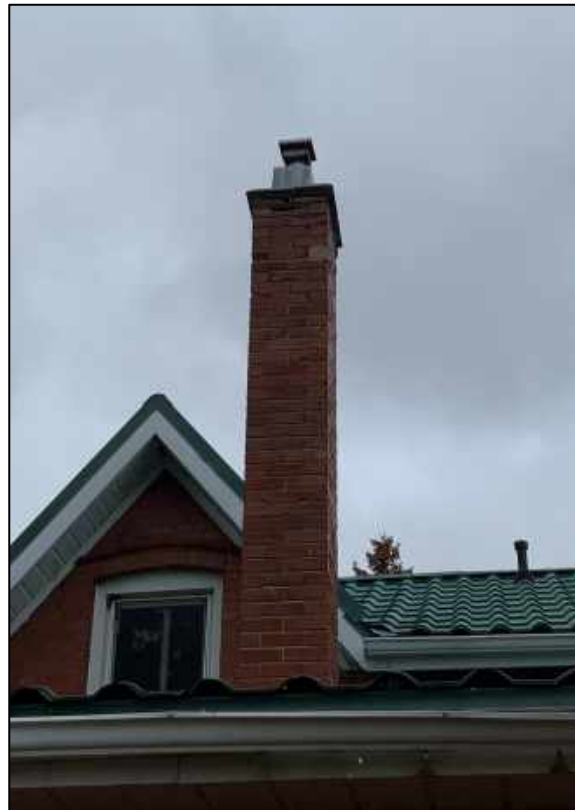
Photograph 19: Severe deterioration of brick at chimney above living room roof line.

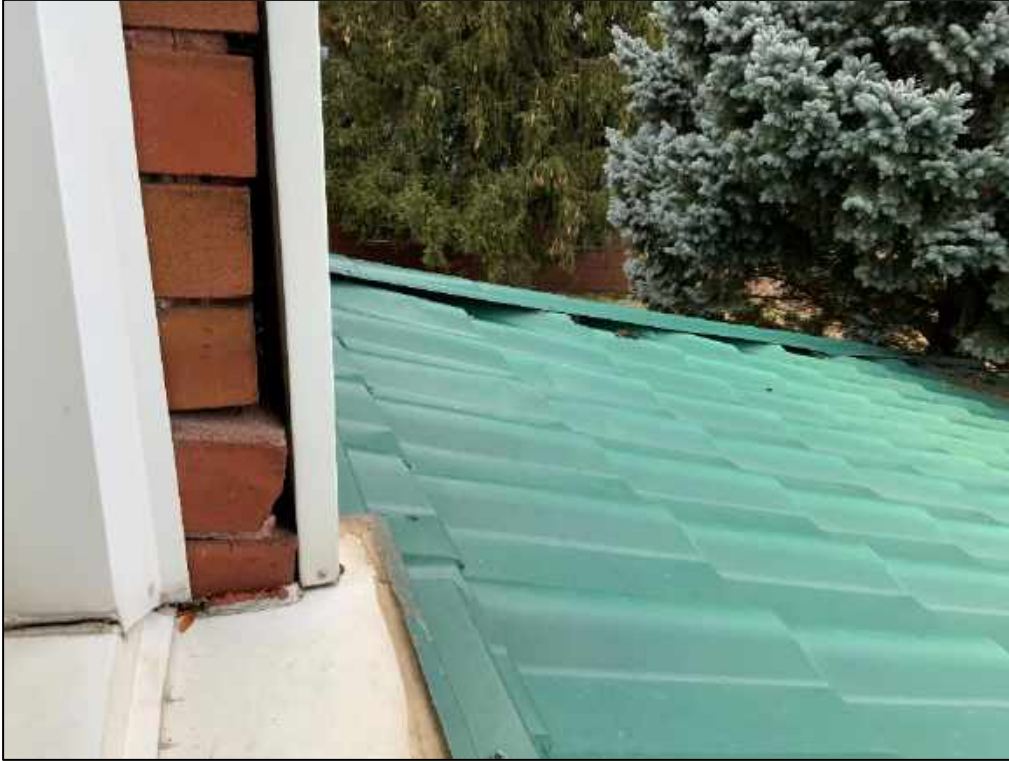
Photograph 20: Failed brick behind decorative shutter above garage.

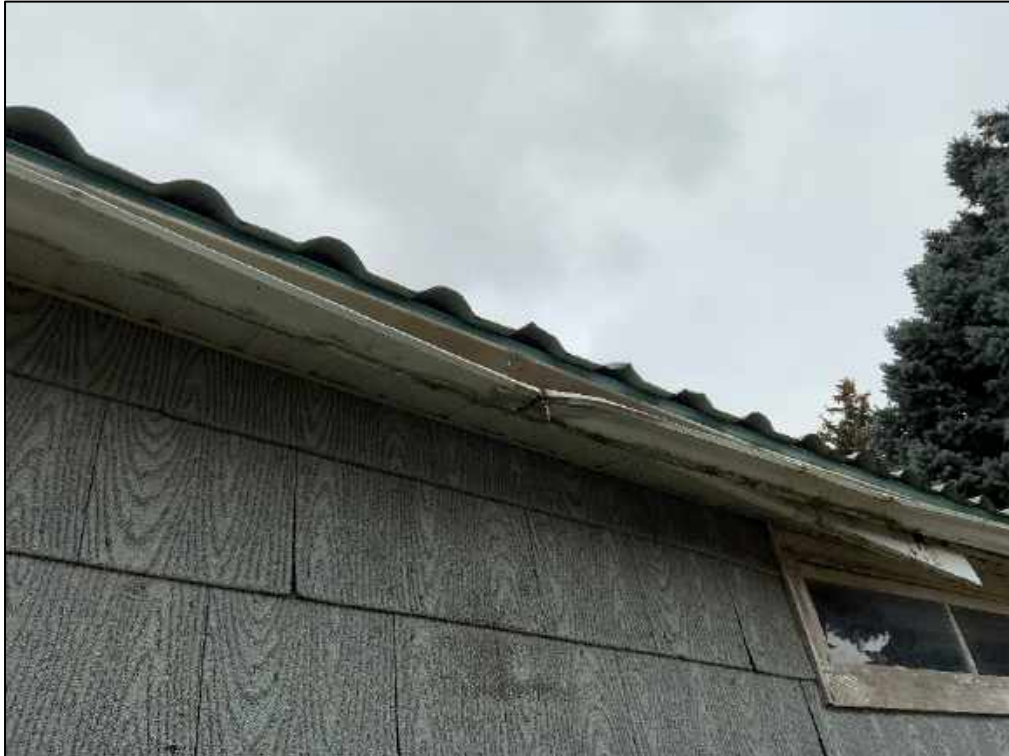
Photograph 21: Damaged eavestrough on garage.

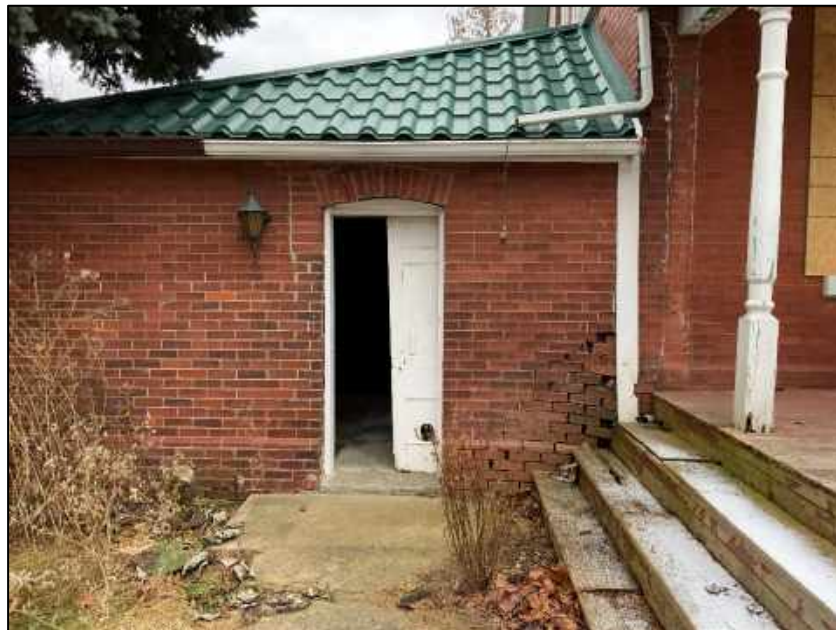
Photograph 23: Buckled and collapsed brick veneer on garage.
