## Cultural Heritage Evaluation Report

9259 Fifth Line  
Town of Halton Hills, Ontario

# Hardy Farm Residence Structural Condition Assessment

9259 Fifth Line  
Georgetown Ontario

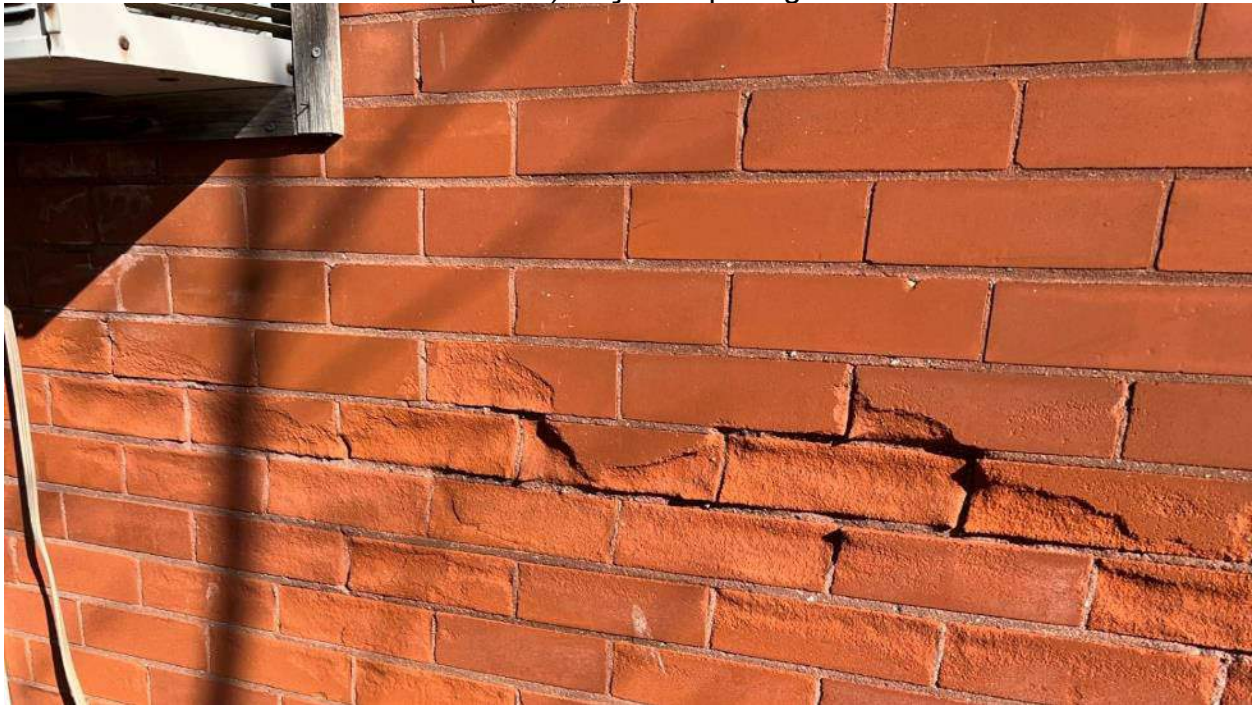
*South (Front) Façade Spalling Brick*

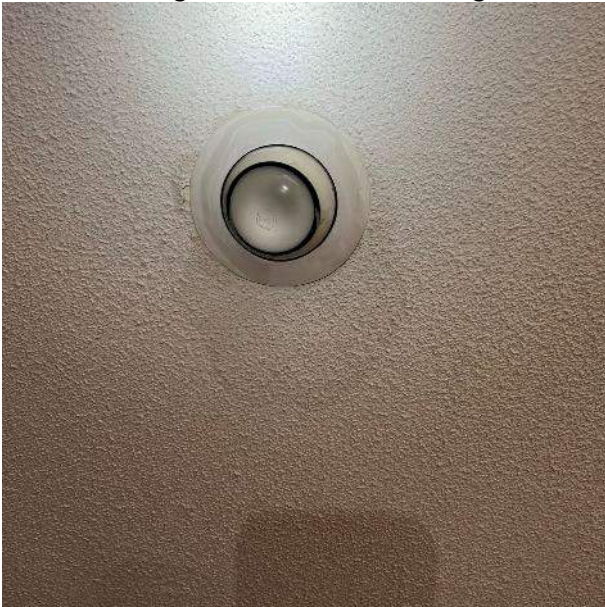
*Pot Light with Water Damage*

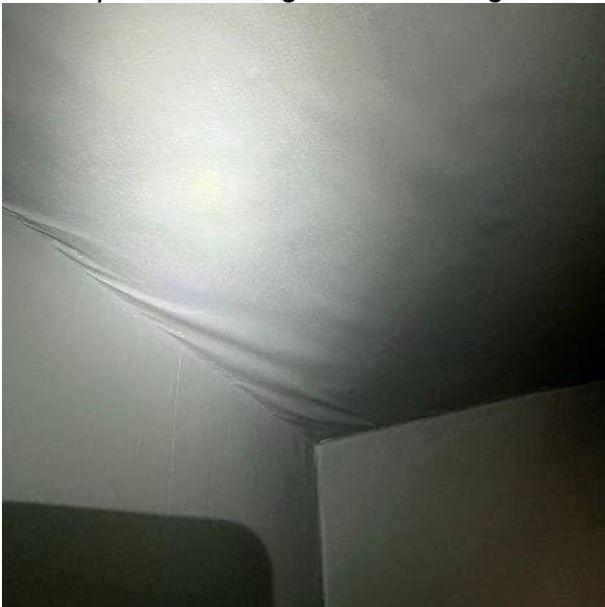
*Upstairs Ceiling Water Damage*

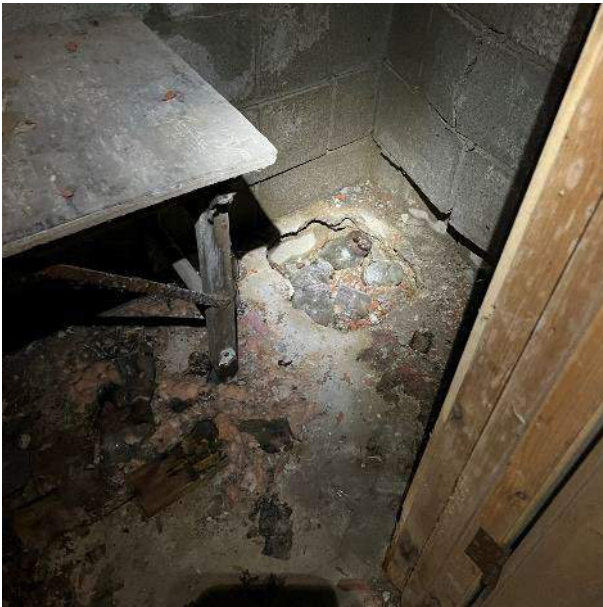
*Basement Storage Room with Buckling  
Concrete Block Foundation*

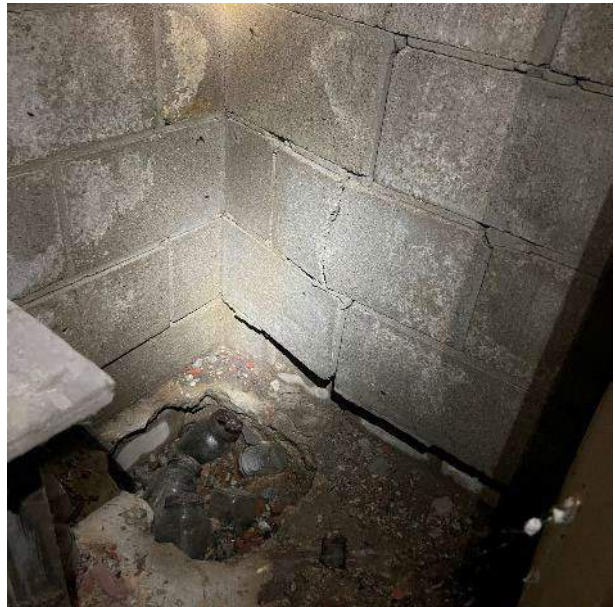
*Buckling Concrete Block Foundation*

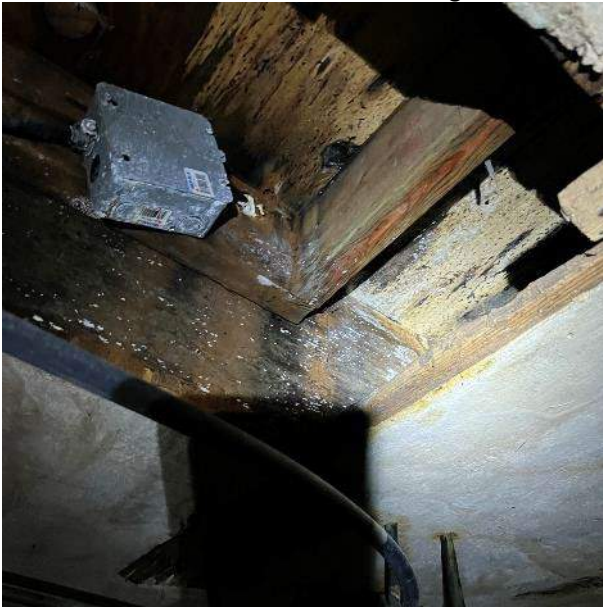
*Basement Water Damage*

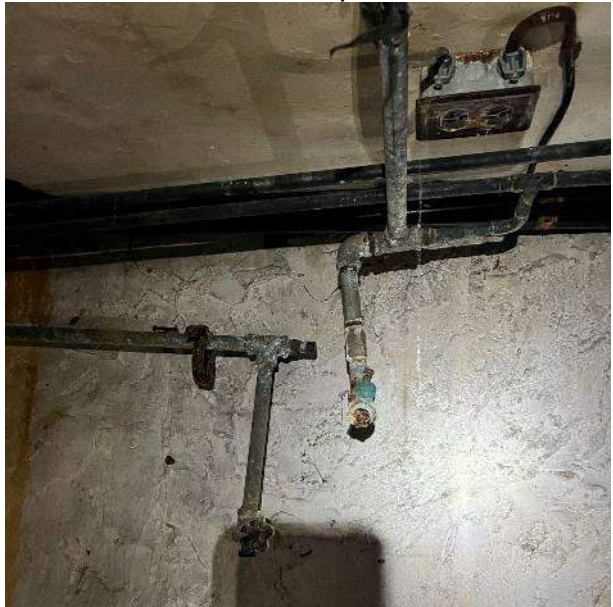
*Burst Pipe*

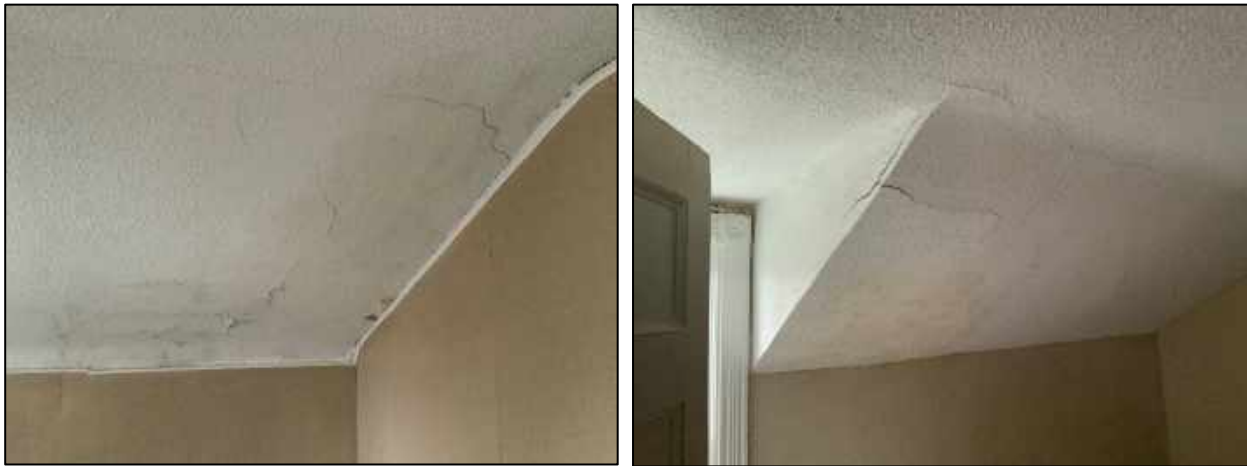
**Photograph 2a & b: Cracks in north wing stair and adjacent bedroom.**

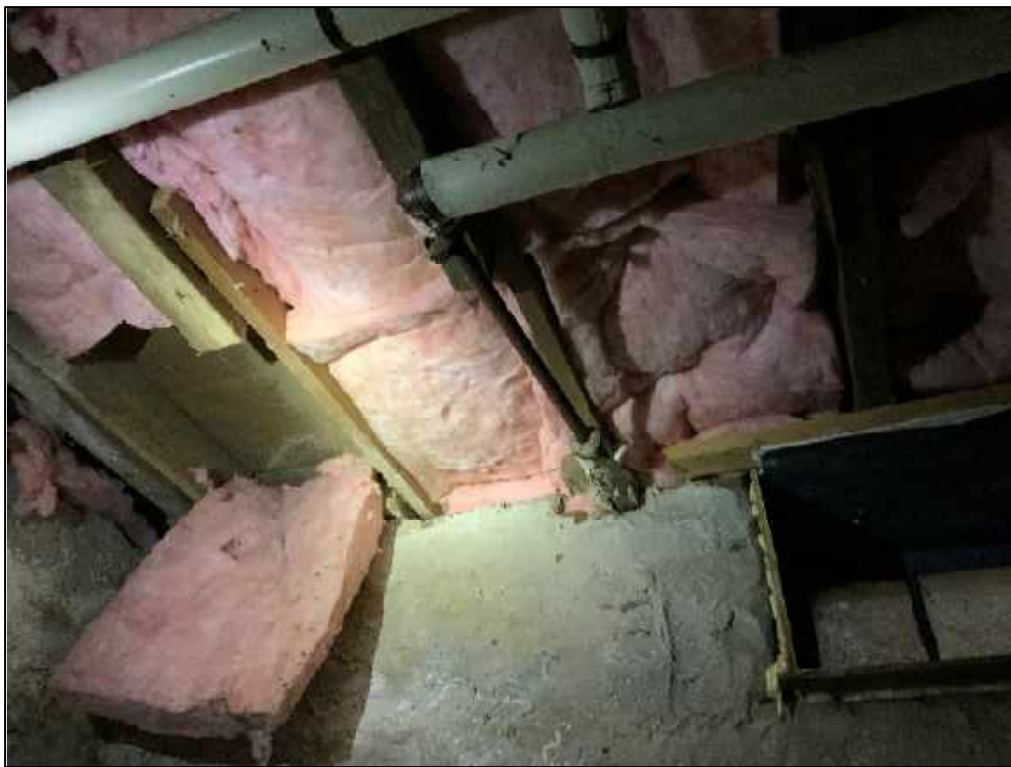
In the southeast room, joists were cut short of their bearing points near the southeast corner of the room, as seen in Photograph 4.

**Photograph 4: Cut joists.**

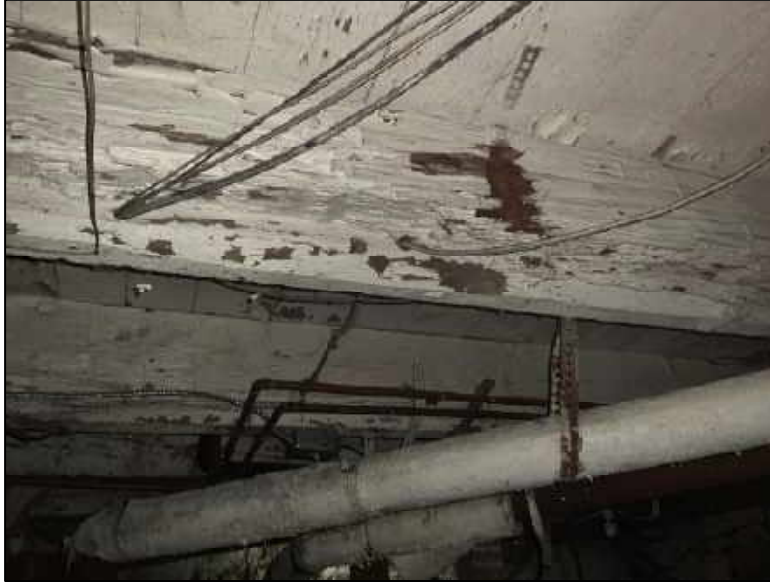
In the southwest room, deterioration of certain joists was noted, as seen in Photograph 5. These joists had been sistered at some point.

**Photograph 5: Deteriorated and sistered joists.**

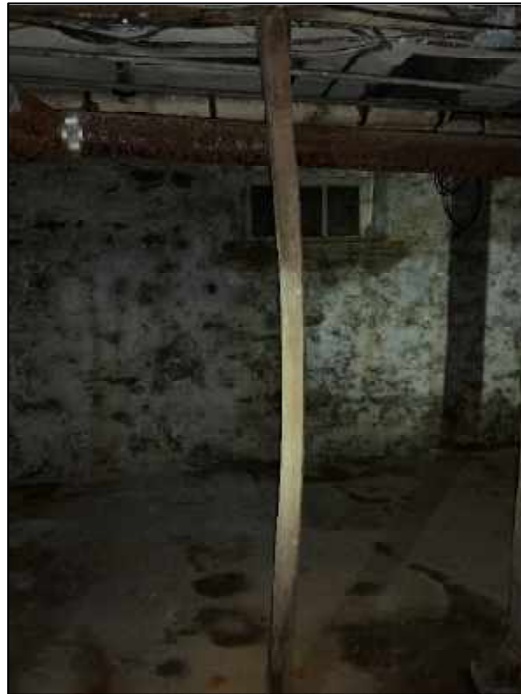
In the northwest room, one of the props in the intermediate bearing line had buckled, as seen in Photograph 6. Water damage was noted on the floorboards and floor joists above and significant amounts of mold were present (Photograph 7). Evidence of water ingress was present from above and staining was noted on the foundation walls at the northeast corner of the room (Photograph 8). The source of the water could not be determined at the time of review. This area of the basement was notably humid, and corrosion was noted on the exterior of a steel pipe (Photograph 9). Deteriorated areas of foundation wall were noted near the door at the south end of the room (Photograph 10). Generally, the foundation walls were otherwise in fair condition.

**Photograph 6: Buckled prop in the intermediate bearing line.**

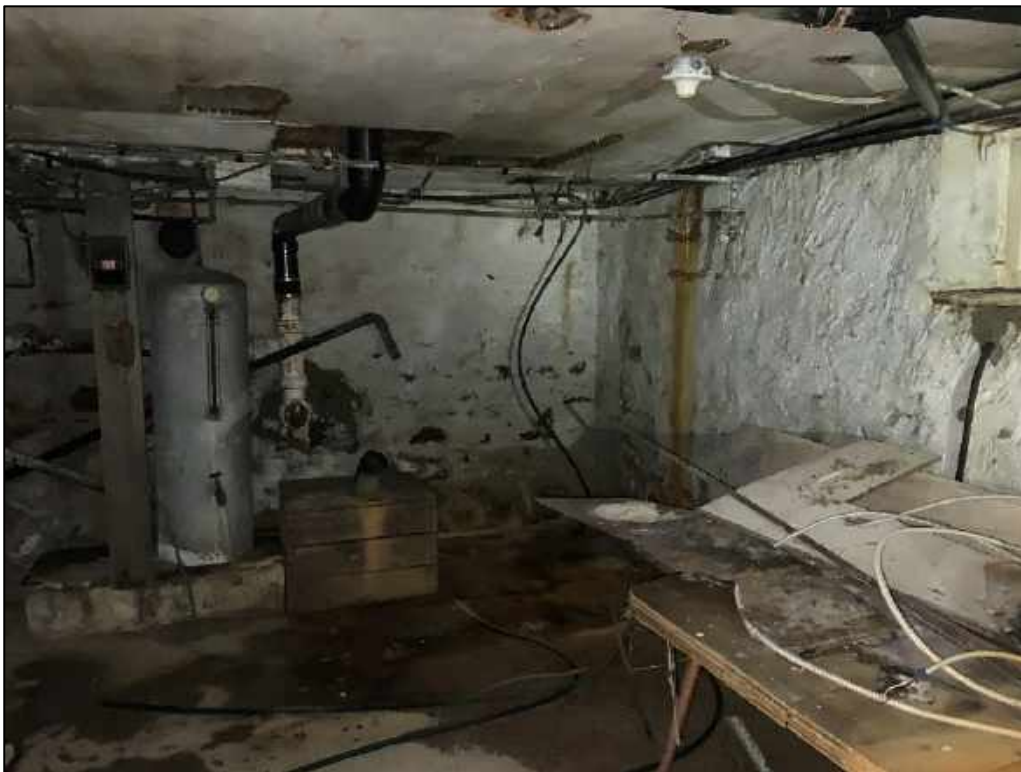
**Photograph 8: Water ingress and staining.**

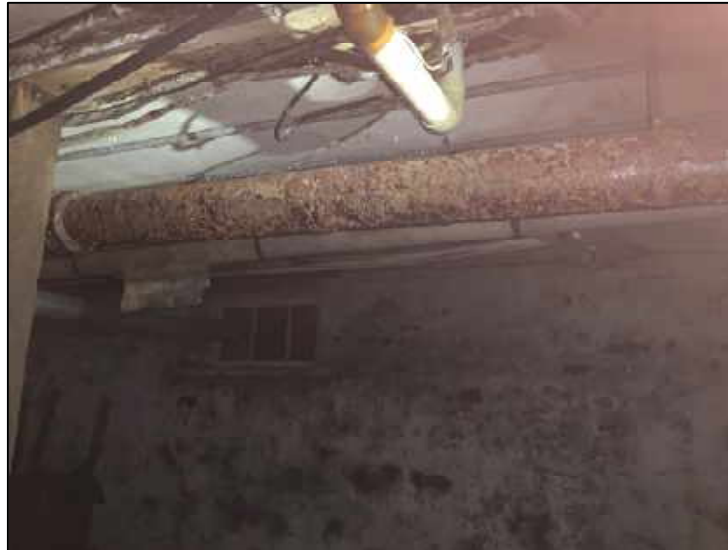
**Photograph 9: Corrosion on exterior of steel pipe.**

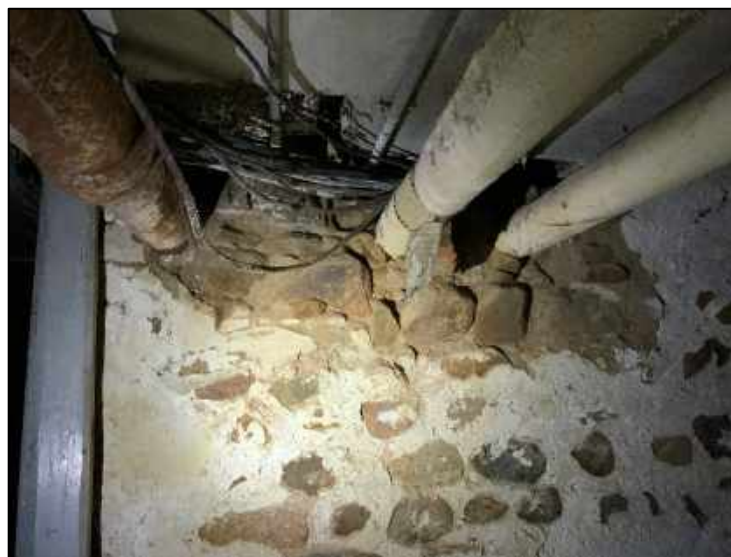
**Photograph 10: Deteriorated area of foundation wall.**

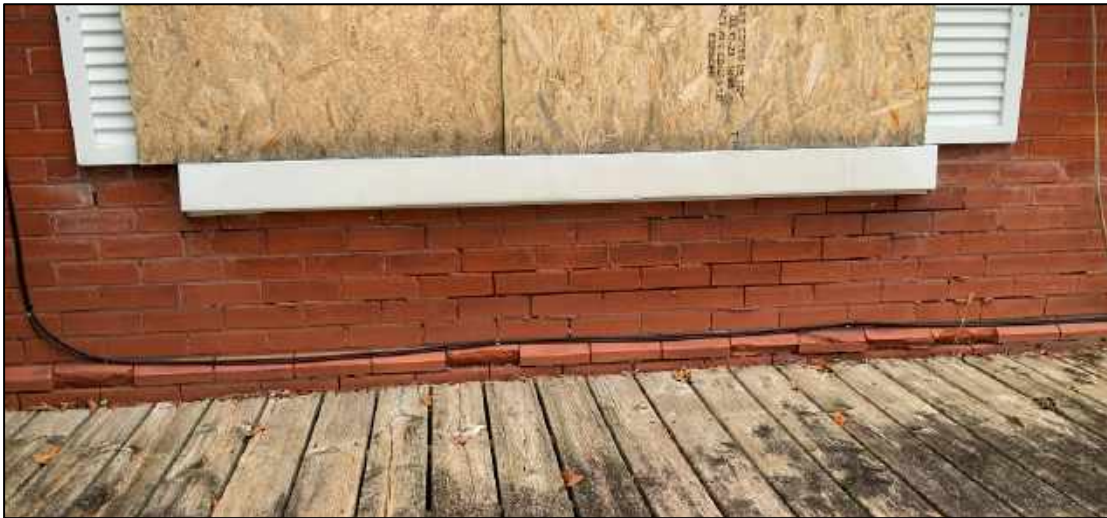
The brick was generally in poor-to-fair condition, with various repairs noted throughout with mismatched mortar colours.

Mortar deterioration in head joints and bed joints, and spalled bricks were noted throughout the building. Open skyward facing joints and spalled bricks were also present in the brick water table. Several openings where mortar was deteriorated in the foundation walls and at the base of the ground floor walls had been filled with spray foam. Deterioration of the brick below several windows was noted, which is often caused by water ingress at the window openings. A sample of the general wall condition can be seen in Photograph 11.

**Photograph 11: General condition of exterior walls.**

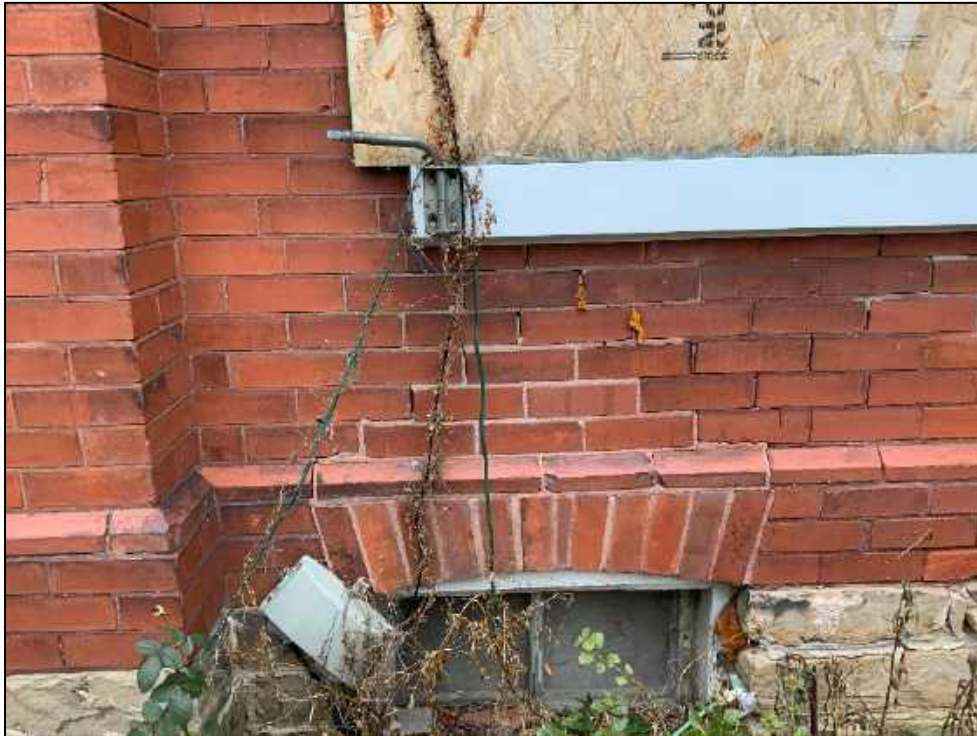
On the west elevation, cracks in the mortar joints above the southernmost basement window and a dropped brick above the southernmost second-floor window indicate failed lintels (Photographs 12 and 13). Deterioration of the chimney above the roof line was also noted (Photograph 14).

**Photograph 12: Cracks in mortar joints above southernmost basement window (west elevation).**

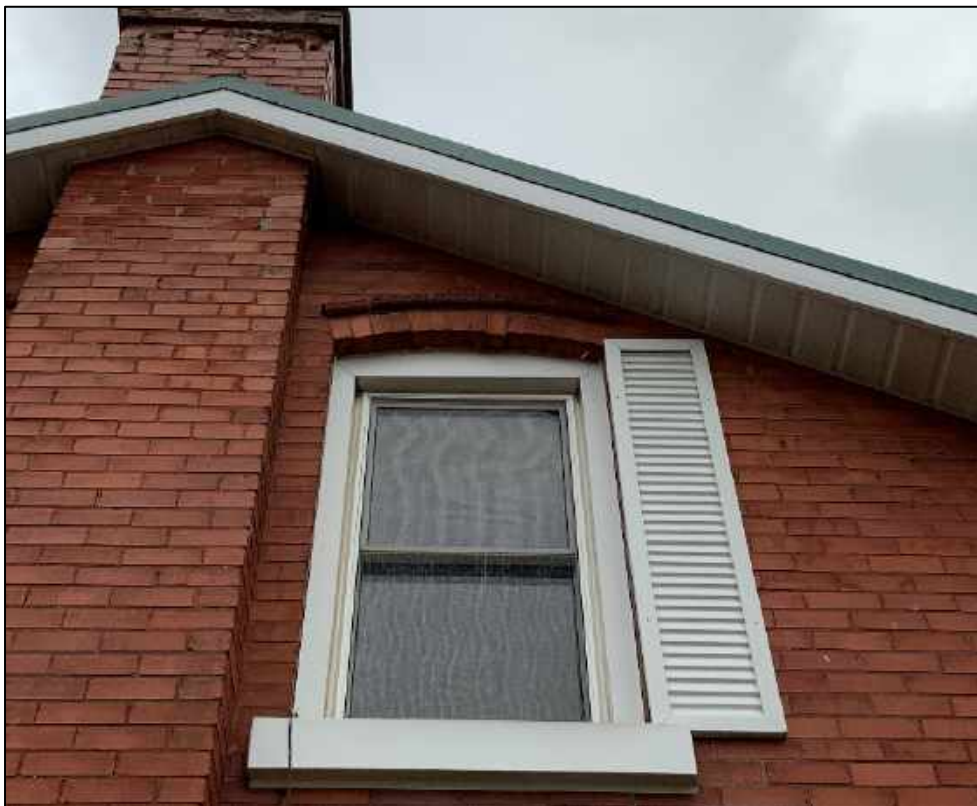
**Photograph 13: Dropped brick above southernmost second-floor window (west elevation).**

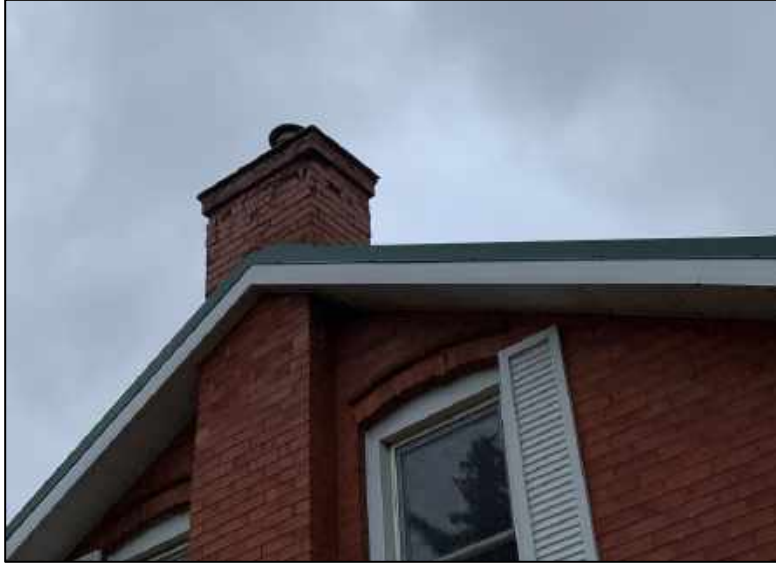
**Photograph 14: Deterioration of chimney above roof line (west elevation).**

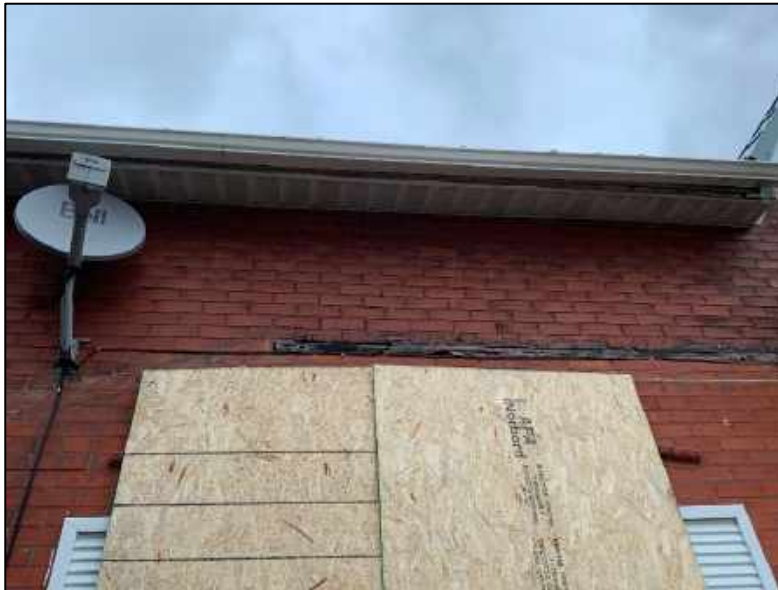
On the south elevation, a wood ledger was present from a previously removed porch roof. The remaining wood has contracted, causing loose mortar joints in the surrounding wall and diagonal cracks in the mortar joints where the brick has deflected above (Photograph 15).

**Photograph 15: Wood ledger with loose joints and diagonal cracks.**

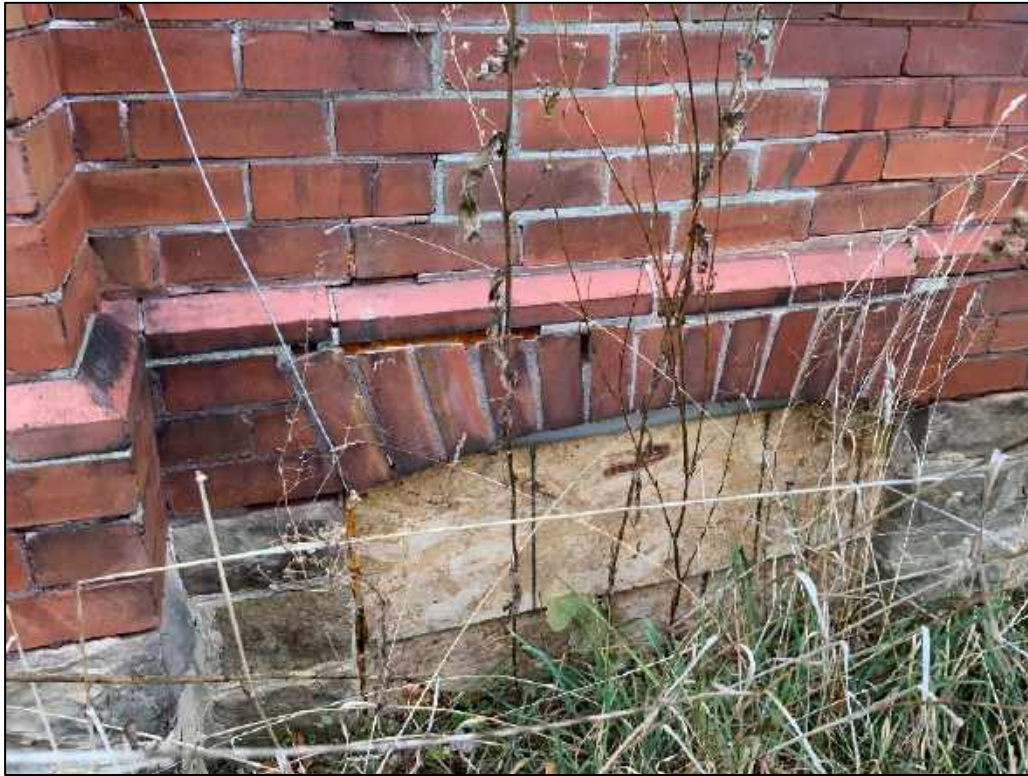
On the east elevation, cracks in the mortar joints and dropped bricks above the southernmost basement window indicate a failed lintel (Photograph 16). Deteriorated bricks were also noted at the corner above the living room addition (Photograph 17). Severe deterioration was noted in the brick below the windows and doors to the living room addition, corresponding to the areas of water damage noticed on the interior (Photograph 18). Bricks were severely deteriorated at the top of the chimney extending above the living room addition roof line (Photograph 19).

**Photograph 16: Cracks and dropped brick above southernmost window (east elevation).**

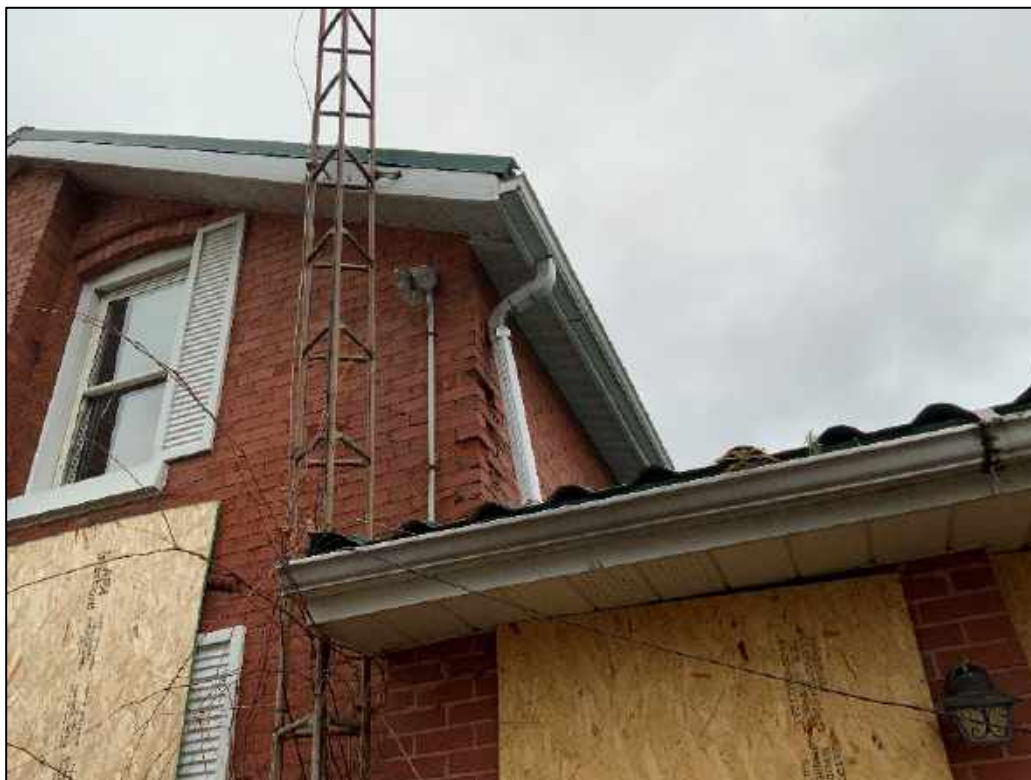
**Photograph 17: Deteriorated brick above living room addition.**

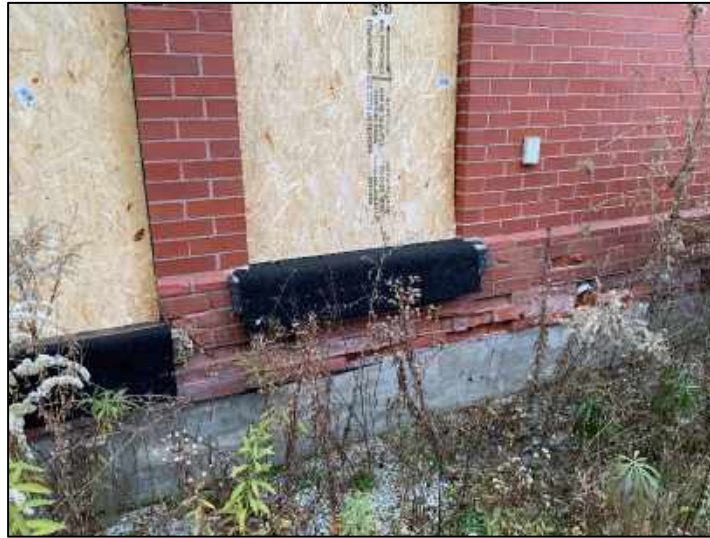
**Photograph 18: Severe deterioration of brick below living room windows.**

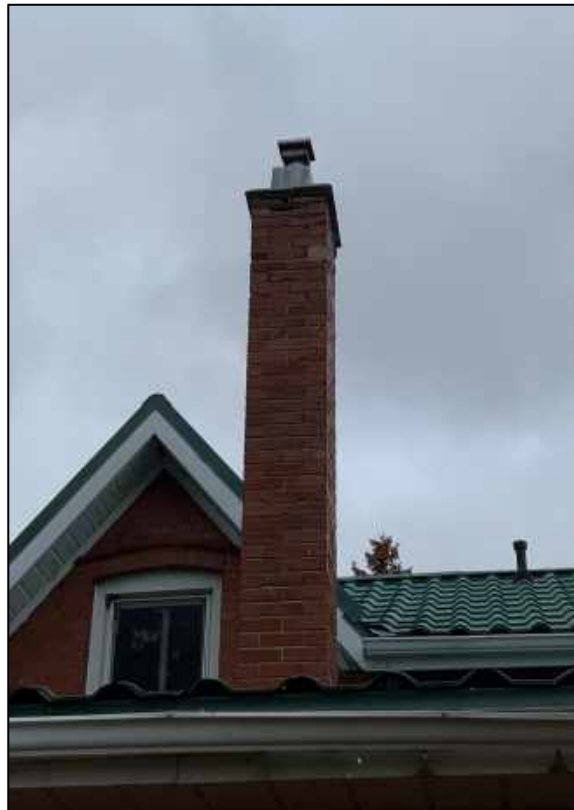
**Photograph 19: Severe deterioration of brick at chimney above living room roof line.**

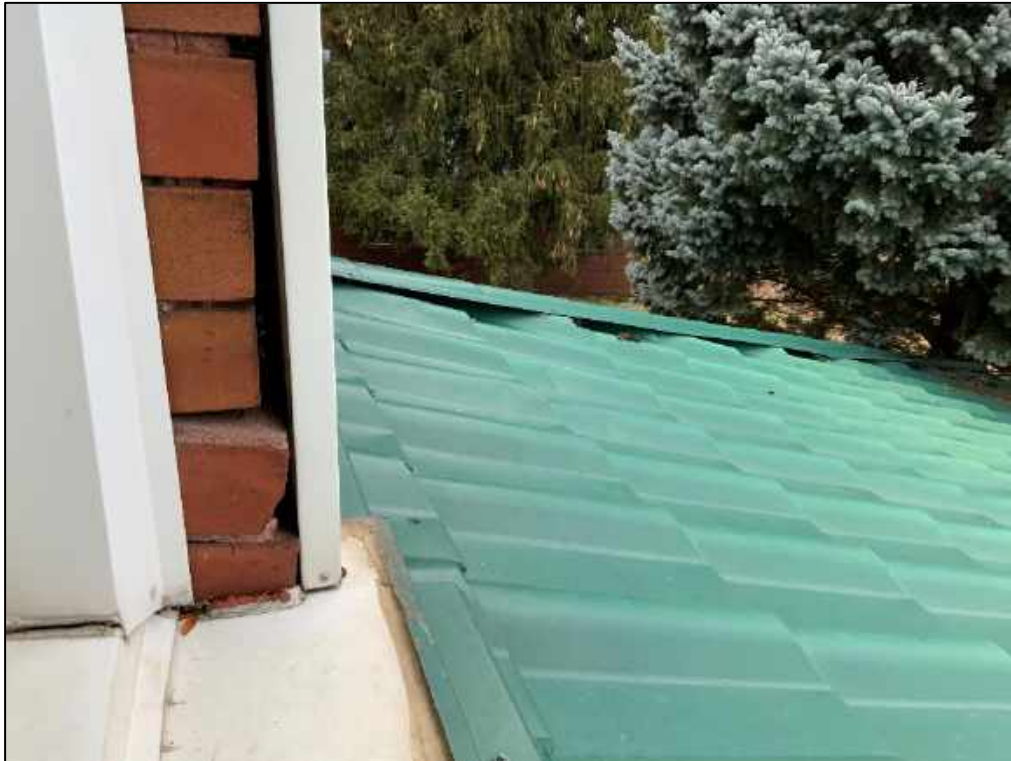
On the north elevation above the garage, failed brick was noted behind the decorative shutter (Photograph 20). At the garage addition, deterioration was observed at the base on the wood shake cladding. An eavestrough was damaged and a corresponding hole was present against the foundation wall with evidence of erosion in the rubble stone (Photographs 21 and 22). On the west elevation, the brick veneer has buckled inward north of the service door and the veneer has collapsed to the south of the door (Photograph 23).

**Photograph 20: Failed brick behind decorative shutter above garage.**

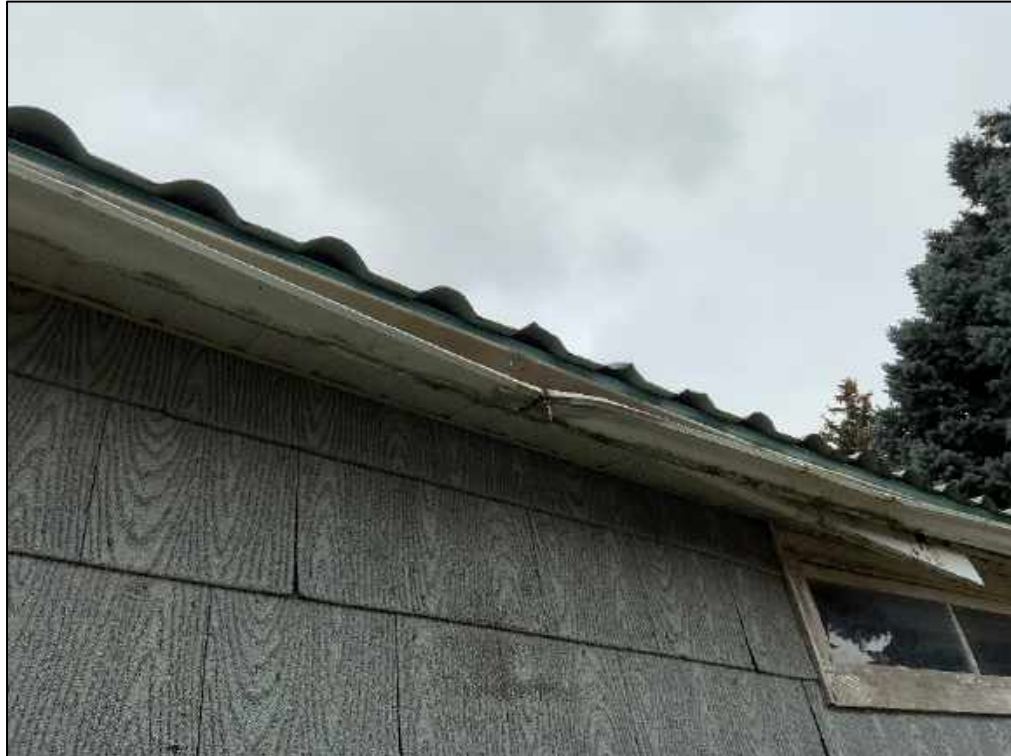
**Photograph 21: Damaged eavestrough on garage.**

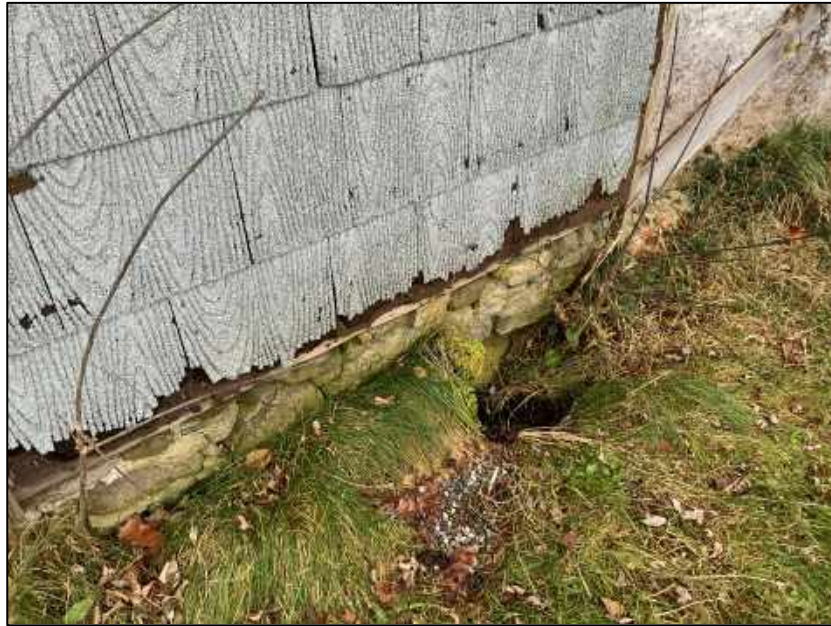
**Photograph 22: Deteriorated wood shakes and hole against garage foundation.**

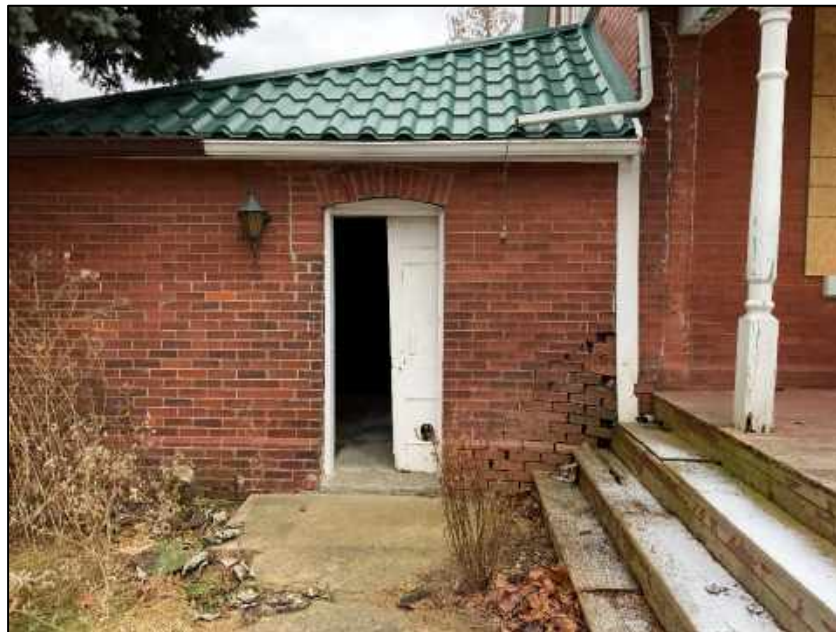
**Photograph 23: Buckled and collapsed brick veneer on garage.**
