Sharon Vincent
14278 3rd Line
Acton, Ontario

May 29, 2024

Project: Condition Assessment of Existing Structure

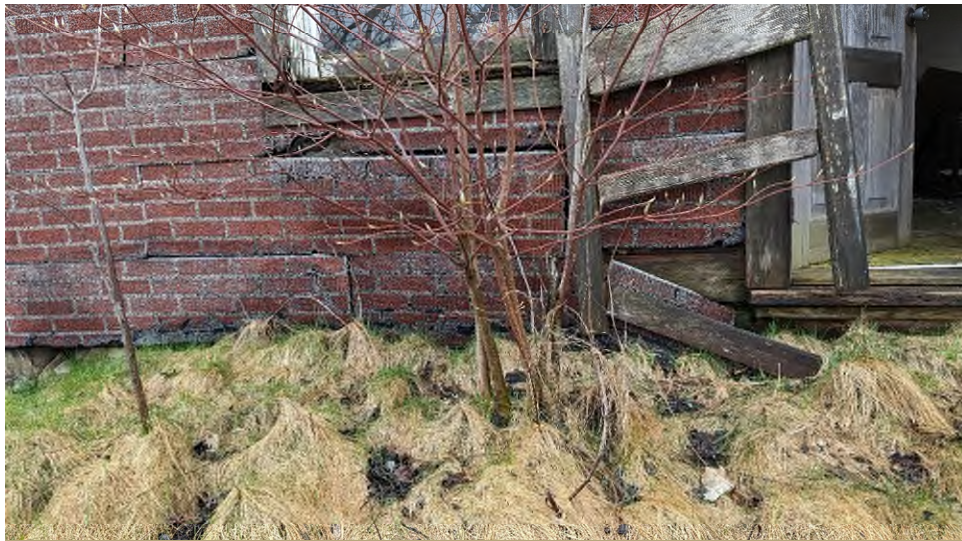
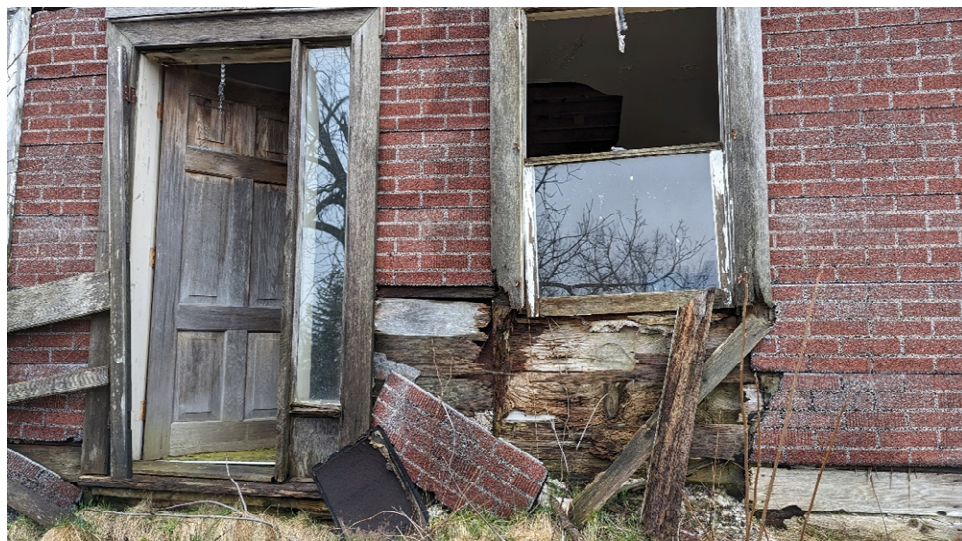
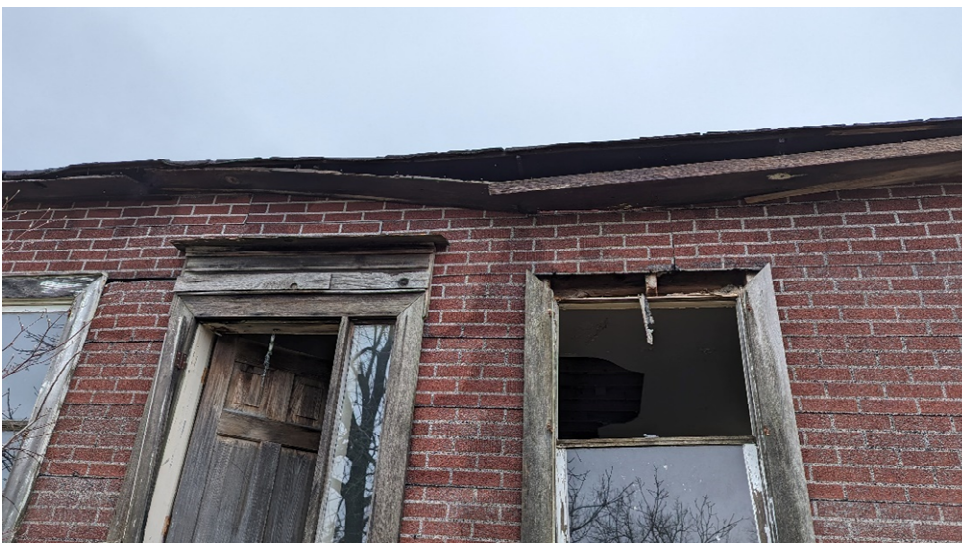
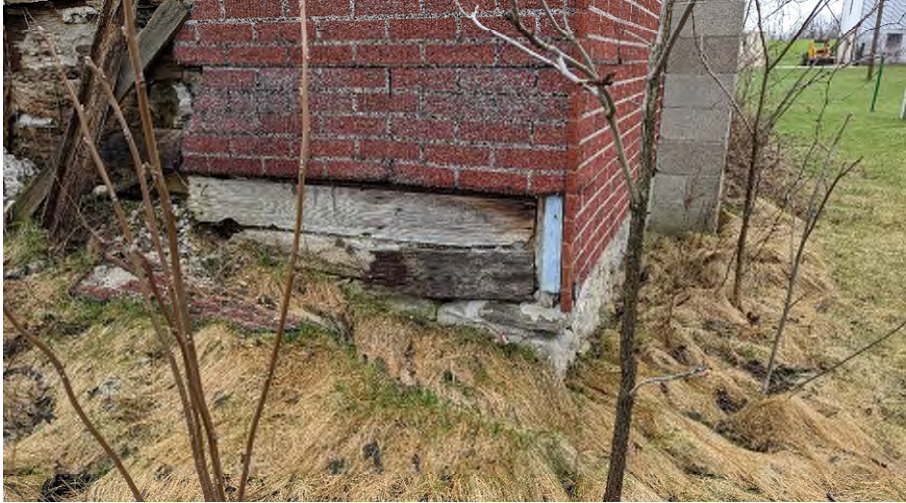
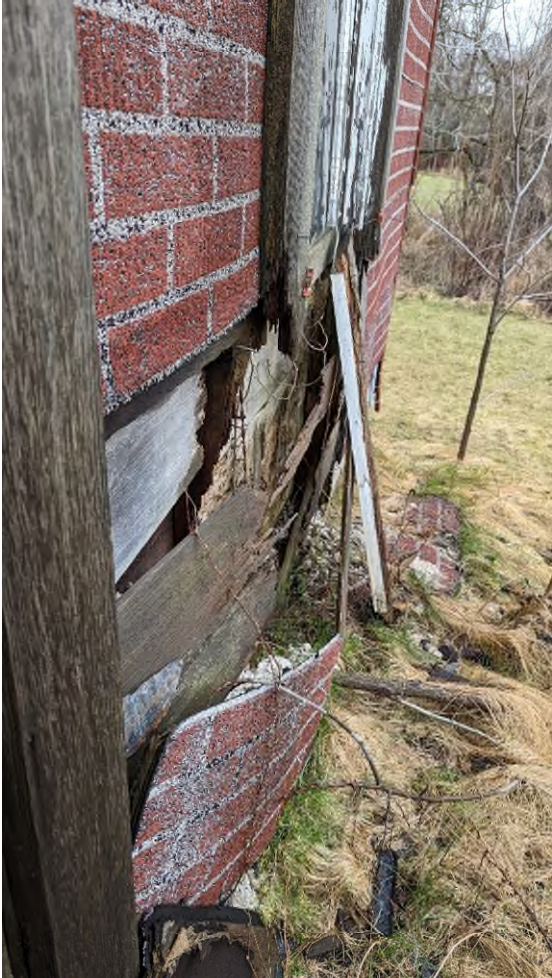
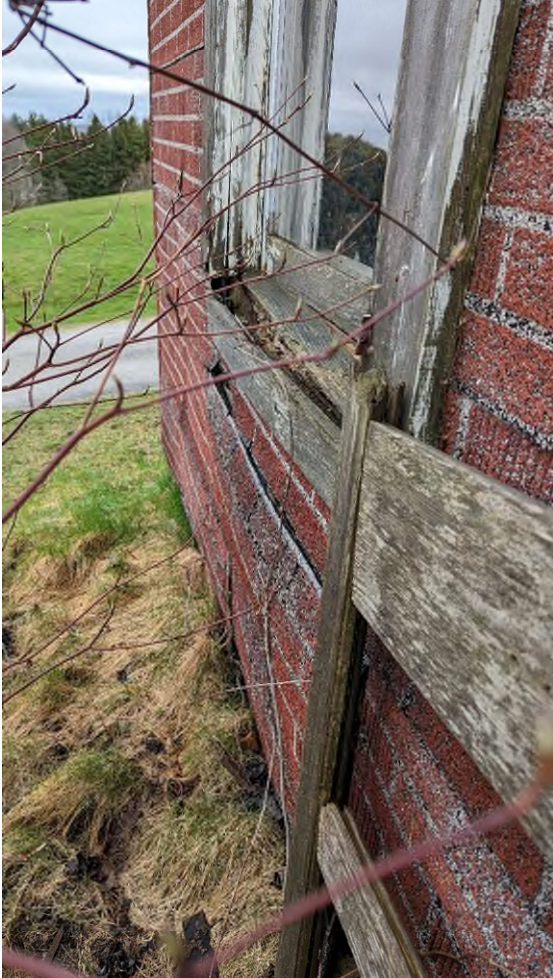
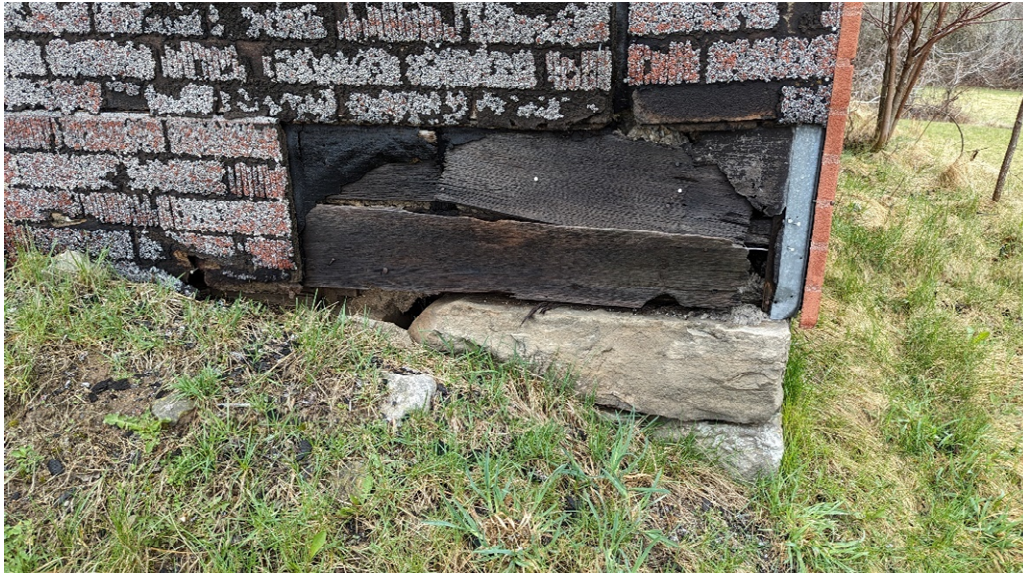
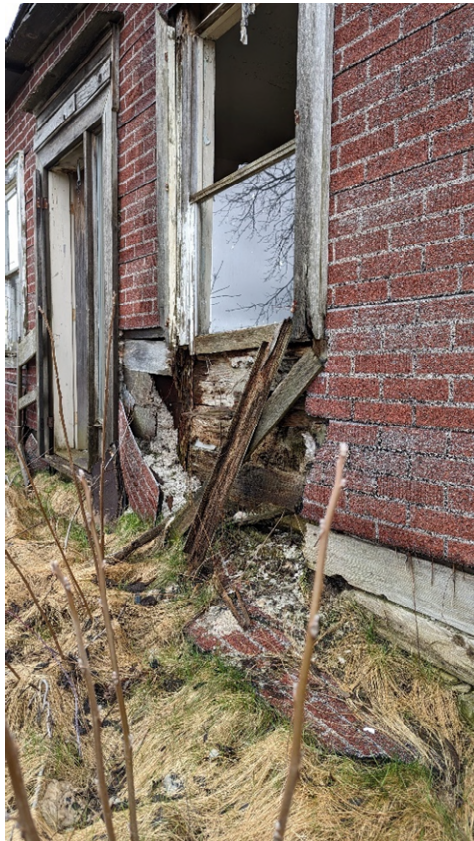
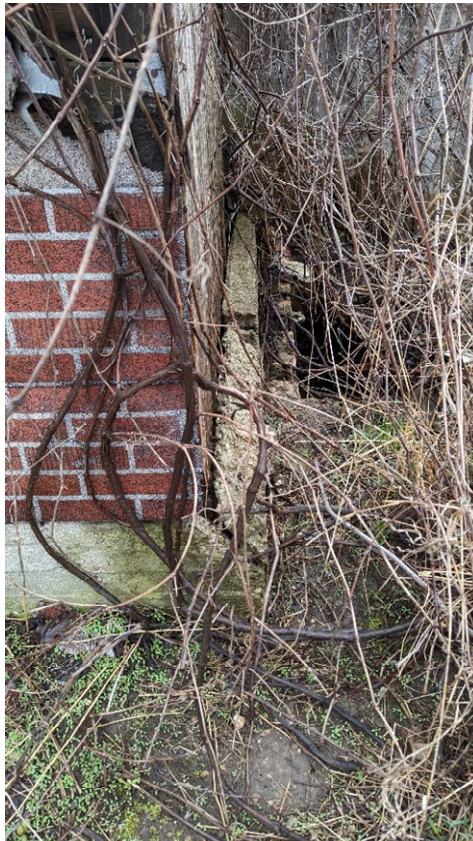
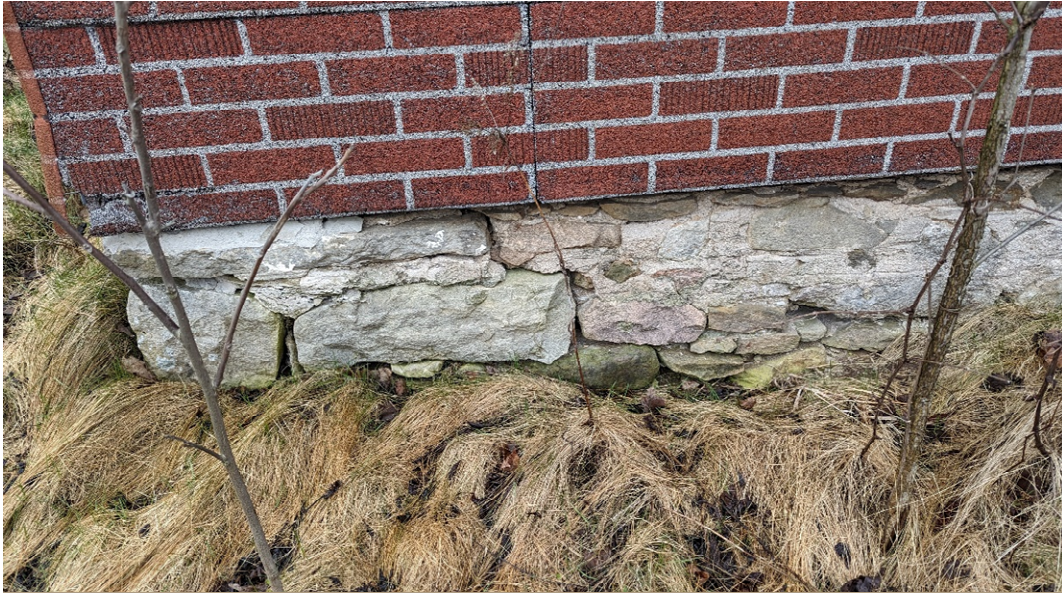
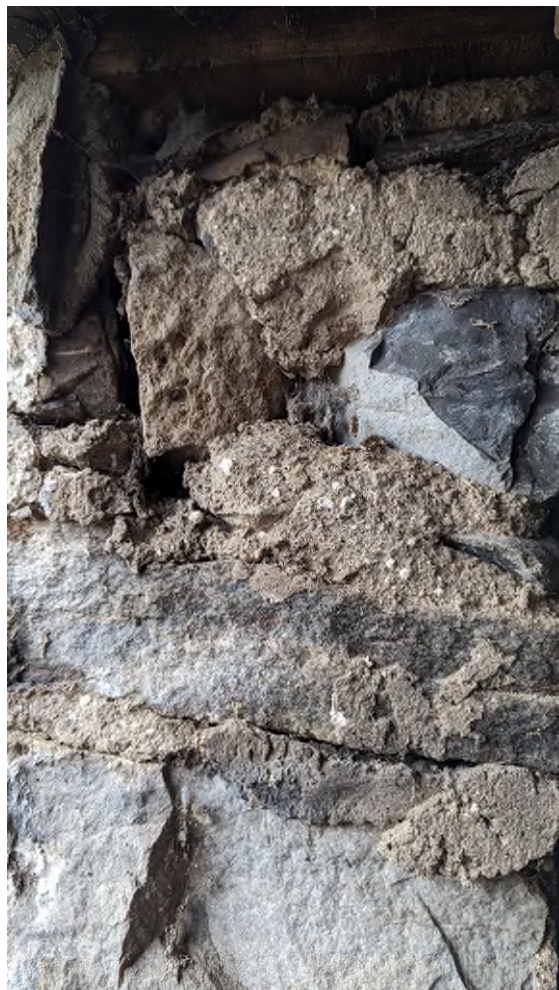
1. The exterior load bearing wood stud walls are generally in very poor condition with extensive wood rot in sections which has resulted in structural failure of portions of the wall framing. Some areas of the walls are bowed, twisted and leaning. The framing around window and door framing is particularly rotted and deteriorated to extremely poor condition.
2. The original exterior wall board sheathing has also rotted in several locations and is in generally very poor condition.
3. The rubble stone foundations are in poor condition. The original mortar between the stones has broken/washed away over the years due to moisture/frost intrusion leaving large open gaps in the stone walls. Much of the remaining mortar is very soft and can be broken away very easily my hand.

4. Due to the extensive deterioration and damages resulting from the above conditions, there are many openings and gaps in the existing structure and building envelope that are allowing water into the structure that will continue to compromise the remaining structure even further over time. In addition, based on the above, we strongly suspect that there is additional extensive rot and decay hidden within walls, floor and roof structure that are not currently exposed to view.
5. Photographs of this portion of the structure are shown on pages 3 to 6.

Based on the above, it is our opinion that the structure is generally in very poor to extremely poor condition with the rear west portion of the building being particularly unsafe to occupy or use due to potential collapse of the roof and floor structures. It is also our opinion that the remaining superstructure and foundations are not suitable to be renovated or repaired to a occupiable condition and we instead recommend that the structure be demolished.

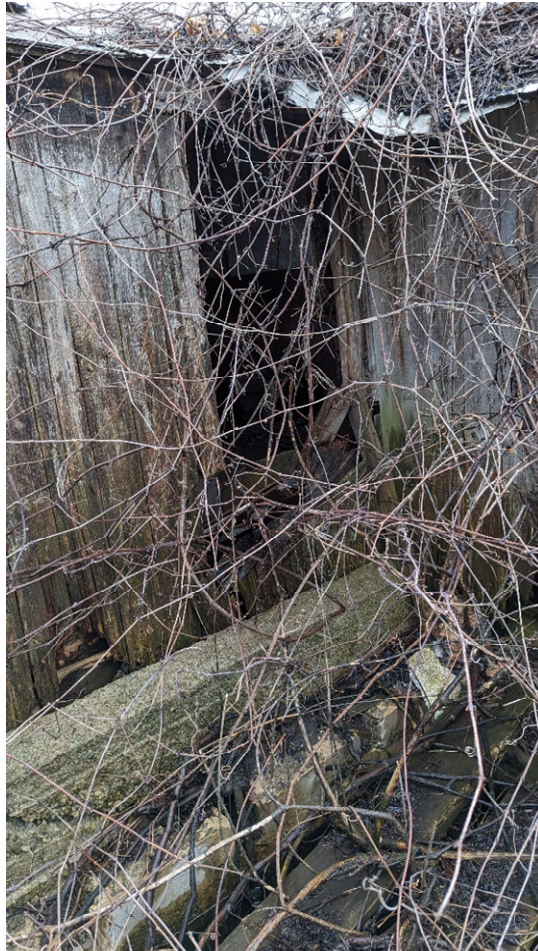
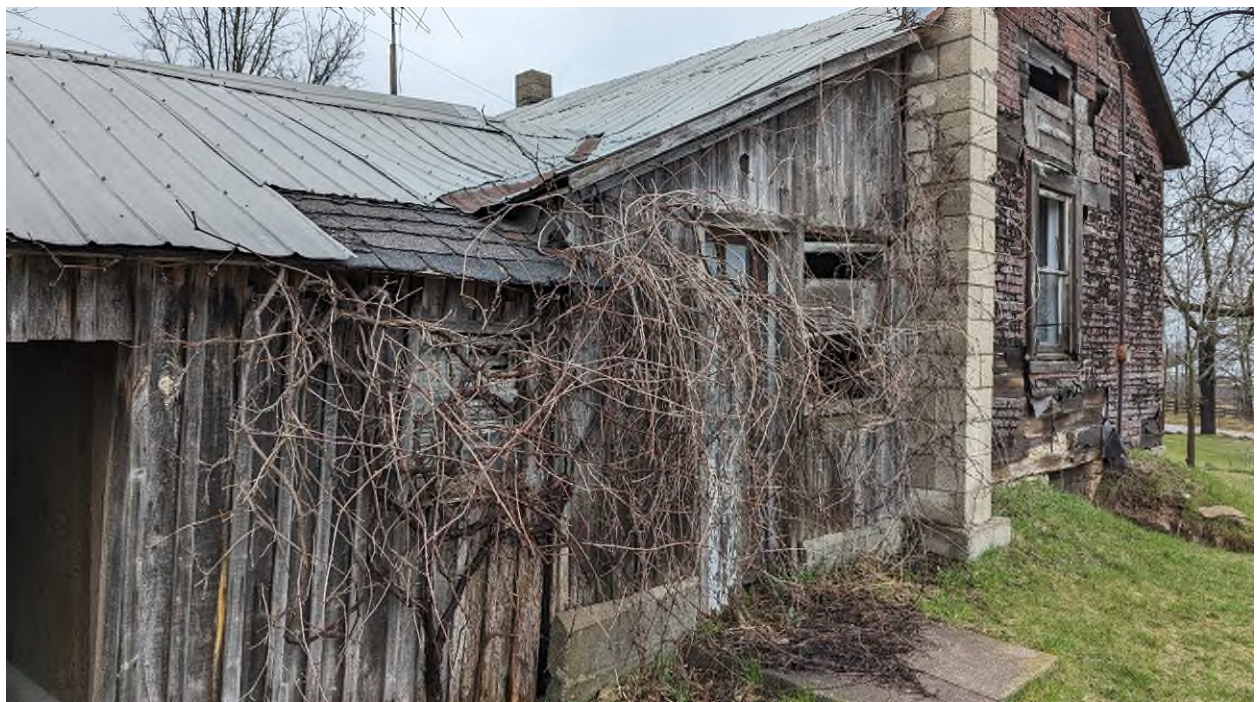
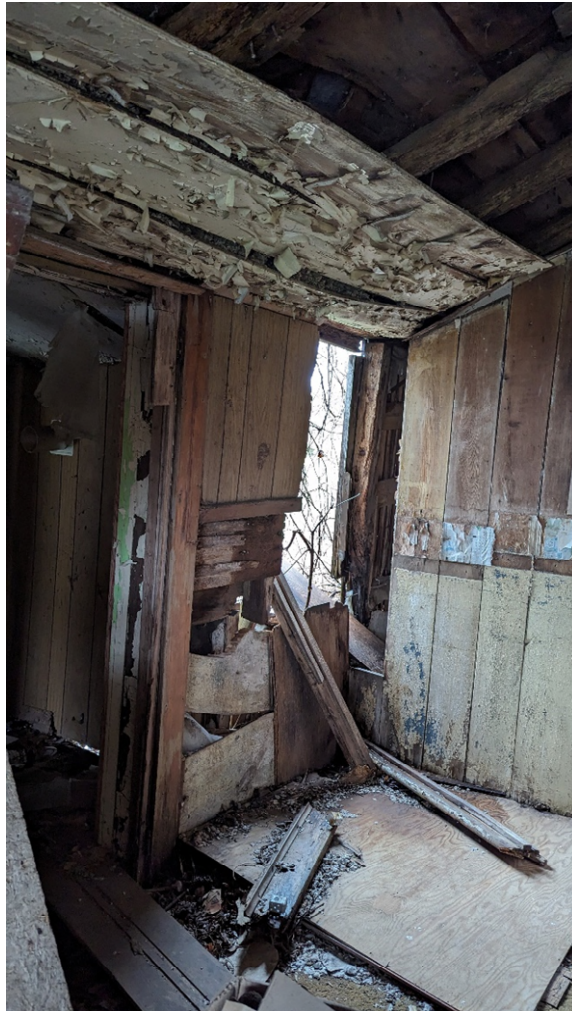
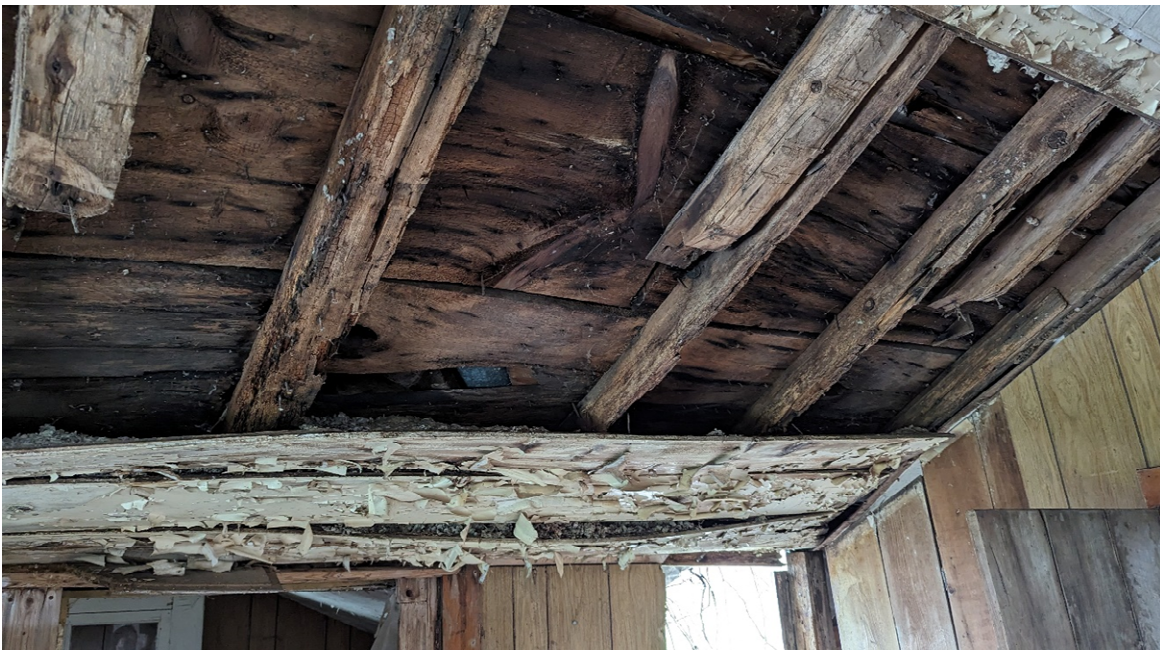
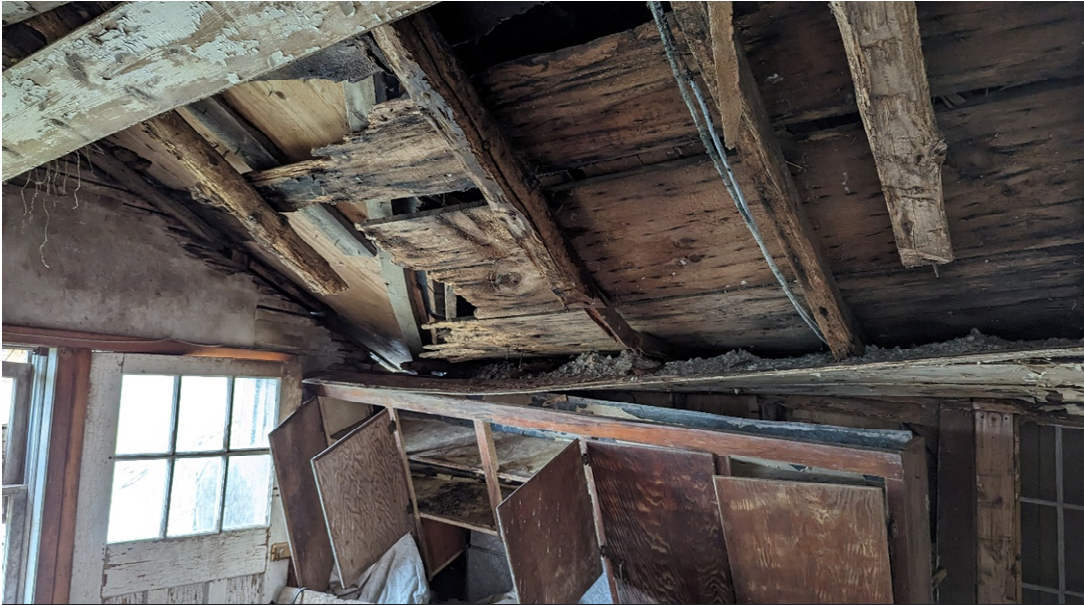
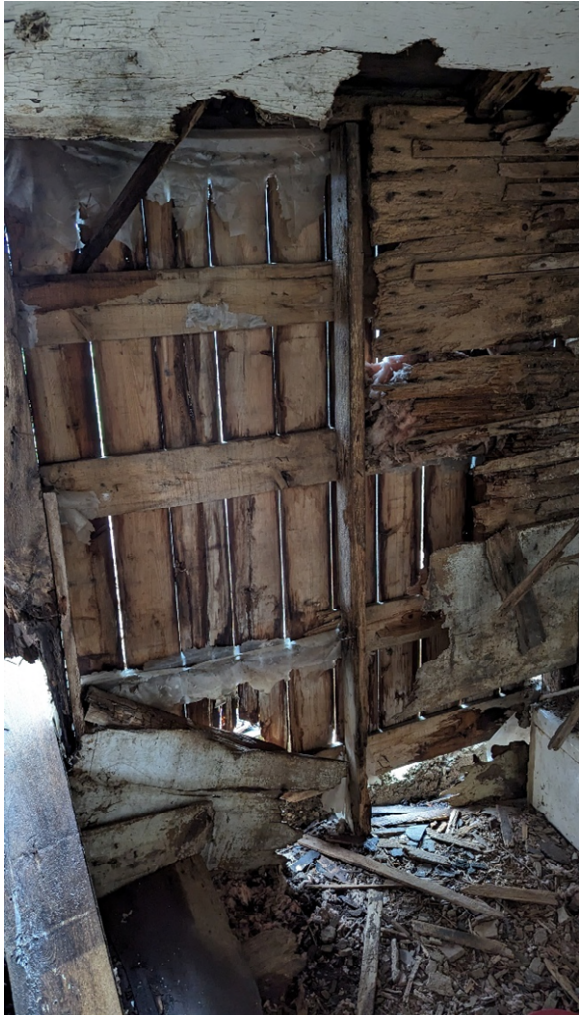
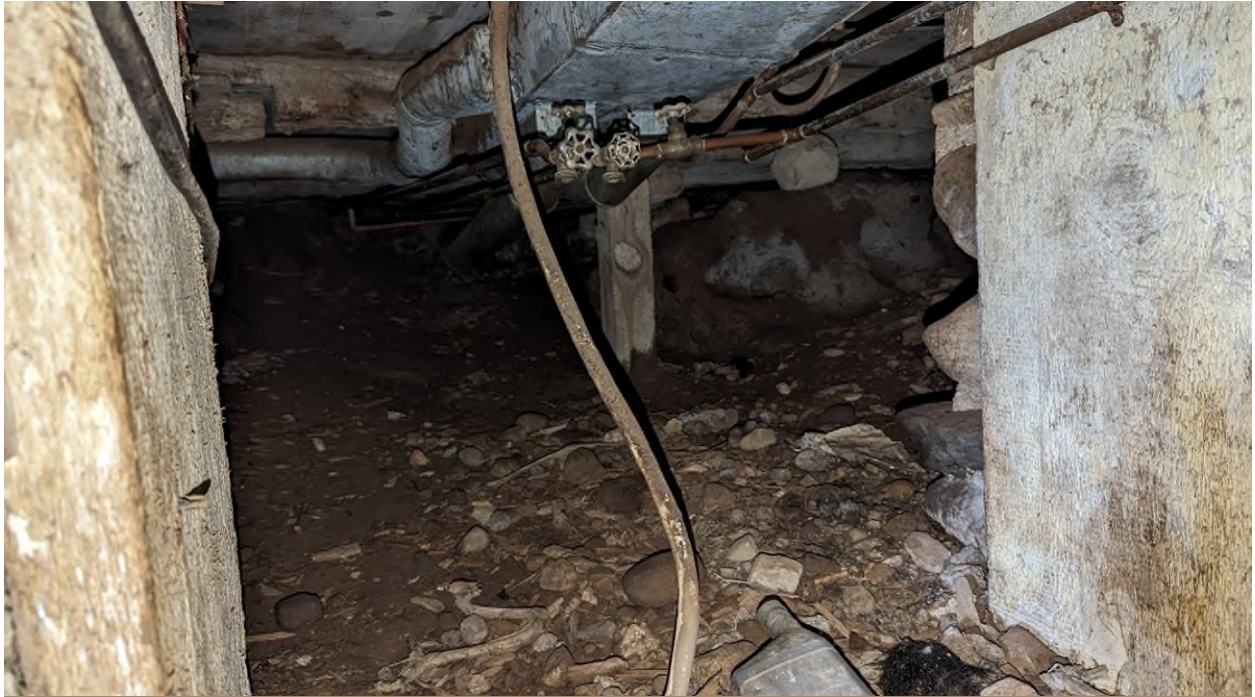
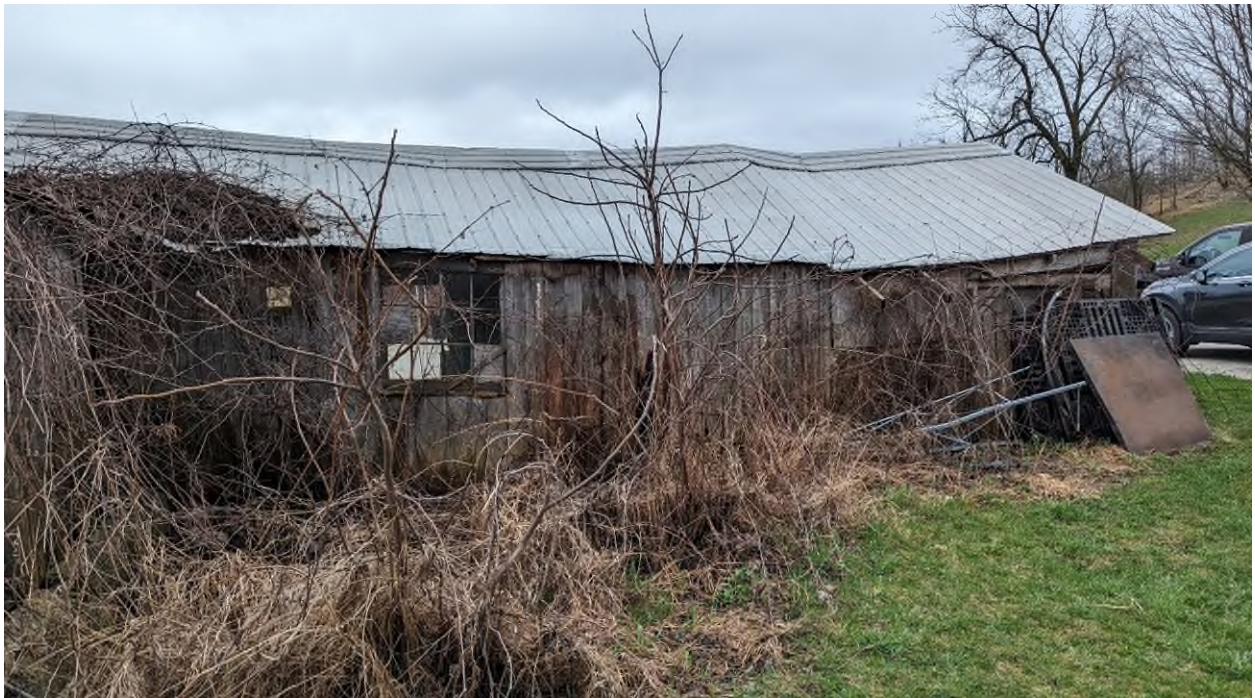
1. The exterior load bearing wood stud walls are generally in extremely poor condition with extensive wood rot throughout which has resulted in structural failure of most of the walls. Most of the of the walls are bowed and leaning, or partially collapsed.

2. The exterior wall board sheathing has also rotted in several locations and generally is in extremely poor condition.
3. The rubble stone foundations that we can see are in extremely poor condition. It is not clear is there is even any foundation under portions of this structure.

4. The roof rafter and beams framing has been exposed to weather and it extensively rotted and partially collapsed in most areas.
5. The overall condition of this portion of the building is extremely poor and is unsafe due to the extensive rot and failure of much of the superstructure.
