# Research and Evaluation Report

## **WHEELER STORE & RESIDENCE**

12428 Kirkpatrick Lane, Limehouse, Town of Halton Hills

September 2021

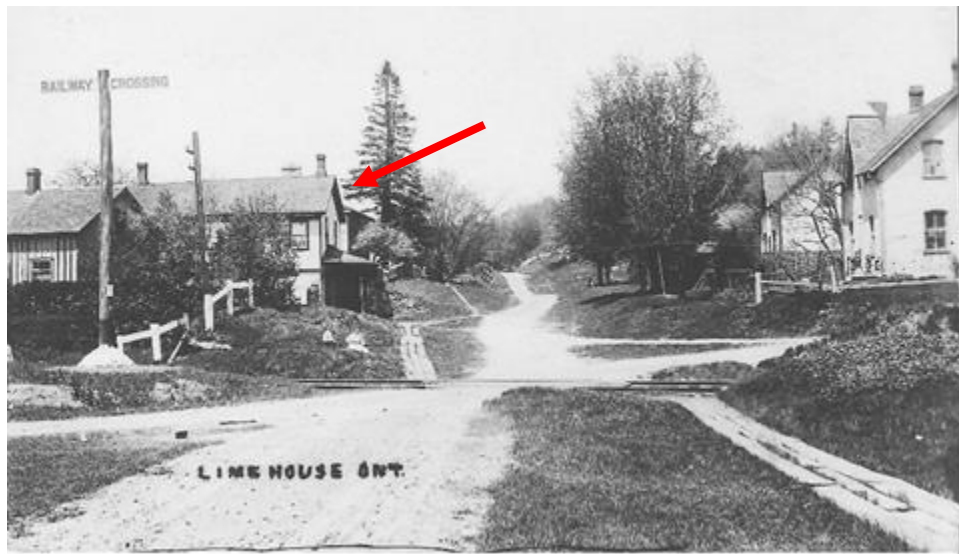
Figure 2: Looking west along Kirkpatrick Lane. The red arrow identifies the house at 12428 Kirkpatrick Lane on the left side of the photograph. The structure appears to be stuccoed and a one-storey porch on the front elevation is visible (EHS10297 c.1912)

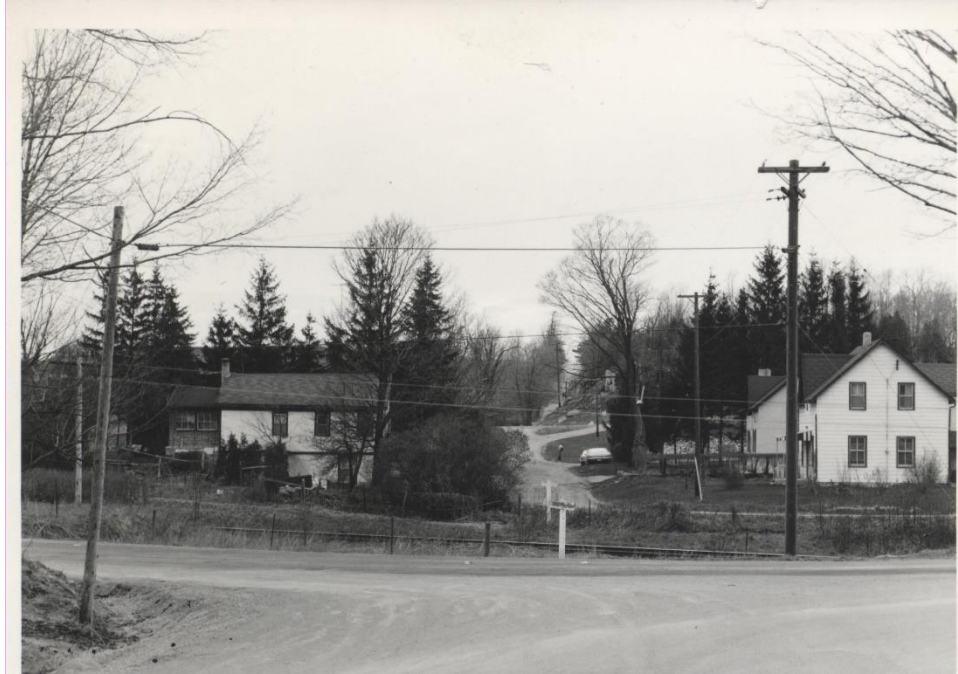
Figure 8: A view from Fifth Line looking northwest over the railway at Kirkpatrick Lane (then Maple Street). This image shows the rear addition and shows the house without the stone veneer and dark wood trim, 1973 (EHS21844).

At the rear of the existing building is a rear addition, with a concrete block foundation and a board and batten addition constructed above. Failed parging is visible on the concrete block foundation. According to the current owner, this addition is believed to have originally been used as a kitchen by former owner Beatrice Geary and has since been turned into a sunroom. The stone area below is a cold storage cellar which was likely used by the Wheeler family while the building served as a general store. A small flat-headed window is located at grade in the stone (Figure 17), while a horizontal flat-headed window opening is located on the upper storey (Figure 18). This addition was built sometime before 1973, as it is present in a photo dated from that year (Figure 8).

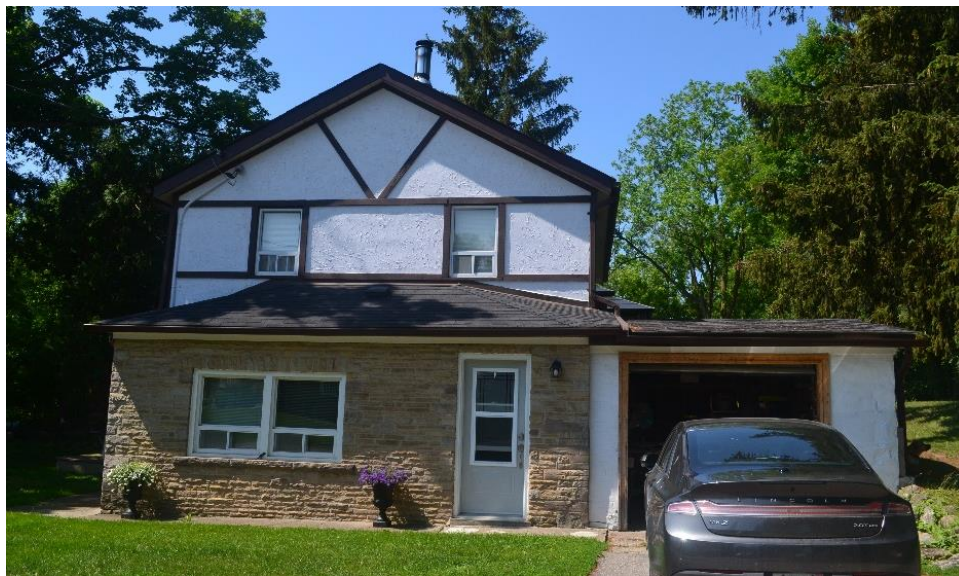
The existing 1860 residential structure on the property is a two-storey wood frame structure, with stucco, wood, and stone veneer. The wood trim over the stucco is a later addition added sometime after 1973 and is reminiscent of a Tudor Revival style (Figure 11). The outside walls of the upper floor consist of the stucco with painted wood trim, while the outside of the main floor is clad with stone veneer siding. The garage is constructed of rubble stone and has been painted.

Figure 11: North elevation (looking south) of 12428 Kirkpatrick Lane (Town of Halton Hills 2021)

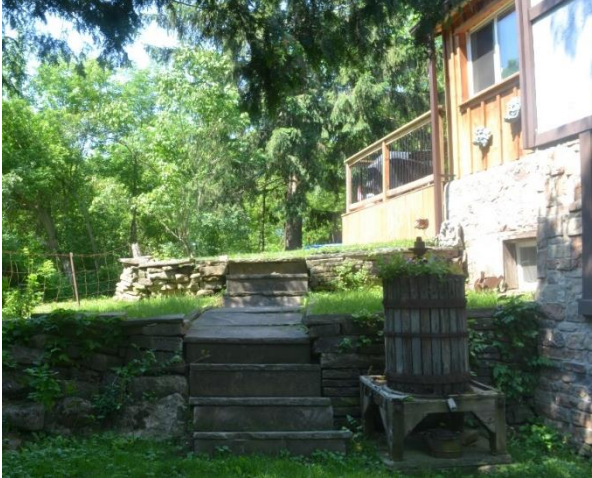
The house is built into a hill, with the first storey at street level along the front elevation and the second storey at grade along the rear elevation. Access from the street is provided to the back of the property via stone steps on the east side of the house leading up the hill (Figure 12). The gable roof of the original building features an original stone chimney in the centre of the south end of the building (Figure 13).

Figure 12: Stone steps leading up the east side of the building (Town of Halton Hills 2021)

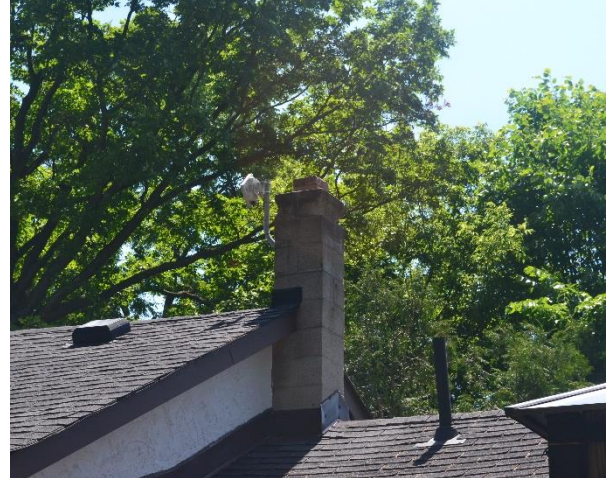
Figure 13: Original cement block chimney in the center of the gable at the south end of the building (Town of Halton Hills 2021)

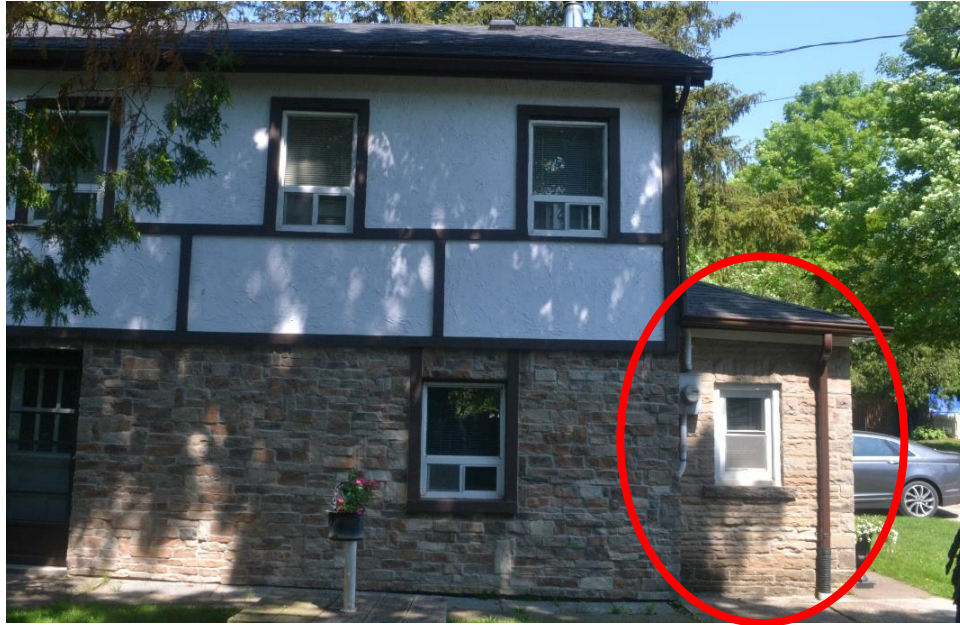
The ground level of the front elevation has a one-storey enclosed porch addition that protrudes approximately 3ft from the original wall and is clad in a brick veneer (Figure 14). The front elevation includes a large flat-headed window opening and a door opening adjacent to the garage addition.

Figure 14: Partial east elevation, showing the side elevation with window opening on the front addition (Town of Halton Hills 2021)

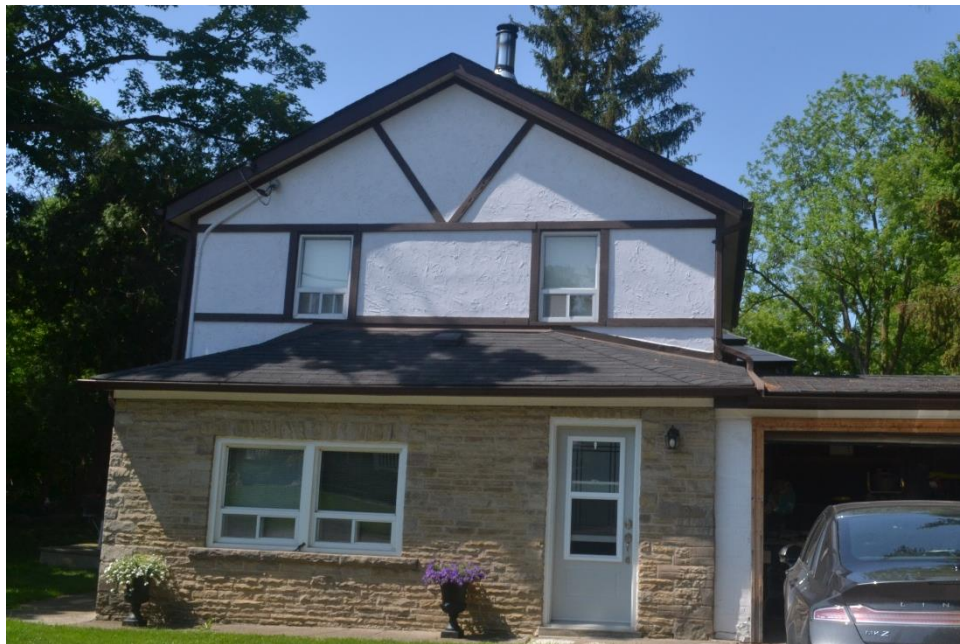
Above the addition, the second storey of the front elevation is stuccoed with painted wood trim. Two symmetrically placed flat-headed windows are located on the second storey above the addition (Figure 15).

Figure 15: Two symmetrically placed flat headed windows on the second storey above the addition on the north elevation (Town of Halton Hills 2021)

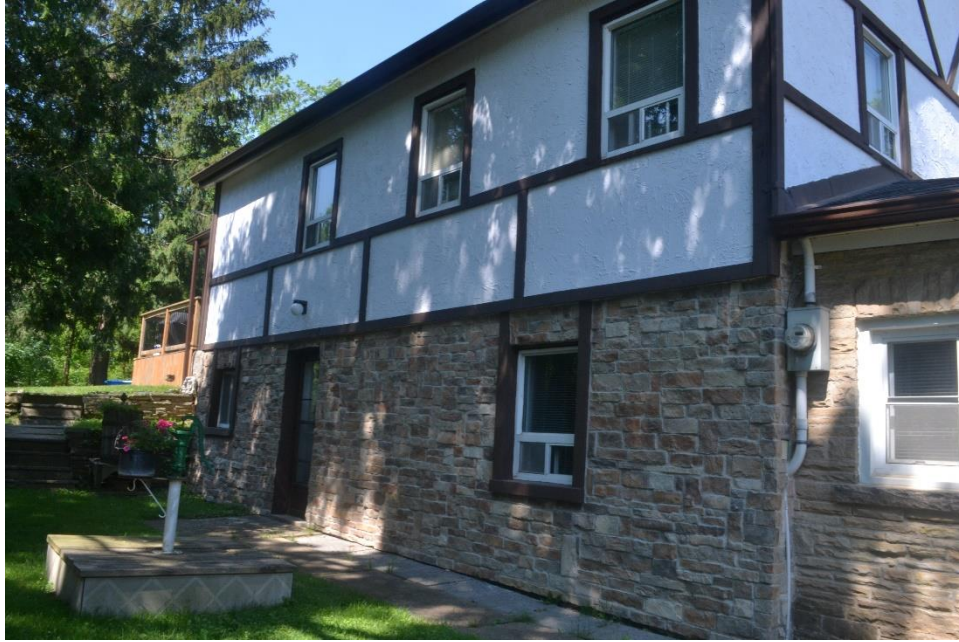
The first storey of the side (east) elevation is clad with a stone veneer. Two flat-headed window openings are located on either side of the flat-headed door opening at the first storey. The second storey of the east elevation is stuccoed with painted wood trim and contains three flat-headed window openings with wood trim (Figure 16).

Figure 16: Partial side (east) elevation (Town of Halton Hills 2021)

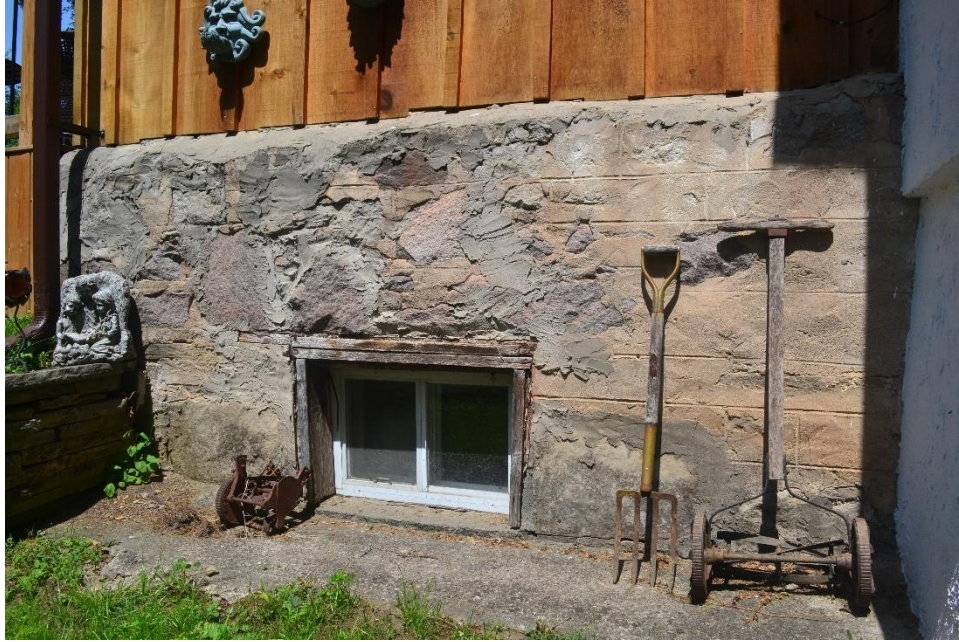
Figure 17: Cold room, east elevation (Town of Halton Hills 2021)

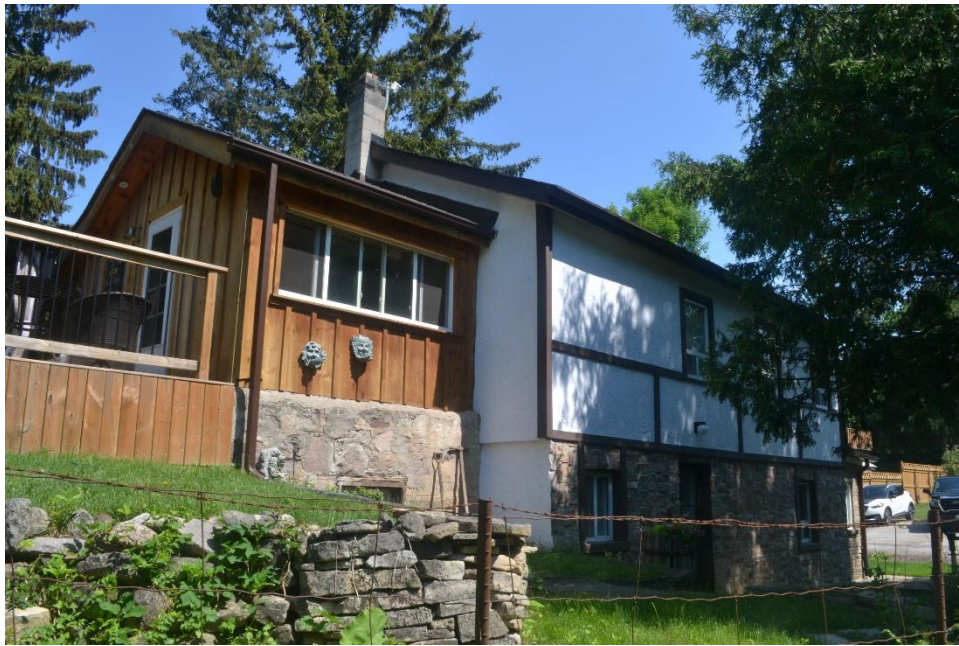
Figure 18: South end of east elevation (Town of Halton Hills 2021)

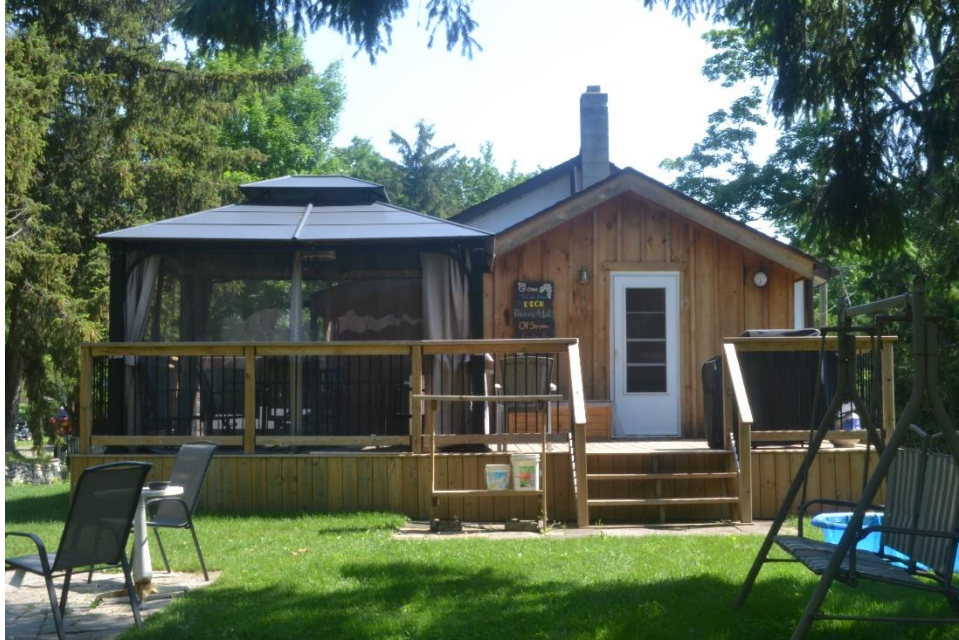
The south elevation of the house is a single storey above ground level at the back of the house. The rear elevation is clad with board and batten siding and includes a single entrance door slightly off-centre beneath the gable roof. The rear wall of the main structure is visible above the roof of the rear addition and a cement block chimney rises above the addition at the centre of the original structure's gable roof (Figure 19). The chimney runs down the length of the original outside wall and is exposed inside the house. A wooden deck, constructed by the current owners, is located to the rear of the addition.

Figure 19: Rear (south) elevation (Town of Halton Hills 2021)

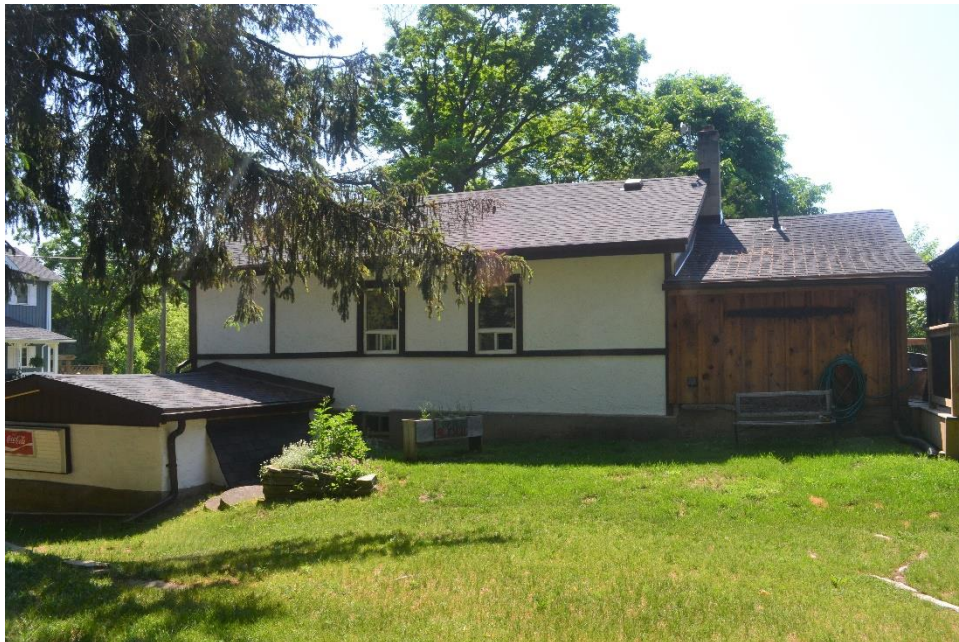
The west elevation of the main building is stuccoed with two flat-headed window openings above a concrete block foundation with small basement window at grade. The first storey is only partially exposed due to the rise in grade towards the rear of the property. The west elevation of the rear addition is clad in board and batten siding. A one-storey garage addition with gable roof is constructed on the west side of the residential building (Figure 20).

Figure 20: Partial side (west) elevation (Town of Halton Hills 2021)

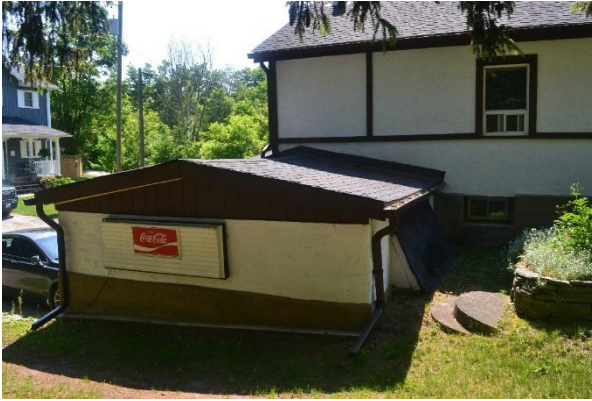
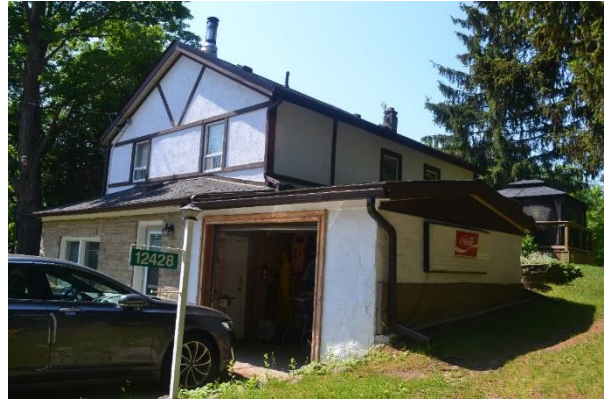
The garage is constructed of rubble stone that has been painted (date of construction unknown). The front (north) end of the garage is at street level and the back end is built into a hill, with a window opening in the centre of the rear wall at grade (Figure 21 & Figure 22).

Figure 21: Facing northeast, looking at the garage on the west elevation of the house (Town of Halton Hills 2021)

Figure 22: Northwest corner of the house, looking south (Town of Halton Hills 2021)

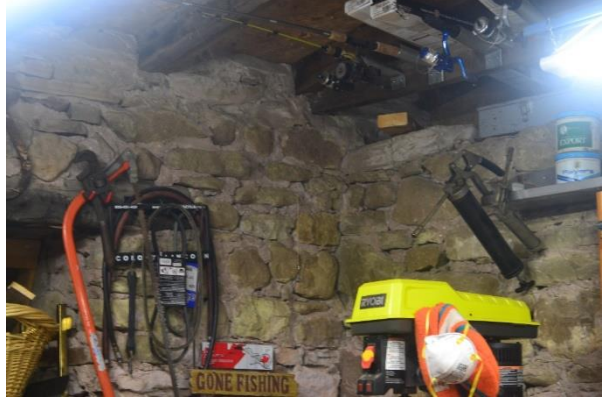
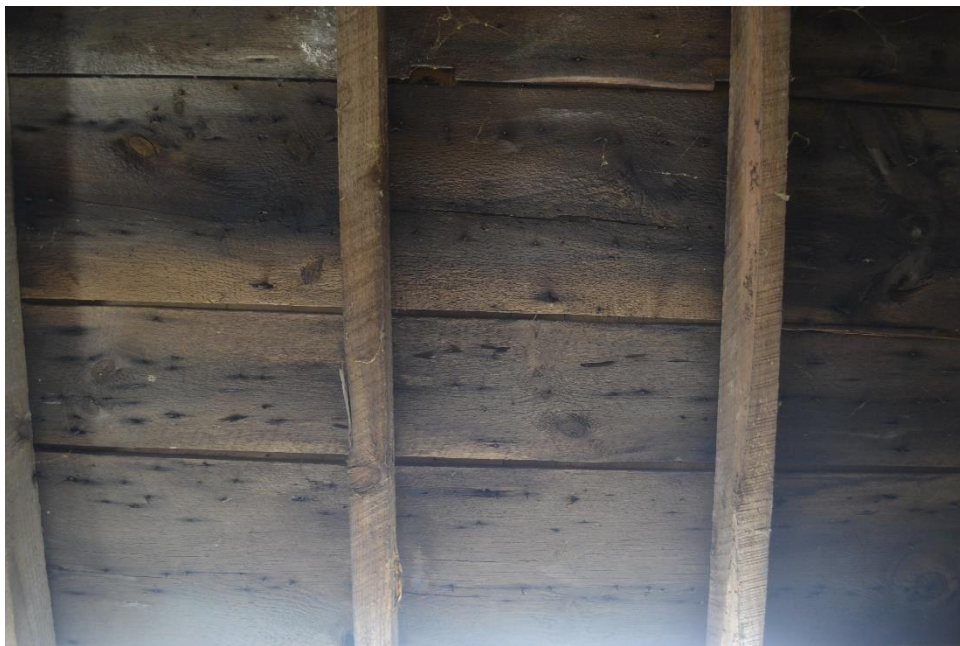
The inside of the garage reveals its rubble stone construction walls and wooden rafters on the ceiling. (Figure 23, Figure 24 & Figure 25).

Figure 23: Looking south inside the garage (Town of Halton Hills 2021)

Figure 24: Detail of stone masonry walls inside garage (Town of Halton Hills 2021)

Figure 25: Detail of rafters within the garage interior (Town of Halton Hills 2021)

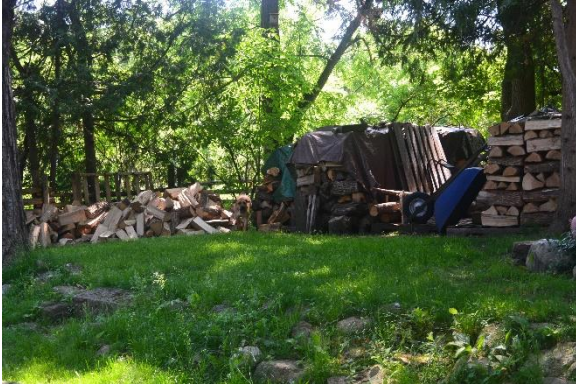
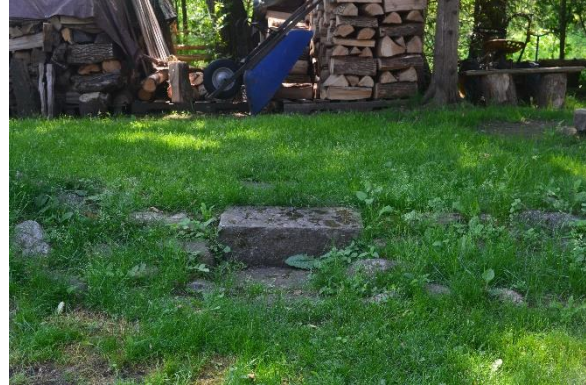
A stone step for an outbuilding that is no longer extant (demolished sometime in the 1920s) is located on the east side of the property, in between the railway tracks and the house (Figure 26 & Figure 27).

Figure 26: Looking northeast towards the train tracks on the east side of the property. This clearing is where an outbuilding once stood (Town of Halton Hills 2021)

Figure 27: A stone step is still present here. The step is directly across from the east elevation of the house (Town of Halton Hills 2021)

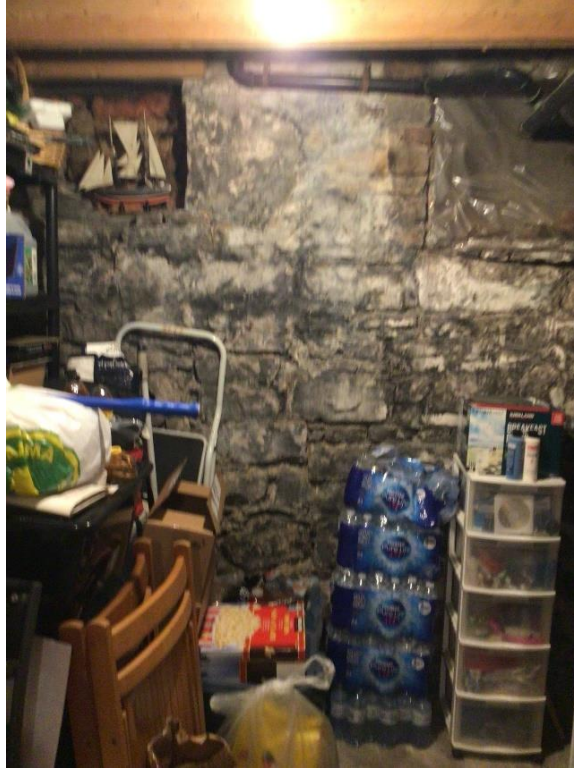
The cold room (Figure 28) is located at the rear of the house, behind the kitchen. It has stone walls and one window on the east side of the room, at grade.

Figure 28: Looking at the back (south) wall of the cold room  
(Town of Halton Hills 2021)

On the interior, the cold room addition built into the hill towards the rear of the property has physical value as a remnant of the original commercial use of the property.

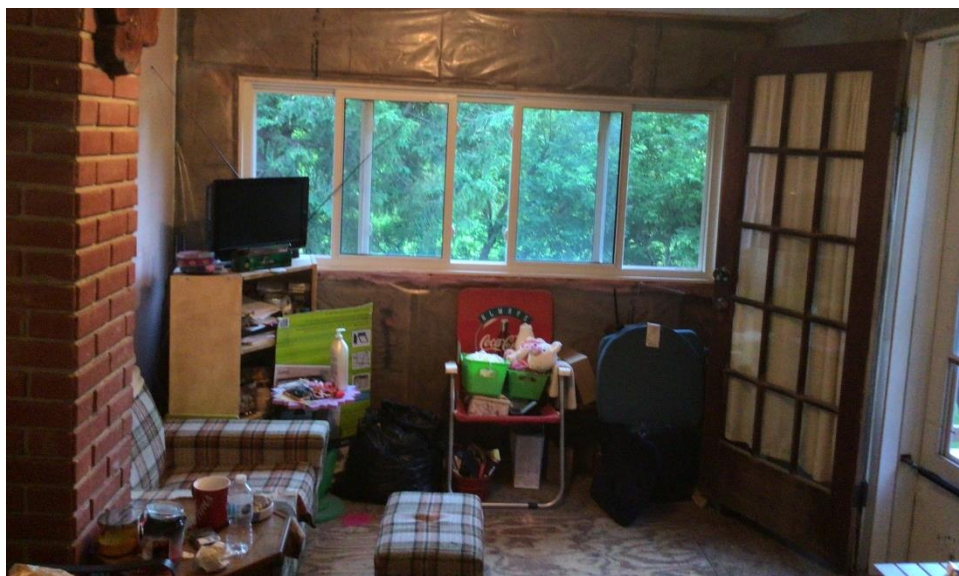
The north wall of the addition above the cold room is the outer wall of the original house. In the center of this wall, next to the doorway, is the original brick chimney, which runs from the floor through the ceiling, and is visible from outside. Directly opposite the chimney on the south end of the room is the doorway leading to the backyard onto the back deck (Figure 29).

Figure 29: Standing just inside the inside doorway to the rear addition, looking east (Town of Halton Hills 2021)
