Heritage Impact Assessment

**10677 Trafalgar Road
Part of Lot 14, Concession 8
Town of Halton Hills
Geographic Township of Esquesing
Regional Municipality of Halton**

HR- 352-2020
Project # 2021-0403

08/02/2022

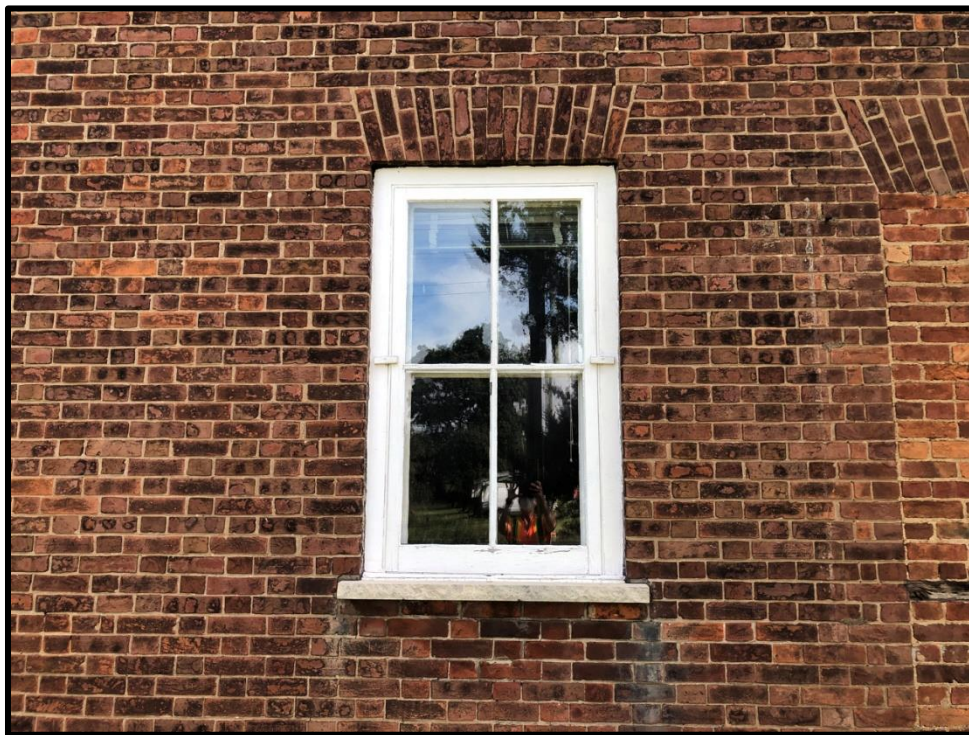
Image 6: Flat or Jack Brick Arches on Window Openings
(Photo taken August 30, 2021; Facing East)

two-over-two wooden sash windows. A brick chimney is located along the ridge line on the north elevation. The openings of the residence are framed by flat brick arches and a simple protruding stone sill (see Image 6). The sills are believed to be replacements due to a change in mortar consistency in the area around them. The façade door entry was originally a double entrance and has been modified into a single doorway positioned slightly right of centre (see Image 7). The wide, former positioning of the entryway is visible through a change in the brick course and colour. The central positioning and width of the former opening is emblematic of a typical Georgian style entrance. The façade masonry is laid in a Flemish bond pattern with an English corner detail (see Image 8).

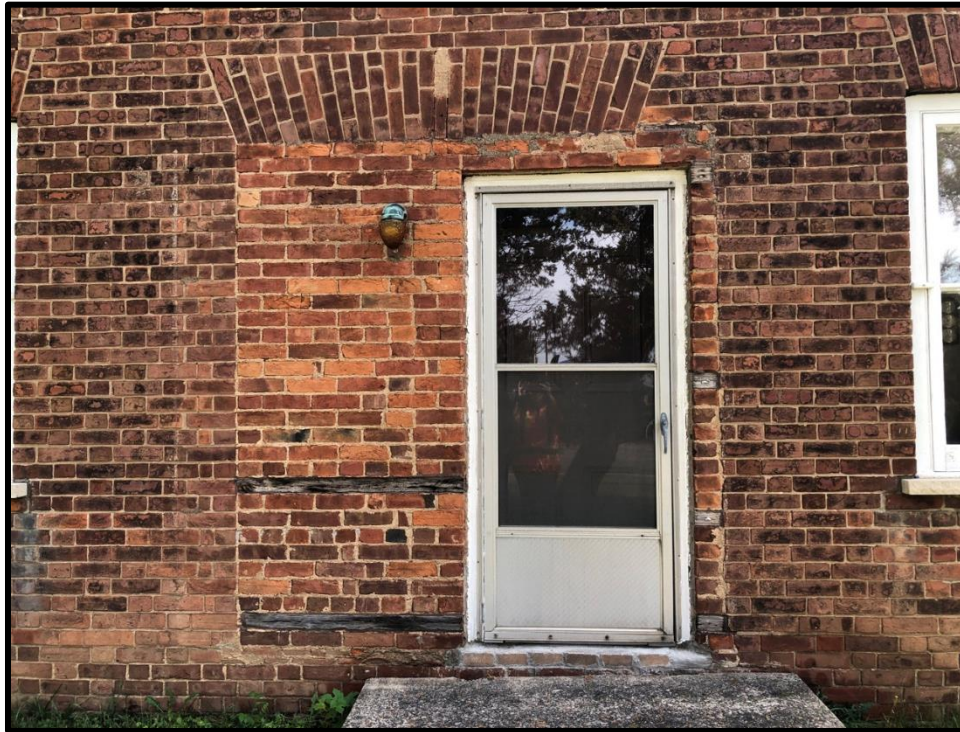
Image 7: Altered Brick Residence Façade Entryway
(Photo taken August 30, 2021; Facing East)

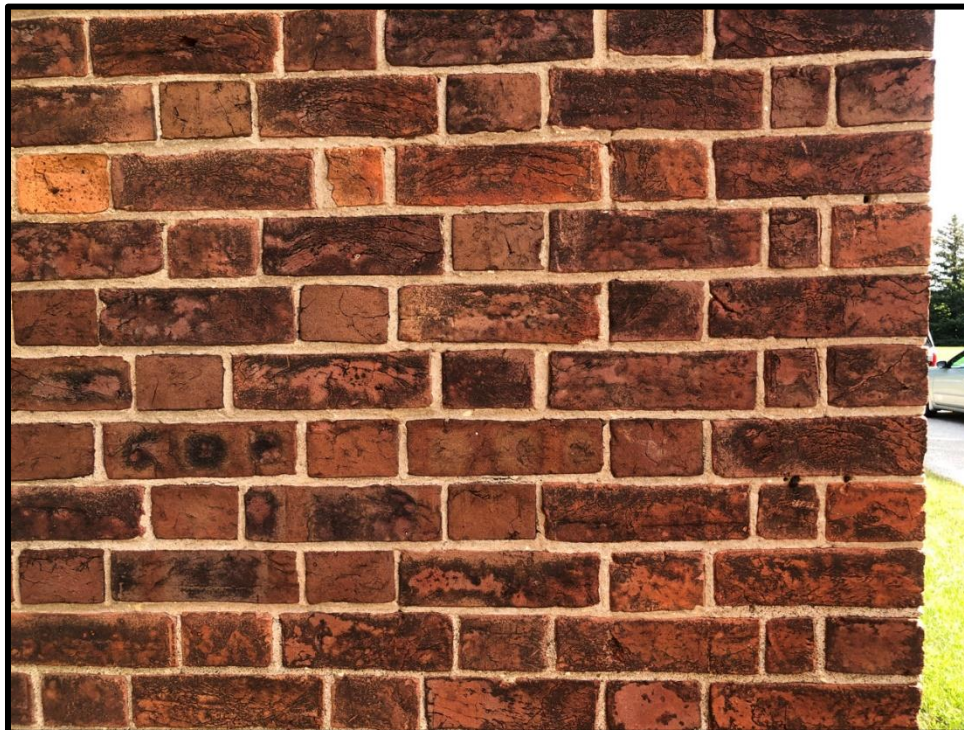
Image 8: Brick Residence Brickwork Laid in Flemish Bond with English Corner Detail
(Photo taken August 30, 2021; Facing East)

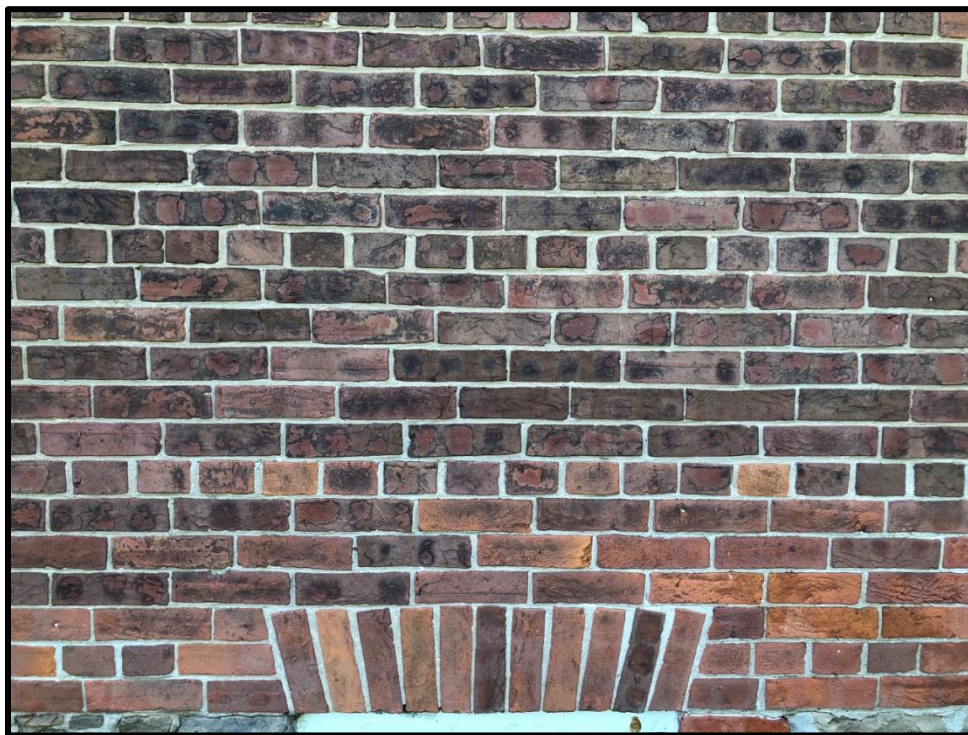
Image 10: Common Bond Brickwork on Side and Rear Elevation
(Photo taken August 30, 2021; Facing Northwest)

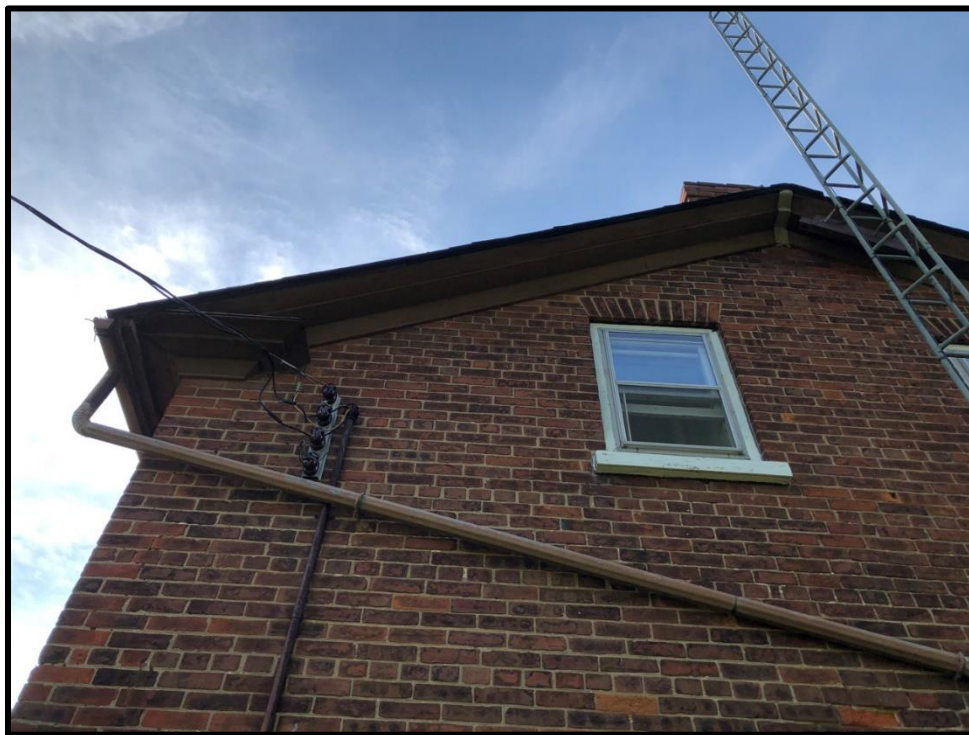
Image 14: Brick Residence Eave Returns
(Photo taken August 30, 2021; Facing South)

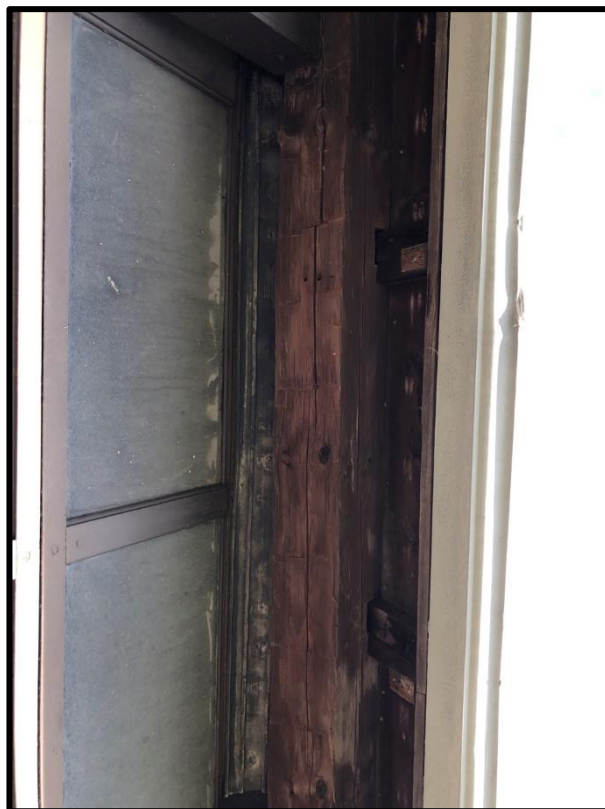
Image 22: Hand Hewn Timbers Visible at Outbuilding Entrance
(Photo taken August 30, 2021; Facing North)

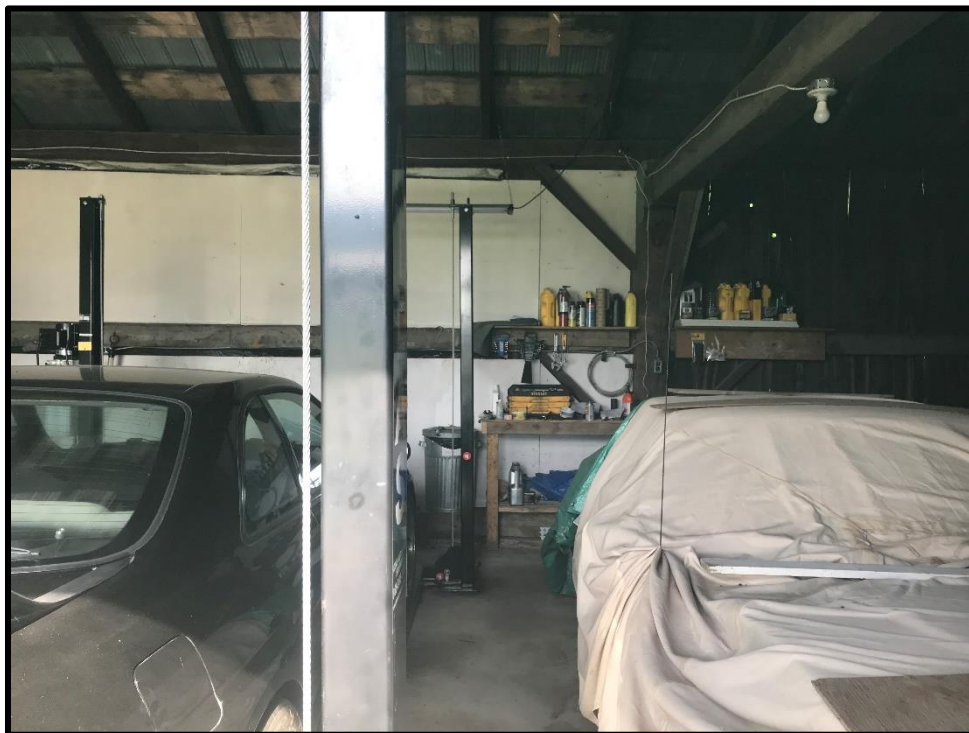
Image 24: Timber Framed Outbuilding – Interlocking Timber Structure Visible
(Photo taken August 30, 2021; Facing Northwest)

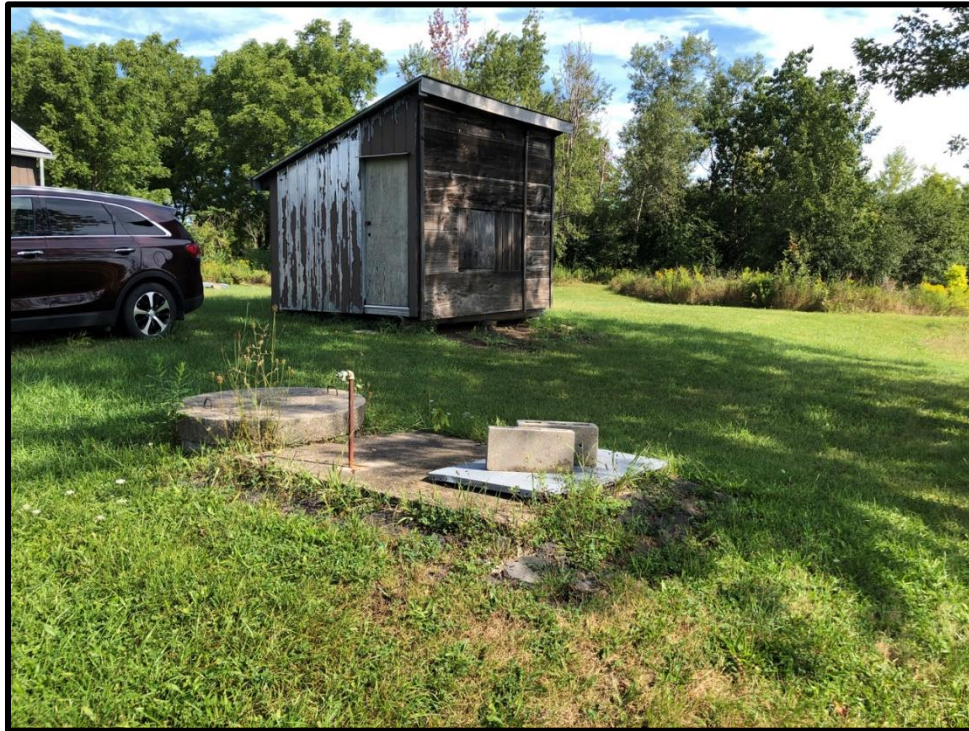
Image 29: Shed Structure – Placed on Logs
(Photo taken August 30, 2021; Facing North)

A small, moveable shed is located to the south of the gable roofed outbuilding. The shed has been relocated at some point and currently sits on logs placed on the ground (see Image 29). The structure has a shed roof, one door opening and boarded up window openings. The shed was noted during the field survey for the wide width of the timbers used to construct the shed's walls (see Image 30). These timbers measured at 19 inches, suggesting the use of old growth wood. The interior of this shed was not investigated and a previous use of the shed was not determined.

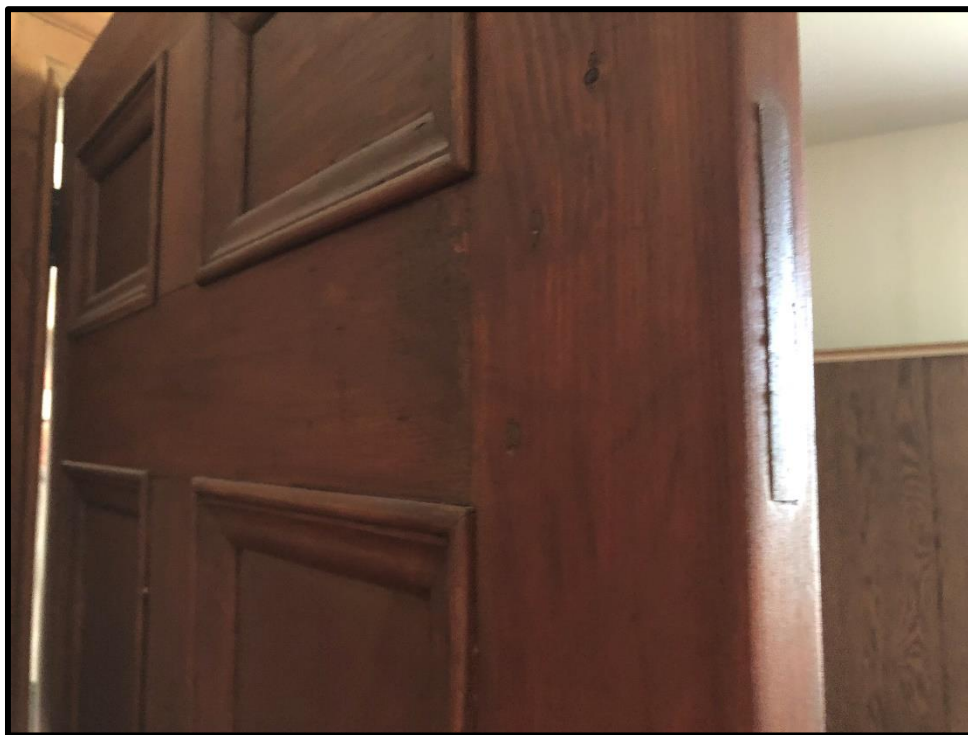
Image 40: Mortice and Tenon Joinery with Through Tenons Visible on Interior Doors
(Photo taken August 30, 2021)

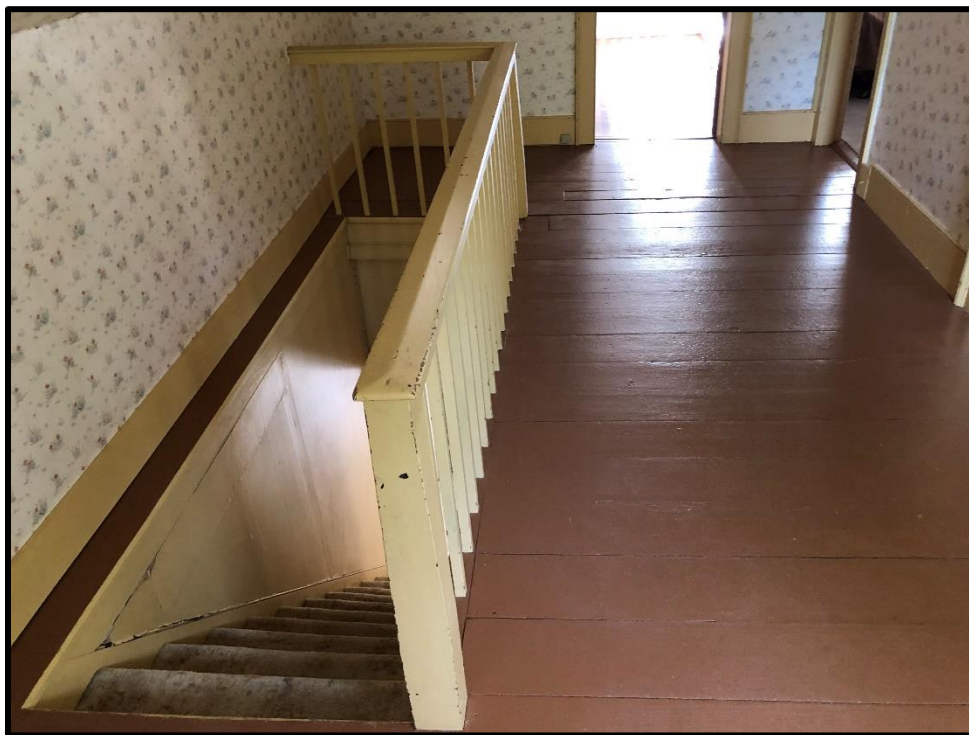
Image 48: Upper Storey with Rudimentary Banister and Baluster
(Photo taken August 30, 2021)

The stairs located off the kitchen lead to the second floor. The stairs with a simple painted banister and squared balusters open to a hallway (see Image 48). The baseboards and window and door surrounds on the second floor are fairly rudimentary in comparison to the woodwork observed on the first floor. The wood flooring is constructed of wide planks of varying widths that have been painted and are oriented in an east-west direction (see Image 49-Image 50). Disruptions in the floor plank length suggest that the layout of the upper storey hallway was modified at some point. The location of this change in the plank size suggest that the residence's staircase may have been realigned at some point and was previously a centre hall floor plan. There is one window opening located on the northern wall of the hallway (see Image 51). The three doorway openings off this hall open to bedrooms (see Image 52-Image 54). These openings contain solid wood six-panel doors with metal hardware (see Image 55-Image 56). The other two bedrooms are of a similar size (see Image 57-Image 59).

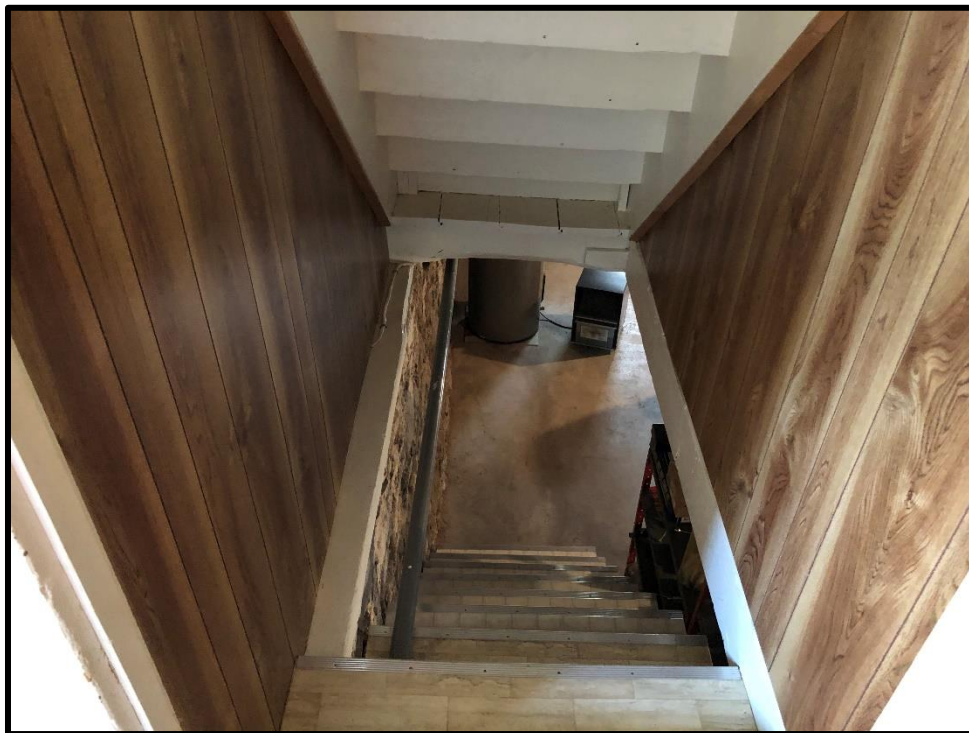
Image 60: Stairs Leading to Basement
(Photo taken August 30, 2021)

Stairs leading to the basement are accessed through the bathroom on the first floor (see Image 60). Hand hewn floor beams were observed in the basement along with floor joists oriented in an east-west orientation (see Image 61). Breaks in the floor joist pattern further support the hypothesis that the residence may have been designed with a centre hall floor plan and was modified at some point. The basement currently has a concrete floor, and the fieldstone foundation is visible with portions of brick infill around the window wells and at the chimney (see Image 62). Brick deterioration along the chimney was observed.

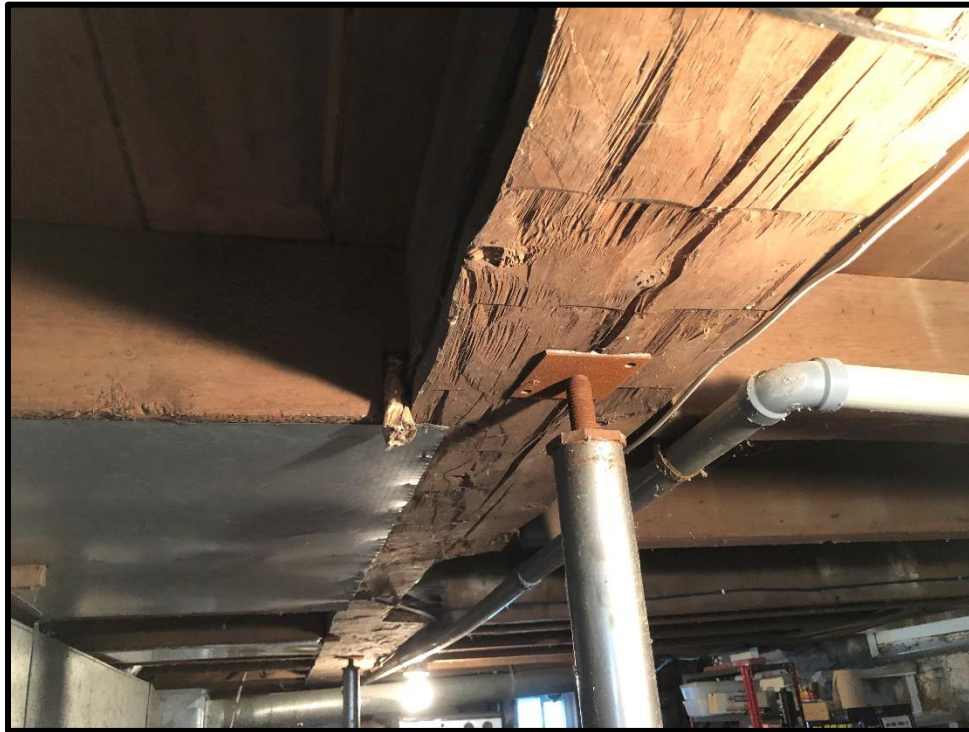
Image 61: Hand Hewn Beams Visible in Basement
(Photo taken August 30, 2021)

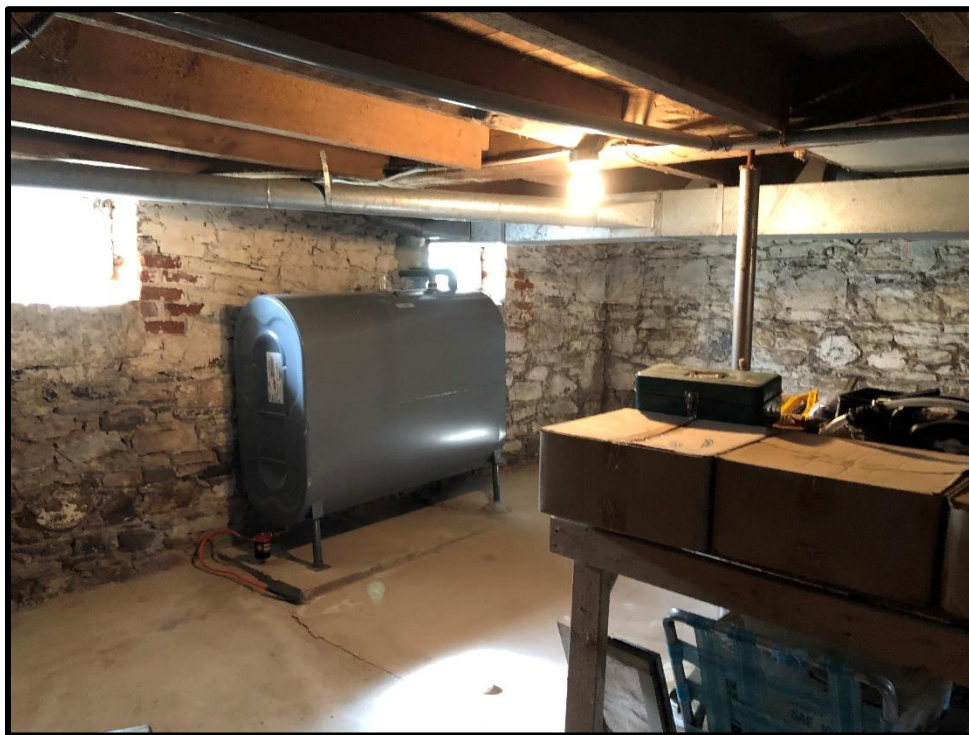
Image 62: Basement with Concrete Floor and Fieldstone Foundation with Brick Infill at Windows
(Photo taken August 30, 2021)

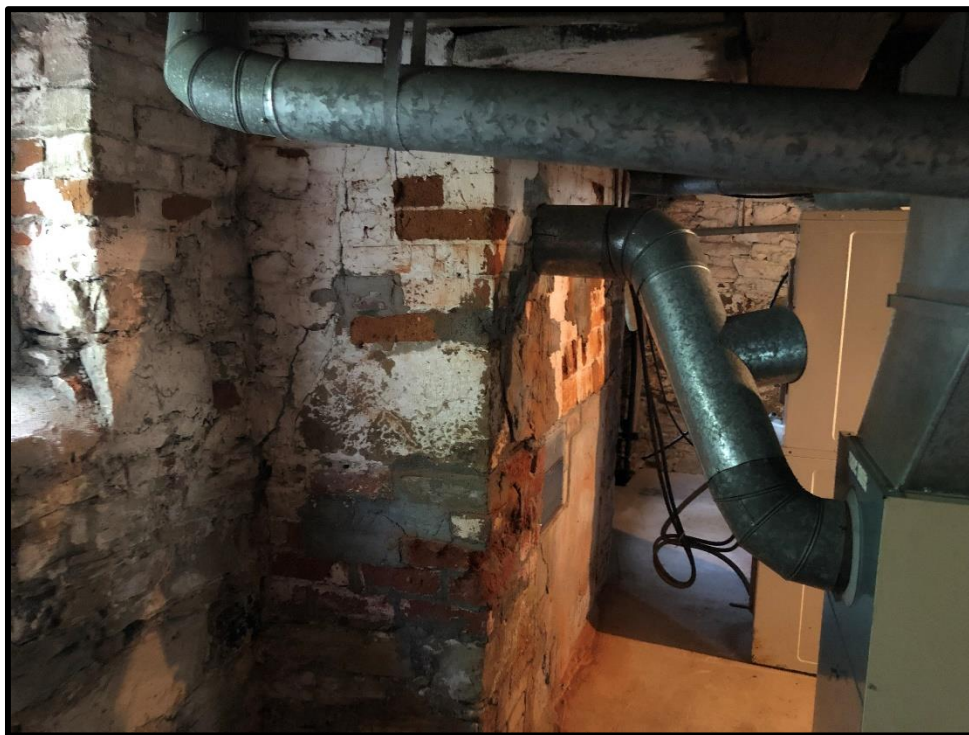
Image 64: Brick Chimney Showing Signs of Brick Deterioration
(Photo taken August 30, 2021)
