Research and Evaluation Report

Villanore

68 Bower Street, Acton, Town of Halton Hills

April 2023

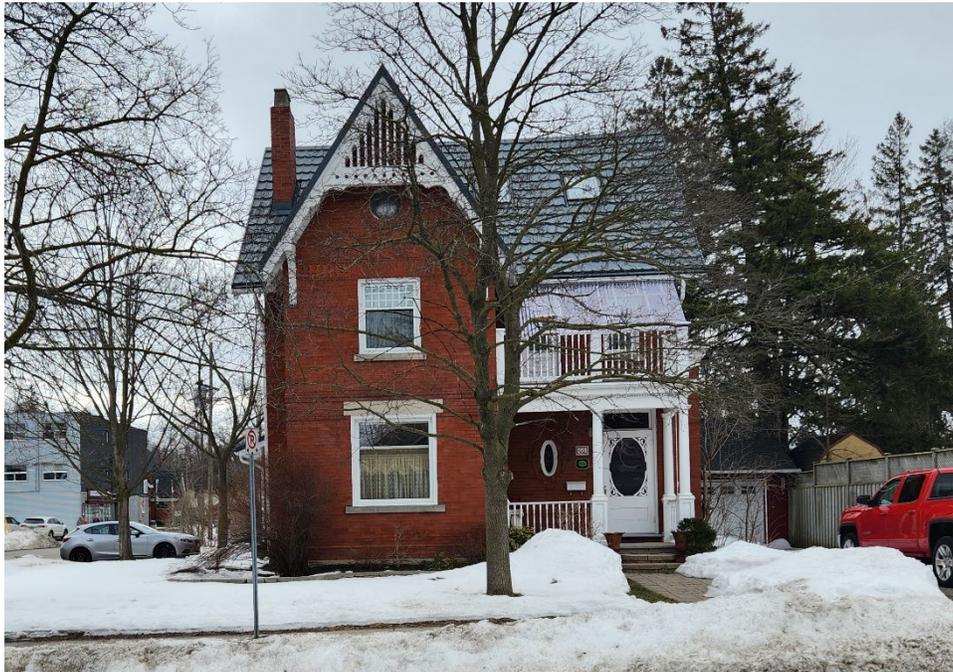
The existing two-and-a-half storey L-shaped residential building is set back from Bower Street and situated within the centre of the lot (Figure 15). The house is accessed by a walkway extending from the sidewalk along Bower Street. The front yard features two large, mature deciduous trees with soft landscaping along the front elevation and a grassed lawn. Mature deciduous trees are located along the rear and sides of the property with a low hedge at the south end of the property along Elgin Street. The single asphalt driveway is accessed from Bower Street and extends to a one-storey garage with gable roof at the rear of the house.

The front elevation features a projecting bay with gable peak and the front entrance along the recessed portion of the elevation. features a covered wooden porch at the first storey with balcony above at the second storey. The porch is accessed by a flight of two stone steps. At the first storey, the wooden porch features a wooden railing with turned balusters and wooden Doric columns above squared bases with recessed panels supporting the flat roof with dentil moulding. The second-storey railing features squared wooden columns with turned balusters.

Figure 15: Front (northwest) elevation of 68 Bower Street (Town of Halton Hills 2023)

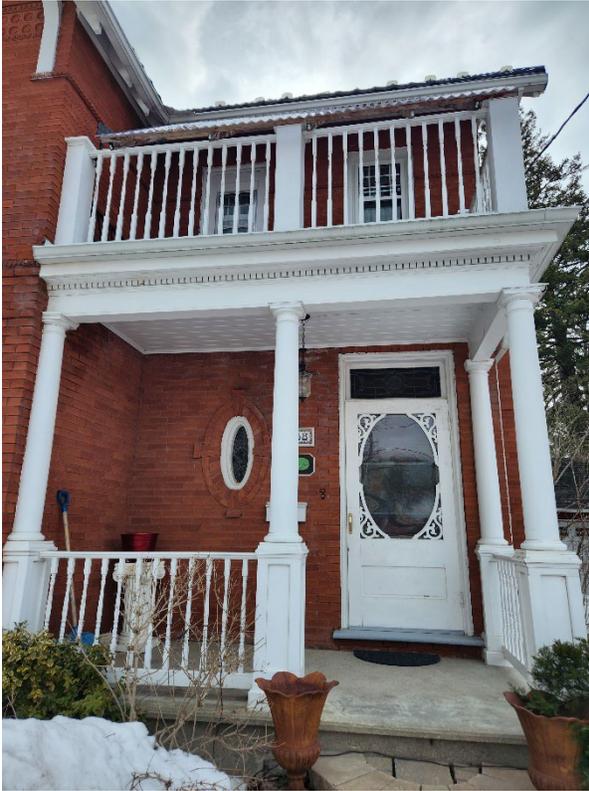
The front entrance features a flat-headed door opening with stained glass transom (Figure 16). Beside the entrance is an oval window with detailed brick surround. Above the first storey are a flat-headed window opening with stone sill and flat-headed door opening onto the porch roof. The front elevation of the projecting bay features a large, flat-headed, rectangular window opening with stone lintel and sill (Figure 17). Brick detailing extends above the lintel and wraps around the corner to the side elevation. At the second storey, a smaller rectangular window opening with brick lintel and stone sill is centered beneath an oval window with brick surround. The gable features decorative brackets with bargeboard

Figure 16: Front Porch Detail, 68 Bower Street (Town of Halton Hills 2023)

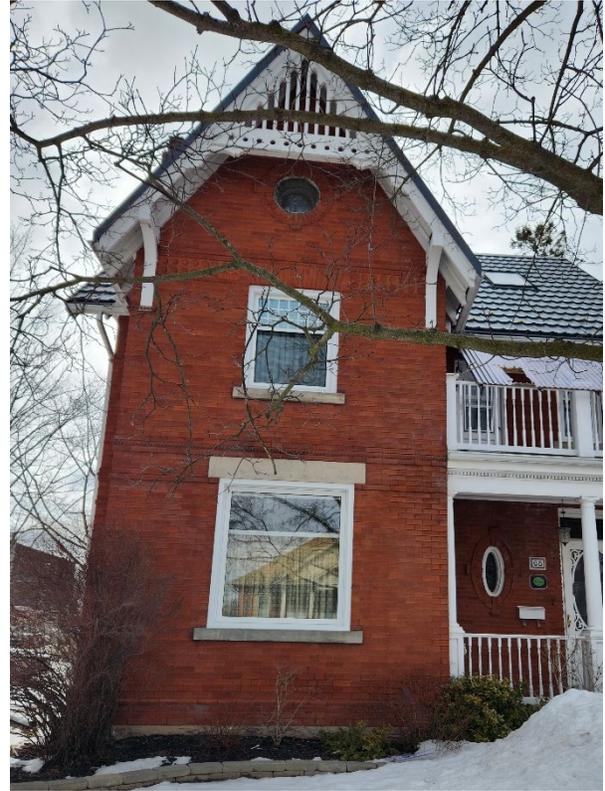
beneath the gable peak, with projecting eaves featuring wooden soffits. The steel roof facing Bower Street features contemporary skylights (Figure 18).

Figure 17: Front elevation detail, 68 Bower Street (Town of Halton Hills 2023)

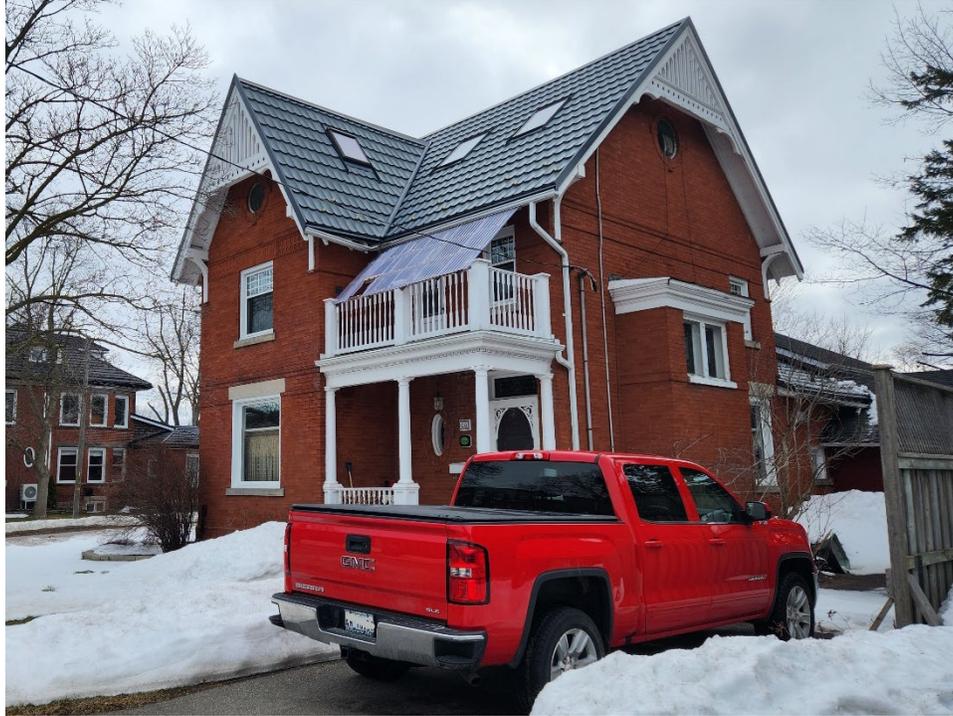
Along the west elevation (Figure 18 through Figure 21), a projecting bay extends above the first storey with a flat headed window opening beneath a small roof, aligning with an interior staircase. Beyond the project bay are smaller rectangular window openings at the first and second storeys. An oval window is located beneath the gable in the upper storey which features bracketed eaves with wooden soffits and decorative bargeboard.

Figure 18: Northwest corner of 68 Bower Street (Town of Halton Hills 2023)

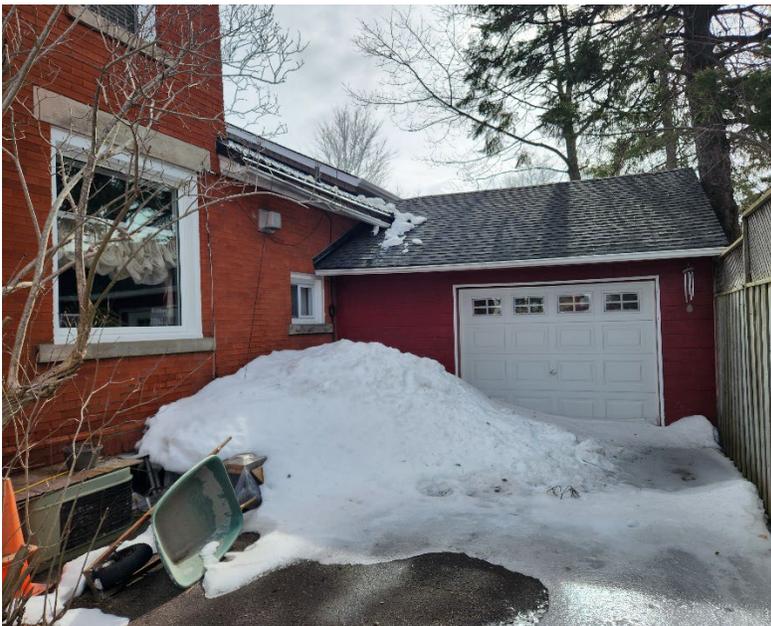
Figure 19: Partial side (southwest) elevation and rear garage, 68 Bower Street (Town of Halton Hills 2023)

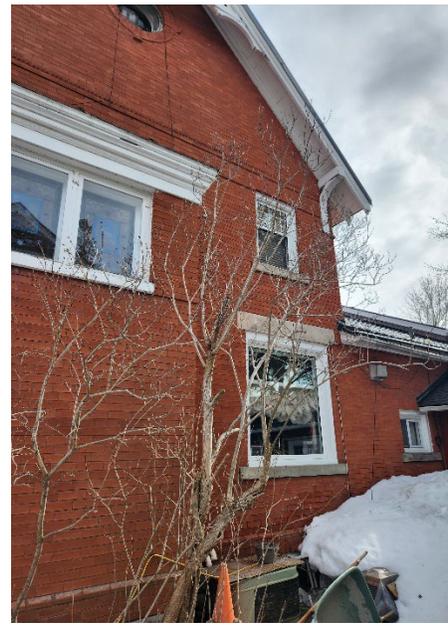
Figure 20: Partial side (southwest) elevation, 68 Bower Street (Town of Halton Hills 2023)

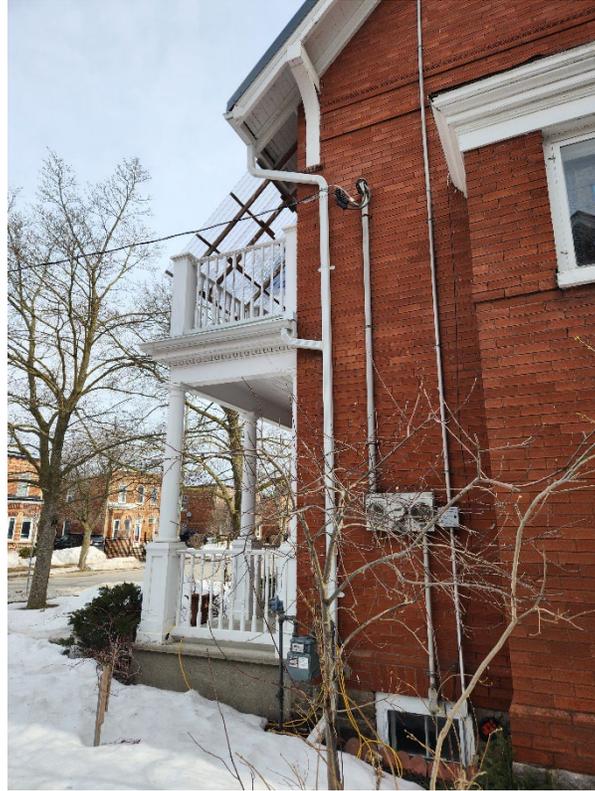
Figure 21: Partial side (southwest) elevation showing front covered porch (Town of Halton Hills 2023)

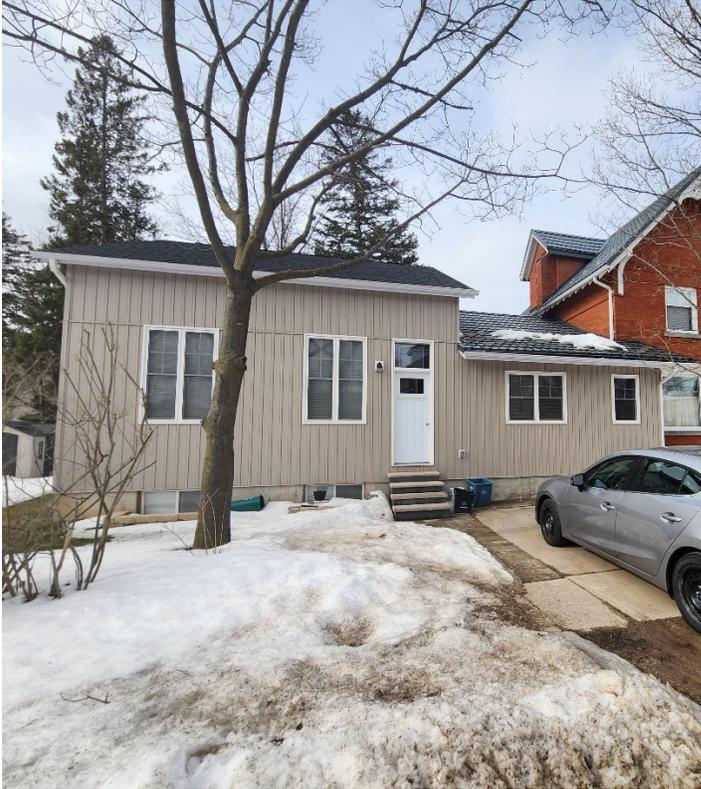
The first storey of the east elevation along Elgin Street features two small vertical window openings and a larger rectangular window opening with stone lintel and sill towards the rear (Figure 23). At the second storey are a smaller rectangular window opening with contemporary hung window with a smaller, horizontal window opening with slider window and stone sill. Centered beneath the gable is a round window opening below the bracketed eaves with wooden soffit and bargeboard, like that on the north and west elevations. A brick chimney extends above the east elevation.

Figure 22: Partial side (northeast) elevation, 68 Bower Street (Town of Halton Hills 2023)

At the rear, a one-storey addition with gable roof, with additional height in the south portion of the addition, connects into the original structure (Figure 22). The contemporary addition is clad in wooden bargeboard. Above the one-storey addition, a gable-roofed dormer is visible within the roof of the original structure, with a small contemporary skylight directly beside it (Figure 24 and Figure 25).

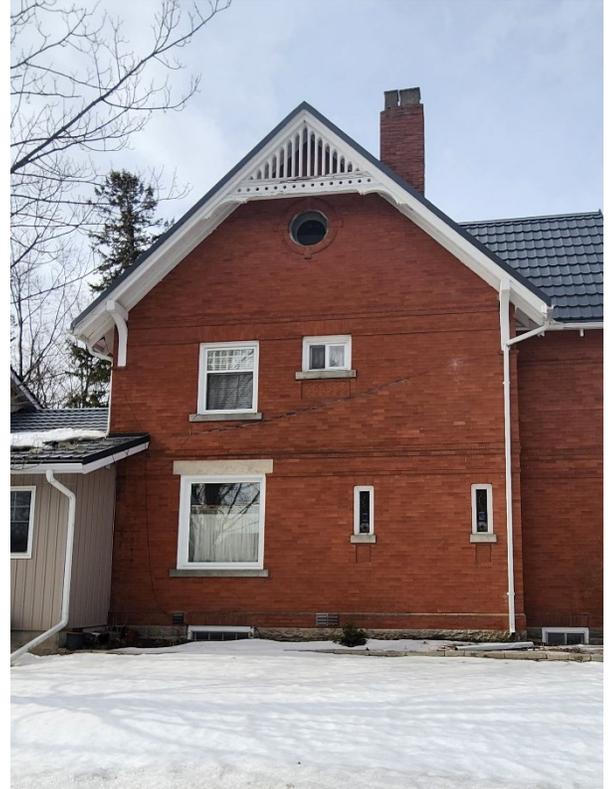
Figure 23: Partial side (northeast) elevation, 68 Bower Street (Town of Halton Hills 2023)

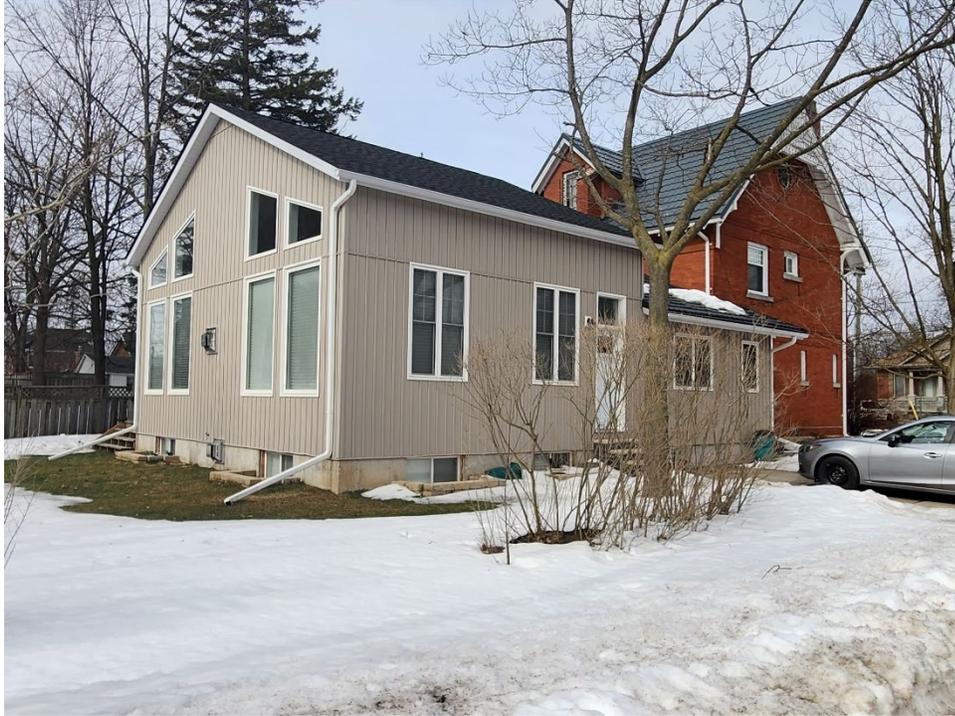
Figure 24: Looking east from Elgin Street towards 68 Bower Street, showing southeast corner (Town of Halton Hills 2023)

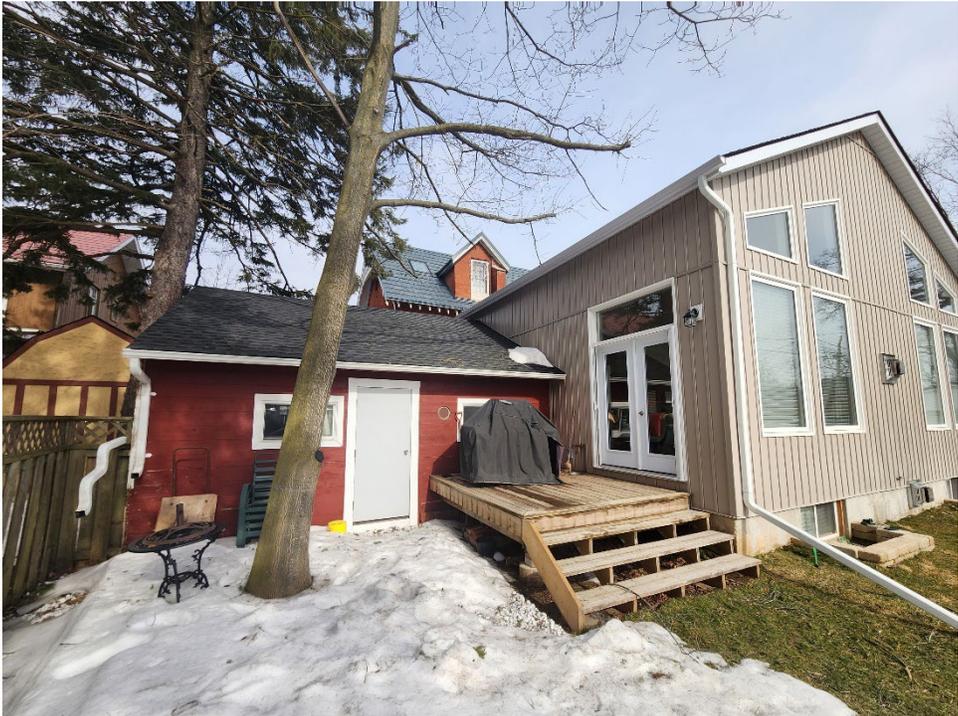
Figure 25: Rear elevation showing one-storey garage, 68 Bower Street (Town of Halton Hills 2023)

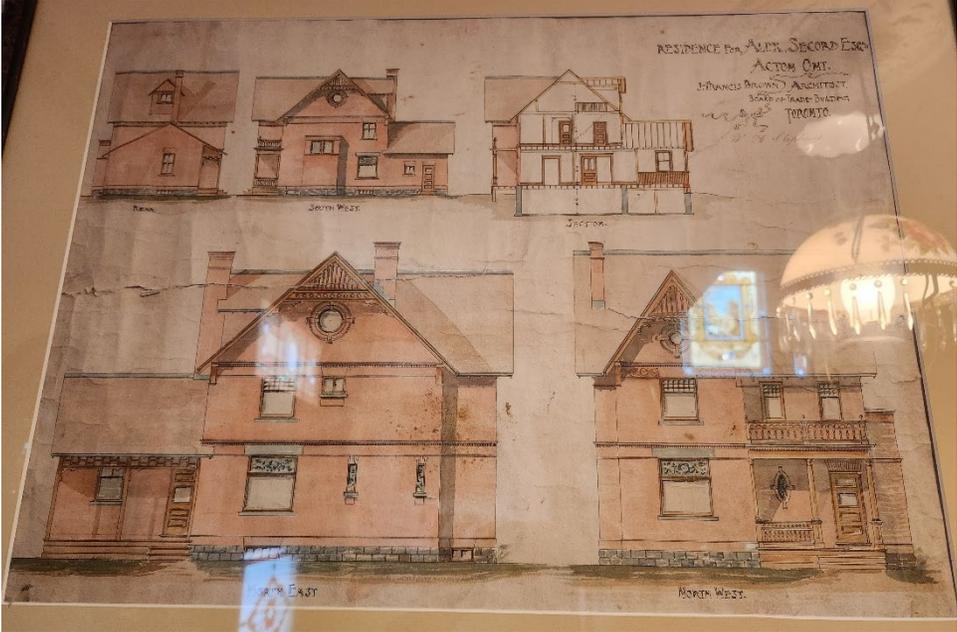
The current owners have the architect's original plans and elevation drawings on display within the residence's foyer (Figure 26 and Figure 27). In 2020, the side verandah (shown on the first-floor plans) was removed for the rear addition which also modified the rear kitchen wall. The plans also demonstrate the alterations to the front porch railings as well as the original windows.

Figure 26: Photograph of the architect's elevations for Villanore

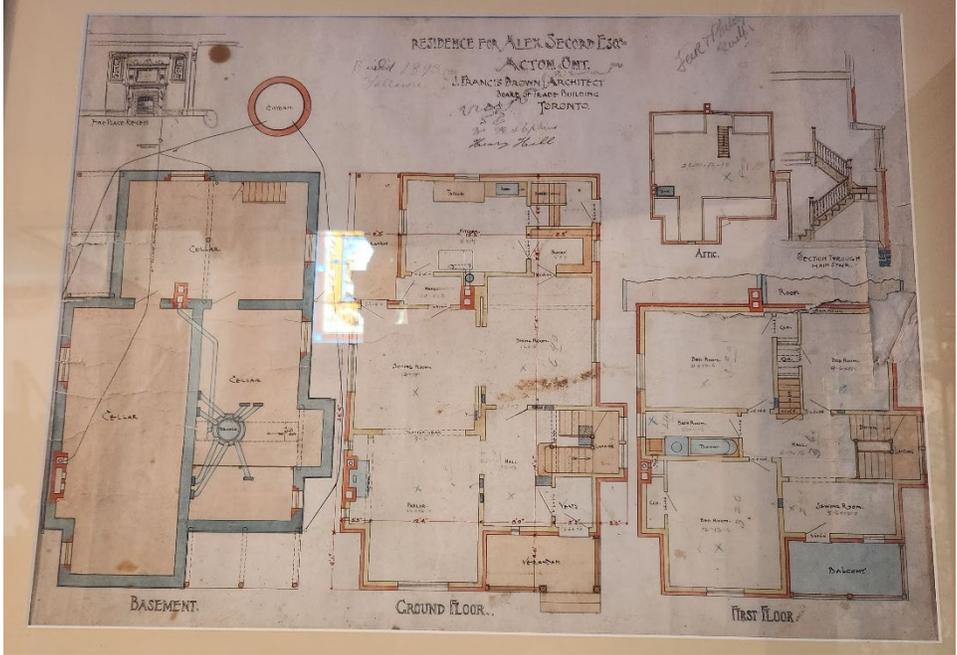
Figure 27: Photograph of the original floor plans for Villanore by J. Francis Brown

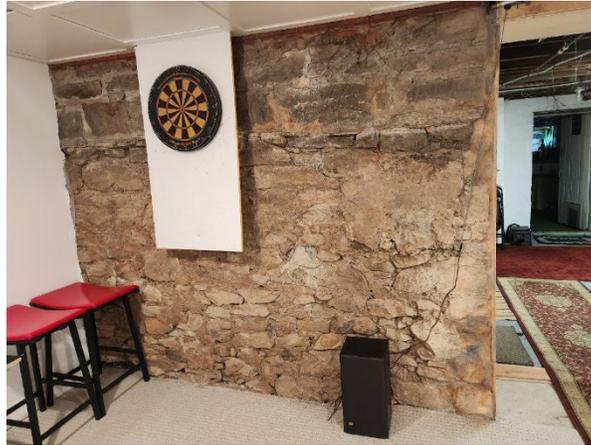
The interior of Villanore has retained many original details and features, while some areas have been renovated over time. At the basement level, the original rubble stone foundation is visible on the interior within the rear addition (Figure 28).

Figure 28: Rubble stone foundation within interior basement, 68 Bower Street (Town of Halton Hills 2023)

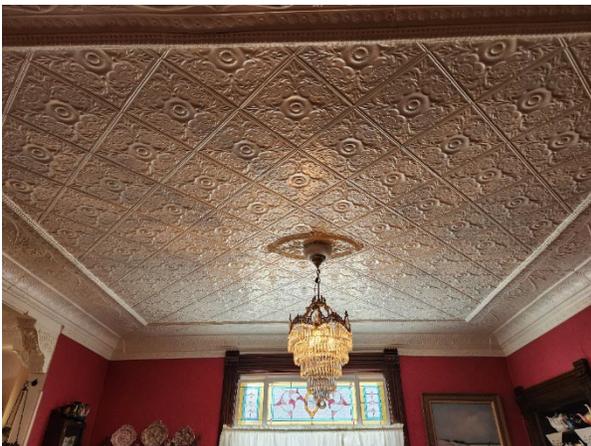
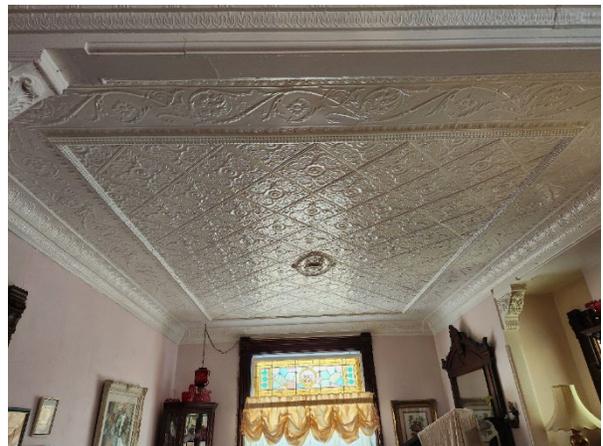
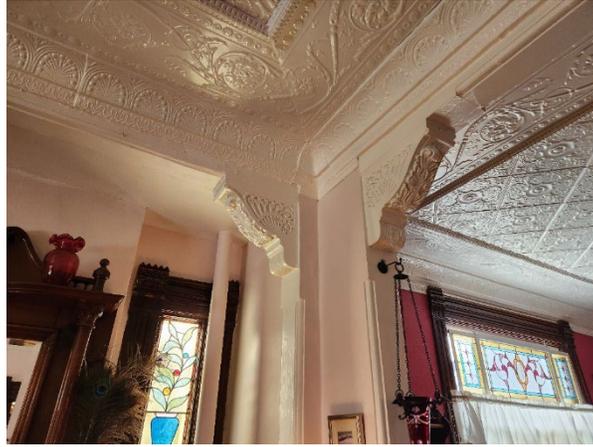
On the first floor, the dining room and living room ceilings feature the original painted tin ceiling supported by decorative brackets (Figure 29, Figure 30, and Figure 31). Dark wood trim is extant around window openings throughout, in addition to wood trim around doorways and along the baseboards (Figure 32 and Figure 39).

Figure 29: Original tin ceiling within the dining room, 68 Bower Street (Town of Halton Hills 2023)

Figure 30: Original tin ceiling within the living room, 68 Bower Street (Town of Halton Hills 2023)

Figure 31: Interior ceiling detail within the living room and dining room, 68 Bower Street (Town of Halton Hills 2023)

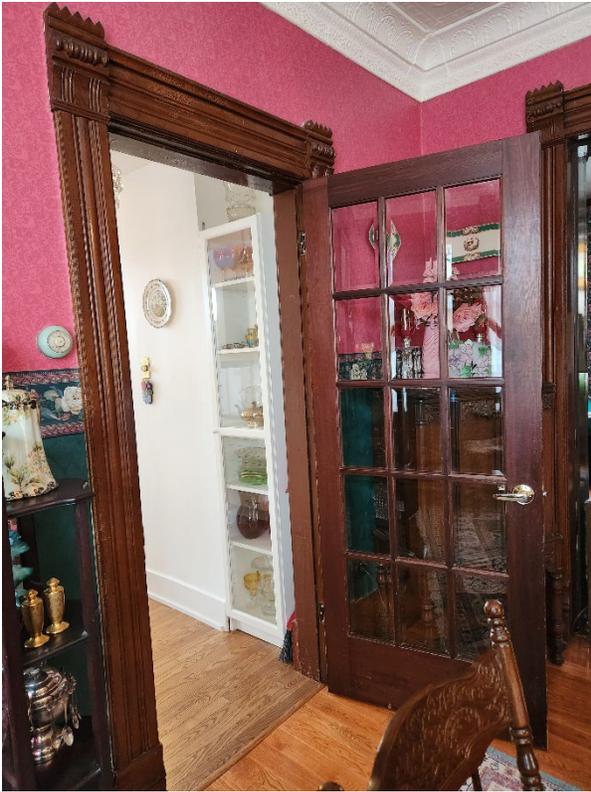
Figure 32: Wood door trim and doors within dining room, 68 Bower Street (Town of Halton Hills 2023)

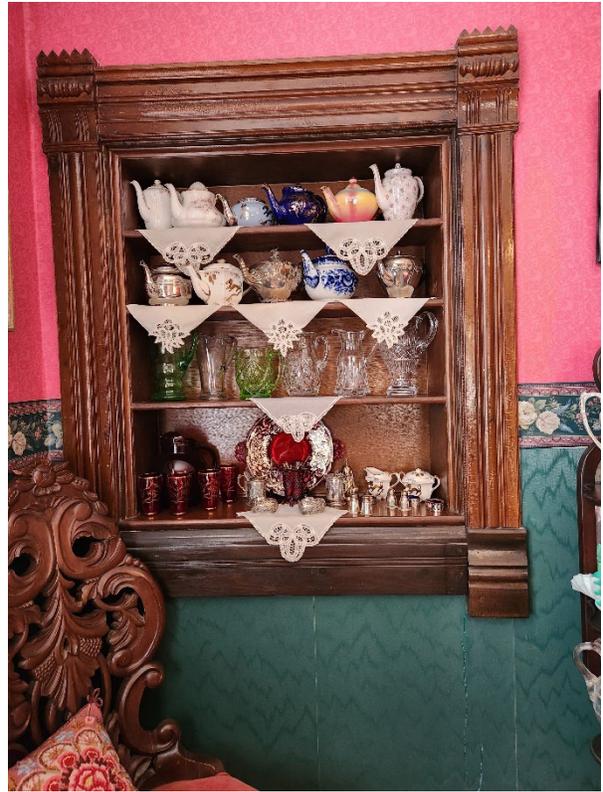
Figure 33: Wooden decorative feature within dining room, 68 Bower Street (Town of Halton Hills 2023)

A built-in decorative shelf features the same wood detailing (Figure 33). While the original windows in the home have almost all been replaced, some of the stained glass windows have remained, including the glass transom above the entrance, oval stained glass window on the primary elevation next to the entrance, two small stained glass windows flanking the fireplace, and a hand-painted pair of stained glass windows above the staircase landing (Figure 34 through Figure 37).

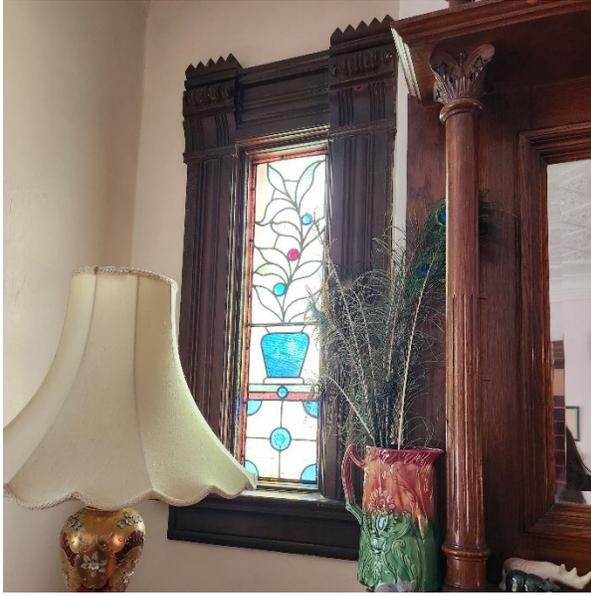
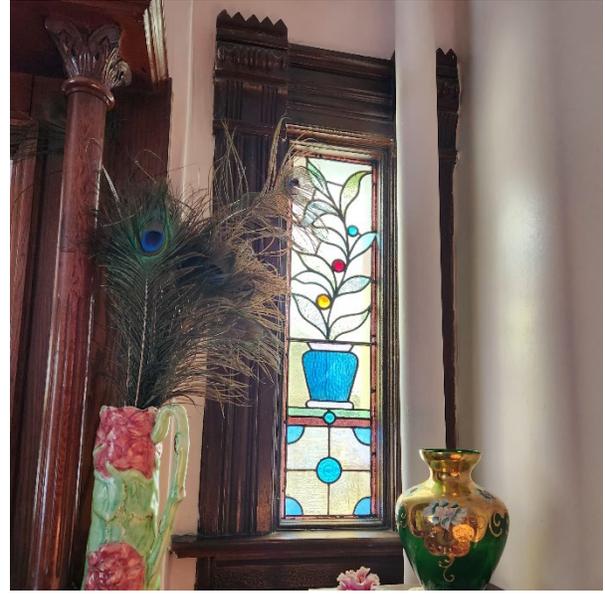
Figure 34: Stained glass window with carved wooden trim within the living room, 68 Bower Street (Town of Halton Hills 2023)

Figure 35: Stained glass windows with carved wooden trim within the living room, 68 Bower Street (Town of Halton Hills 2023)

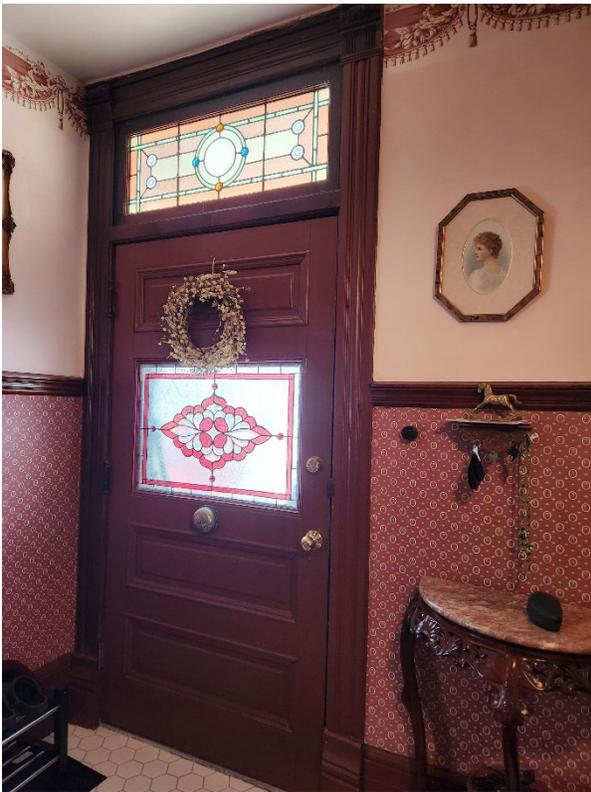
Figure 36: Front entrance within foyer showing wooden door trim and stained-glass transom above, 68 Bower Street. Existing door is not original (Town of Halton Hills 2023)

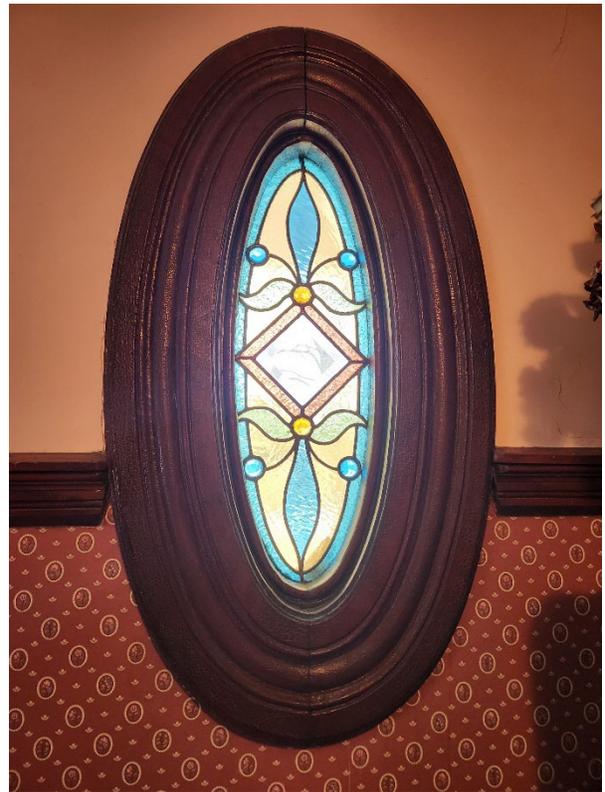
Figure 37: Stained glass window adjacent to front entrance from within foyer, 68 Bower Street (Town of Halton Hills 2023)

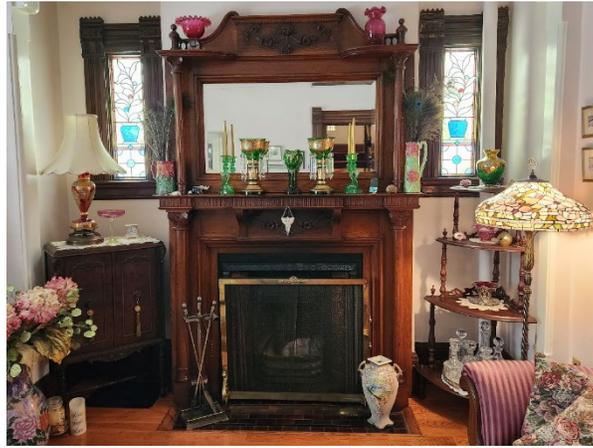
The living room features an ornately carved fireplace surround and mantel with its original tile hearth (Figure 38).

Figure 38: Original wooden fireplace within the dining room, 68 Bower Street (Town of Halton Hills 2023)

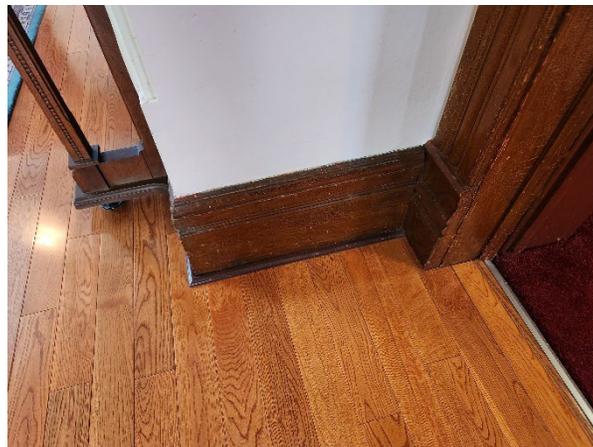
Figure 39: Interior wooden baseboard within living room, 68 Bower Street (Town of Halton Hills 2023)

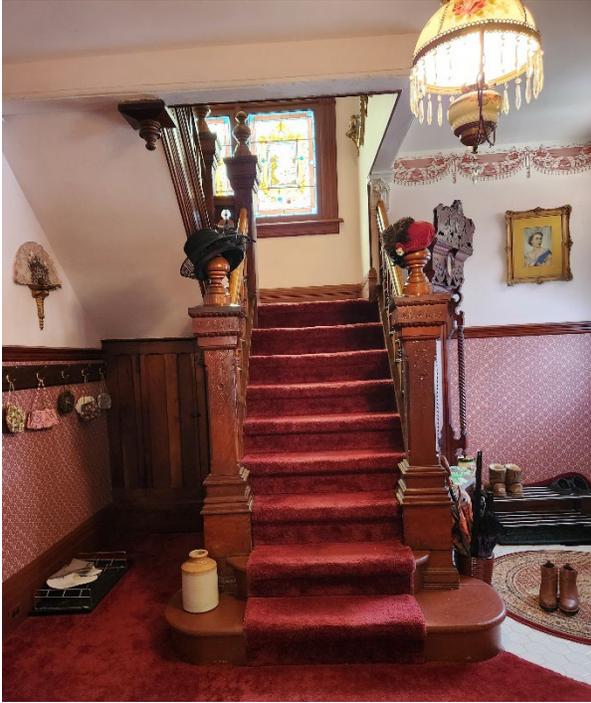
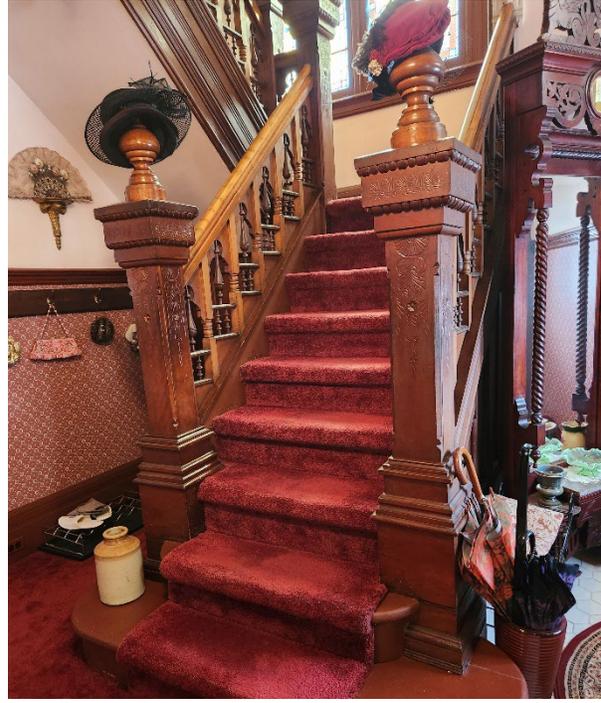
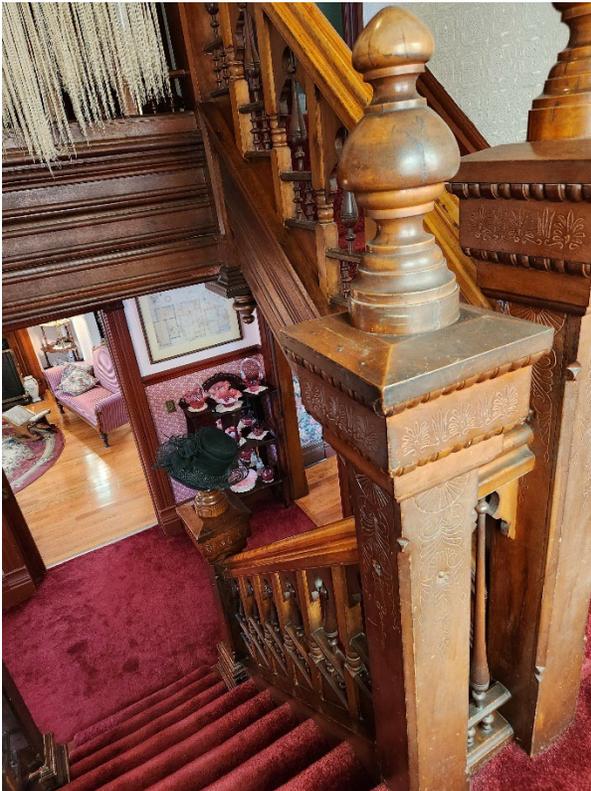
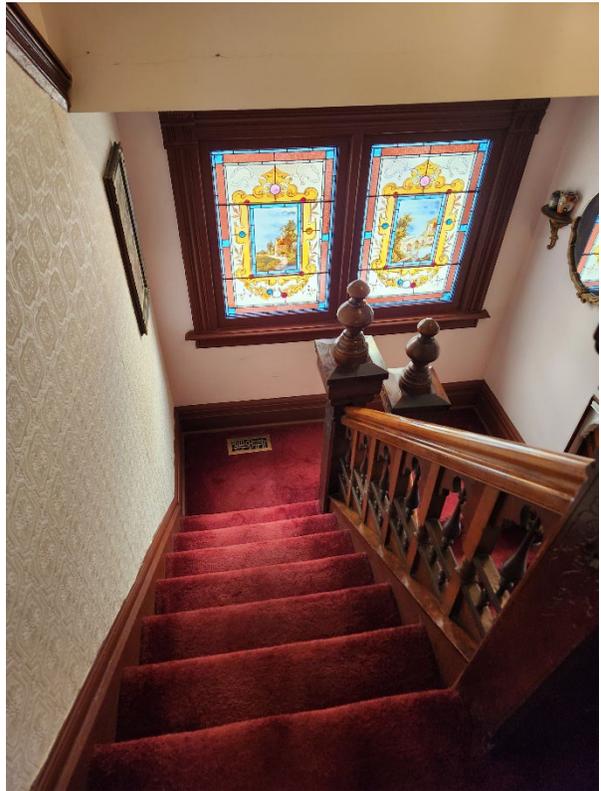
Within the front foyer, an ornately carved and detailed staircase extends to the second floor, providing access to the hand-painted stained glass windows above the landing in between floors (Figure 40 through Figure 44).

Figure 40: Carved wooden staircase, 68 Bower Street (Town of Halton Hills 2023)

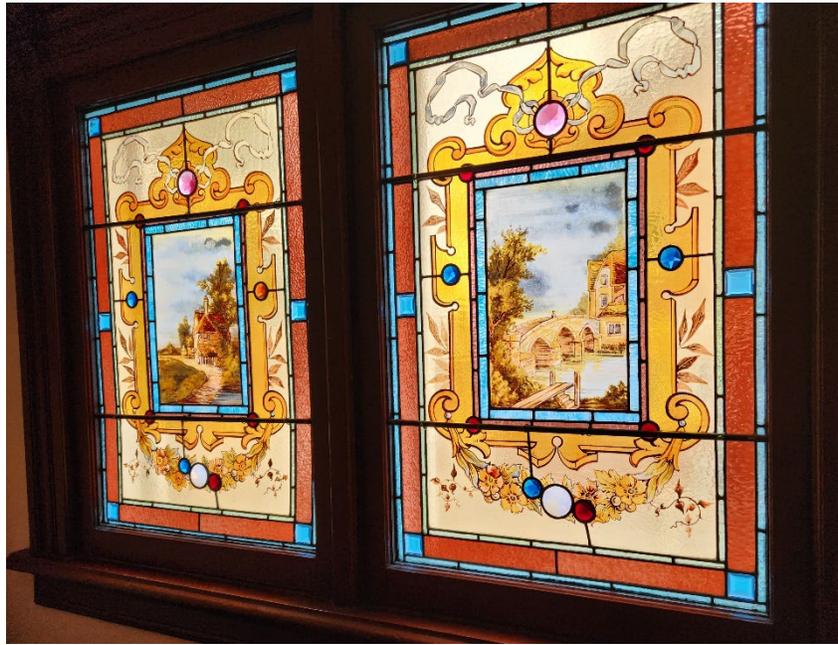
Figure 44: Hand-painted stained-glass windows at staircase landing, 68 Bower Street (Town of Halton Hills 2023)
