# Research and Evaluation Report

## St. John's Anglican Church

10996 Trafalgar Road, Stewarttown Town of Halton Hills

June 2023

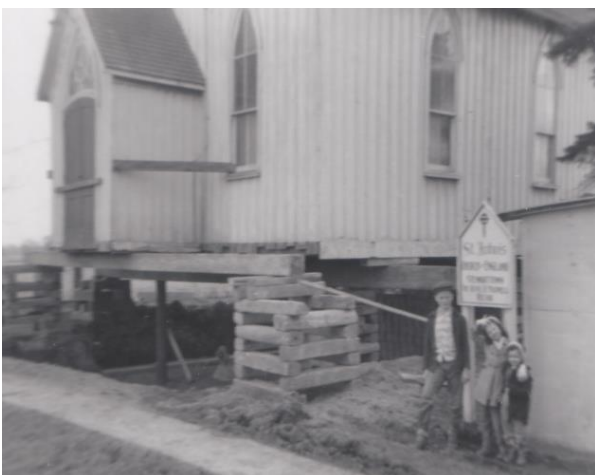
Figure 11: St. John's Anglican c.1958 during the basement construction (Courtesy of The Georgetown Vault)

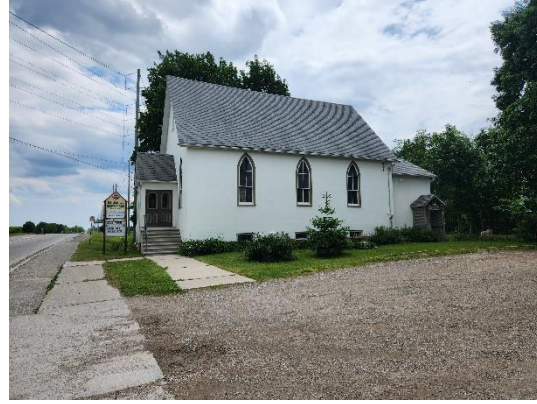
Figure 25: Looking south along Trafalgar Road towards the subject property (Town of Halton Hills 2023)

The property at 10996 Trafalgar Road is located at the southwest corner of 15 Side Road and Trafalgar Road. The property includes a one-storey frame church building with a gravel parking lot, paved walkway to the front entrance, and features several mature deciduous trees along the property line (Figure 24 and Figure 25).

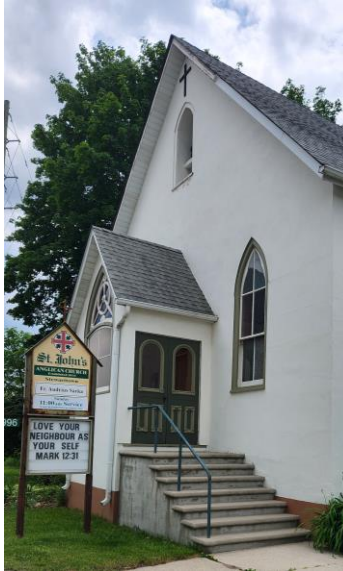
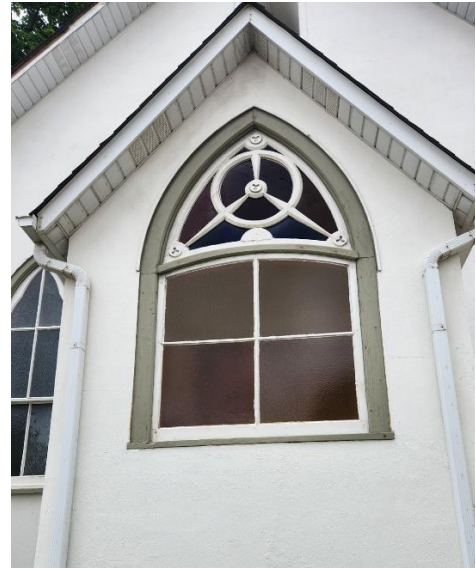
The existing one-storey structure is a wood frame building clad with stucco, with a front gable roof. Each side elevation features three symmetrically placed Gothic-arched windows. On the front elevation along Trafalgar Road, a window opening is located on either side of the entrance vestibule which features a side double-door entrance above a flight of concrete steps. The entrance was previously centered within the vestibule along Trafalgar Road according to historic photographs. Above the vestibule and beneath the gable roof is the church bell within a recess on the front elevation. (Figure 26 through Figure 28)

Figure 26: Front elevation of St. John's Anglican Church (Town of Halton Hills 2023)

Figure 27: Front elevation of St. John's Anglican Church (Town of Halton Hills 2023)

Figure 28: Detail of front elevation of St. John's Anglican Church (Town of Halton Hills 2023)

- The setback, placement, and orientation of the c.1840s frame church building at the southwest corner of 15 Side Road and Trafalgar Road
- The scale, form and massing of the one-storey stuccoed frame structure with gable roof with front vestibule;
- The materials, including stuccoed exterior;
- On the front (east) elevation:
  - The central vestibule with wooden lancet stained-glass window with wood surround;
  - Beneath the centre gable, the recessed alcove with bell; and,
- On the side (north and south) elevations, the three symmetrically placed lancet window openings with wood surrounds.

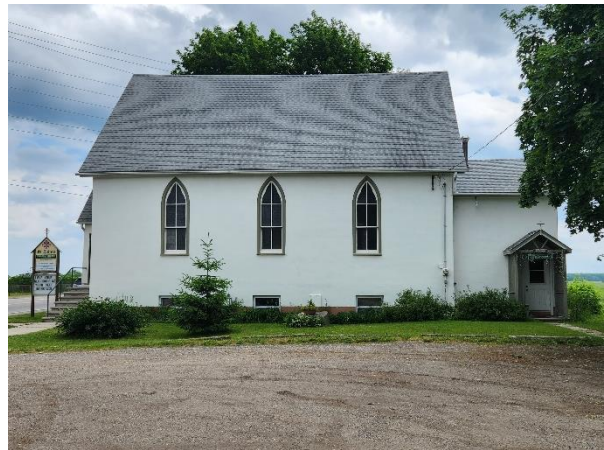
The side elevation along 15 Side Road features the same symmetrically placed Gothic-arched window openings with basement windows located below, and a gable-roofed entrance within the rear one-storey addition. The entrance within the rear addition is located beneath a gable roofed open porch structure (Figure 30 and Figure 31)

Figure 30: Northwest corner of St. John's Anglican Church  
(Town of Halton Hills 2023)

Figure 31: Side (north) elevation of St. John's Anglican Church  
(Town of Halton Hills 2023)

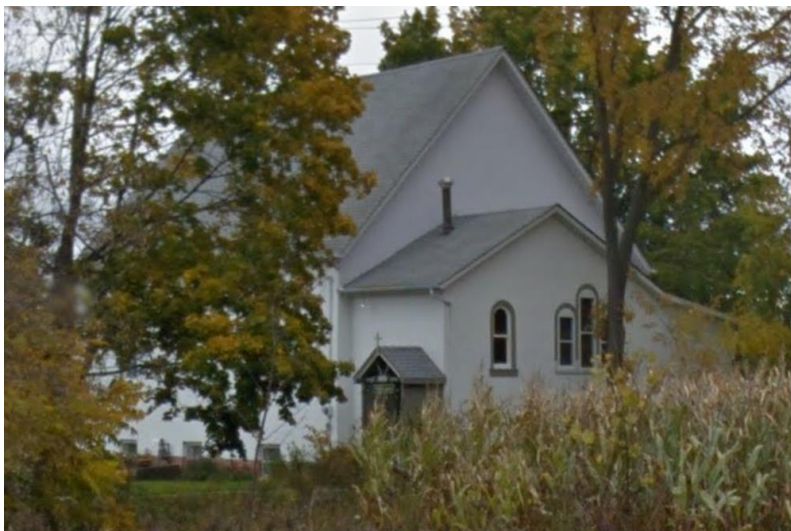
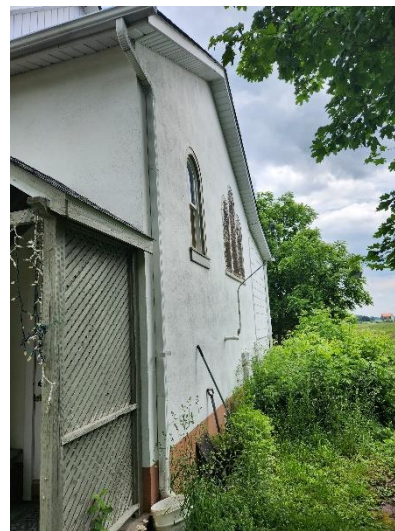
The rear elevation of the main church building is a blank wall with no openings, while the one-storey addition features a single round-arched window and a tripartite round window opening. A small metal chimney is located above the roof of the addition (Figure 32).

Figure 32: Rear (west) elevation of St. John's Anglican Church (Google Streetview 2021)

Figure 33: Rear (west) elevation of St. John's Anglican Church (Town of Halton Hills 2023)
