Research and Evaluation Report

St. John's Anglican Church

10996 Trafalgar Road, Stewarttown Town of Halton Hills

June 2023

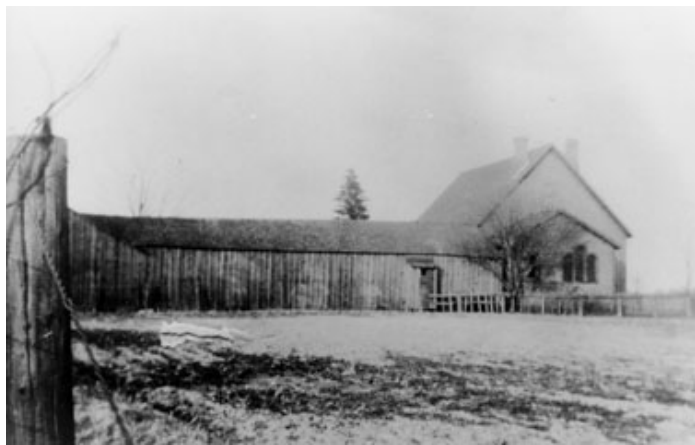
Figure 10: Rear of St. John's Anglican Church and driving sheds, which were removed in 1958, c.1948. As evidenced in the photograph, the church building has been stuccoed (EHS 475f).

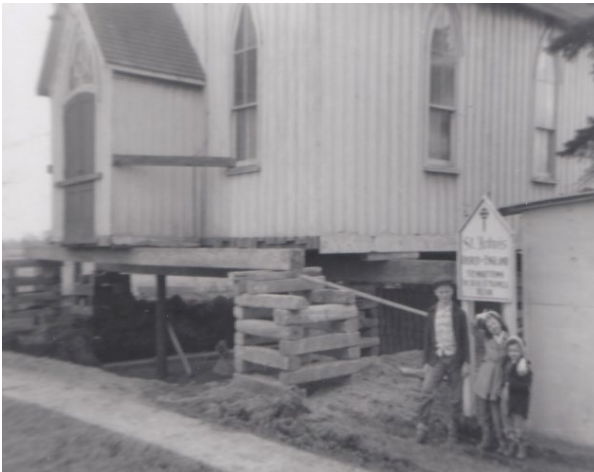
Figure 11: St. John's Anglican c.1958 during the basement construction (Courtesy of The Georgetown Vault)

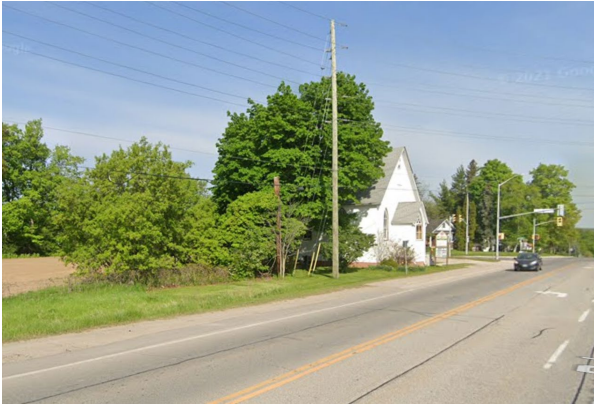
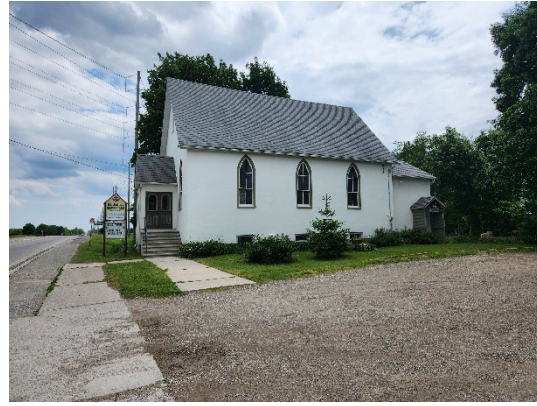
The property at 10996 Trafalgar Road is located at the southwest corner of 15 Side Road and Trafalgar Road. The property includes a one-storey frame church building with a gravel parking lot, paved walkway to the front entrance, and features several mature deciduous trees along the property line (Figure 24 and Figure 25).

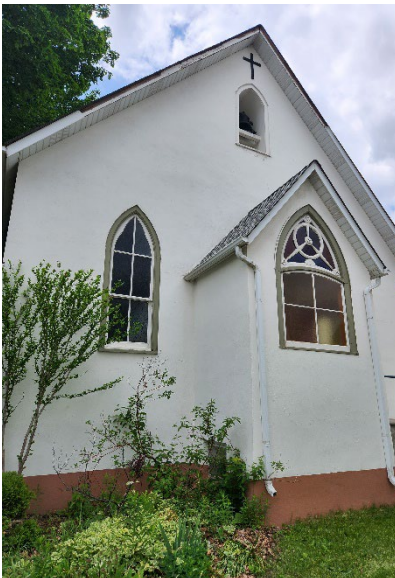
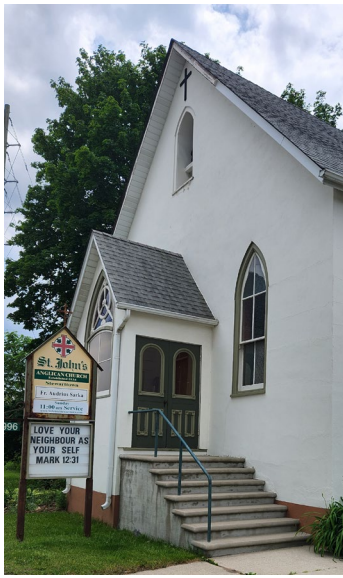
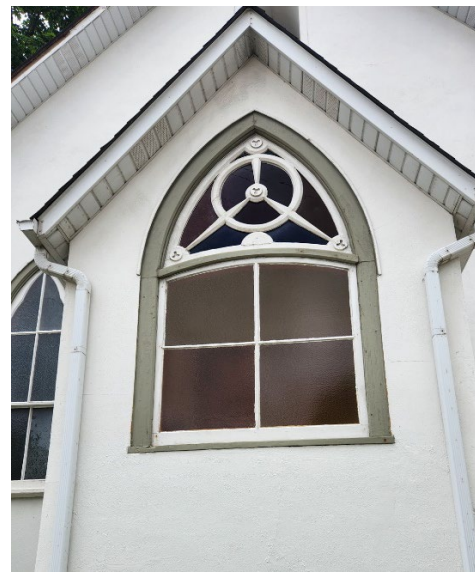
The existing one-storey structure is a wood frame building clad with stucco, with a front gable roof. Each side elevation features three symmetrically placed Gothic-arched windows. On the front elevation along Trafalgar Road, a window opening is located on either side of the entrance vestibule which features a side double-door entrance above a flight of concrete steps. The entrance was previously centered within the vestibule along Trafalgar Road according to historic photographs. Above the vestibule and beneath the gable roof is the church bell within a recess on the front elevation. (Figure 26 through Figure 28)

The steeply-pitched gable roof of St. John's Anglican Church is characteristic of the Gothic Revival style, as are its pointed lancet windows. Aside from those features, however, the church itself is a vernacular box shape and features no other significant ornamentation on the exterior, apart from the central stained glass window within the front vestibule.

- The setback, placement, and orientation of the c.1840s frame church building at the southwest corner of 15 Side Road and Trafalgar Road
- The scale, form and massing of the one-storey stuccoed frame structure with gable roof with front vestibule;
- The materials, including stuccoed exterior;
- On the front (east) elevation:
 - The central vestibule with wooden lancet stained-glass window with wood surround;
 - Beneath the centre gable, the recessed alcove with bell; and,
- On the side (north and south) elevations, the three symmetrically placed lancet window openings with wood surrounds.

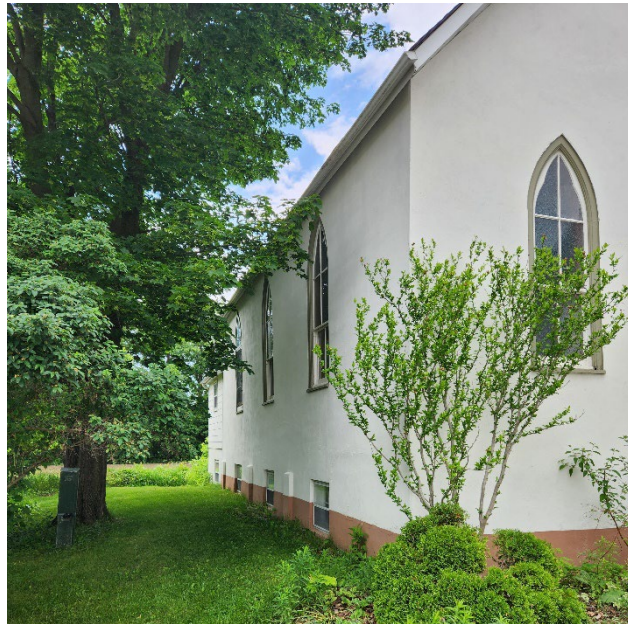
Figure 29: Side (south) elevation of St. John's Anglican Church (Town of Halton Hills 2023)

The south elevation of the church features three symmetrically placed lancet windows and flat-headed window openings at the basement level. A rear one-storey addition is visible on the west side of the original church building (Figure 29).

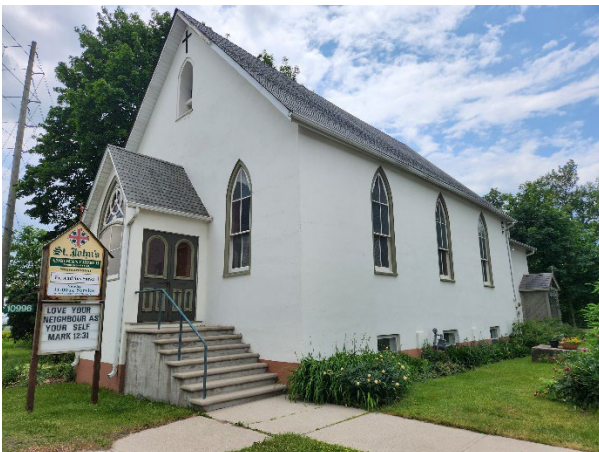
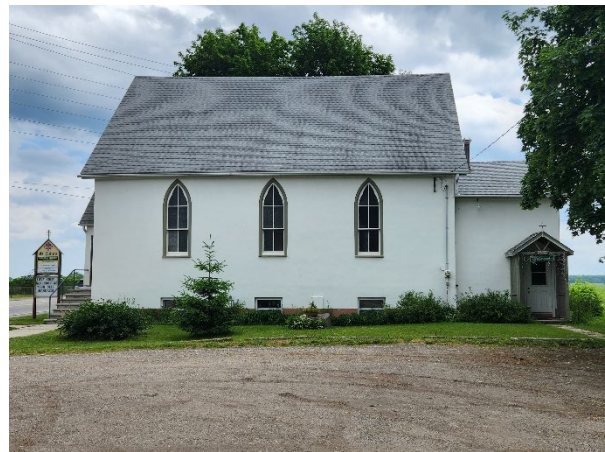
The side elevation along 15 Side Road features the same symmetrically placed Gothic-arched window openings with basement windows located below, and a gable-roofed entrance within the rear one-storey addition. The entrance within the rear addition is located beneath a gable roofed open porch structure (Figure 30 and Figure 31)

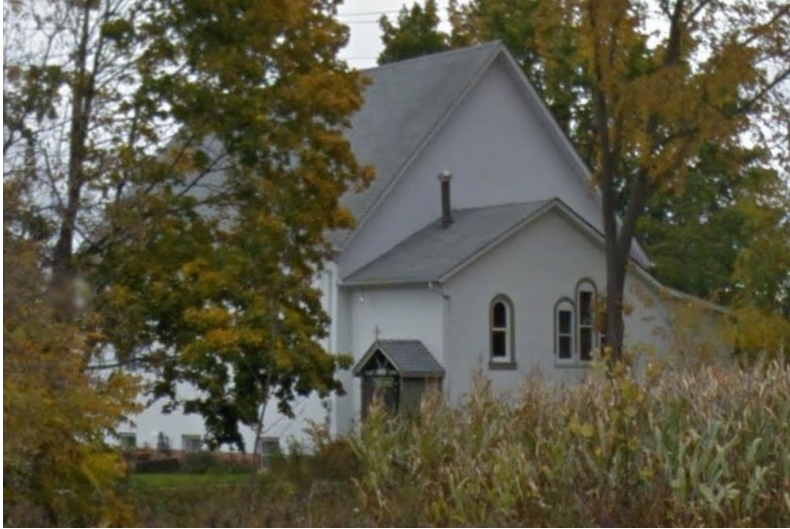
Figure 32: Rear (west) elevation of St. John's Anglican Church (Google Streetview 2021)

The rear elevation of the main church building is a blank wall with no openings, while the one-storey addition features a single round-arched window and a tripartite round window opening. A small metal chimney is located above the roof of the addition (Figure 32).
