Research and Evaluation Report

Knox Presbyterian Church
116 Main Street South, Georgetown, Town of Halton Hills

July 2023

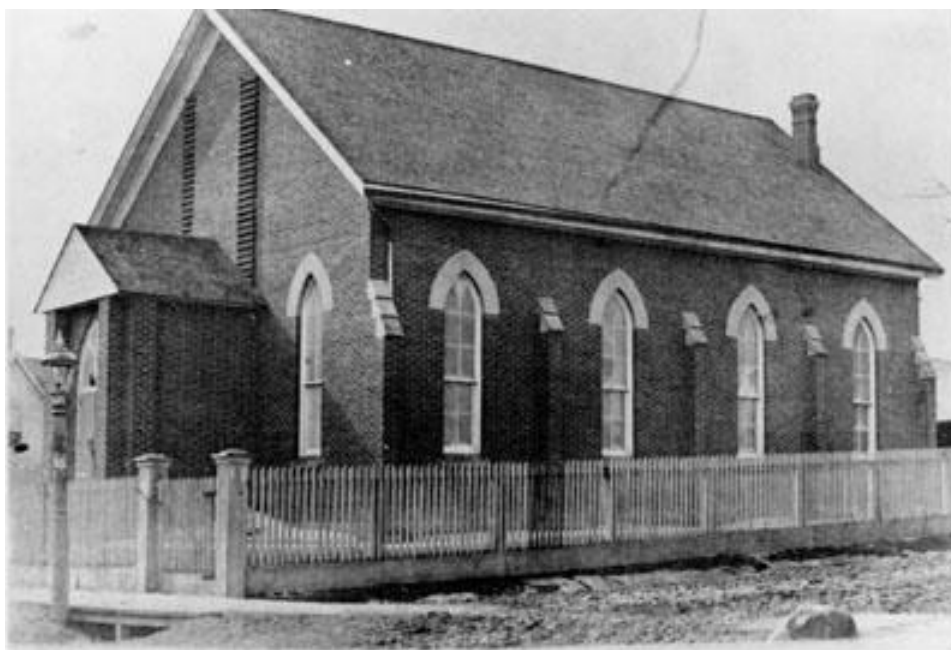
Figure 6: Original brick Knox Presbyterian Church, c.1886. It was erected in 1867 and dismantled in 1887 and rebuilt as a house at the entrance to Fairgrounds Park (EHS00447)

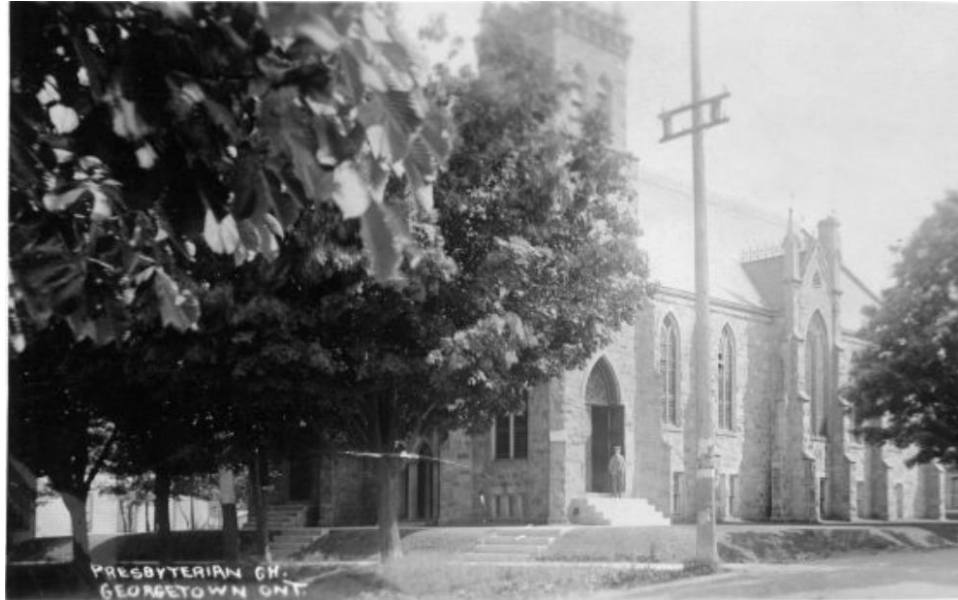
Figure 7: Knox Presbyterian Church at Main and Church Streets, c.1887 (EHS26017)

As the church congregation grew over time, construction began on a new stone church in this location to seat approximately 500 people at an estimated cost of \$15,000. It was completed in 1887 while Reverend W.G. Wallace was minister. Brick from the original church was used to construct a house at the corner of Park Avenue and Charles Street known as Pine Grove Cottage (Figure 8), owned then by the local McDermid family who owned a local grocery business.

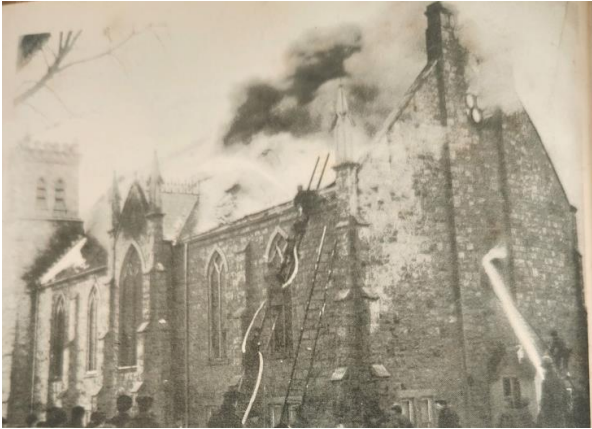
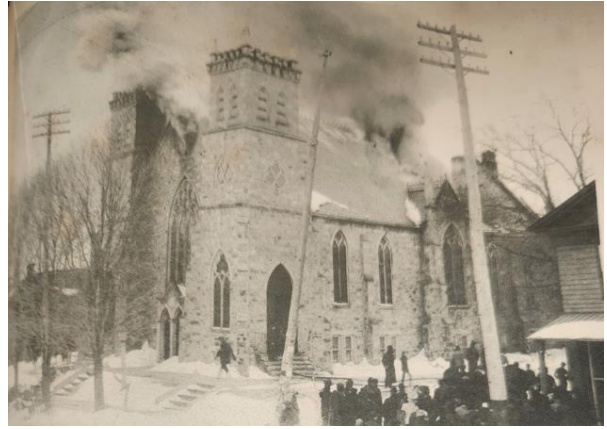
On February 16, 1901, the church was partially destroyed by a fire believed to have started in the church furnace (Figure 9 and Figure 10). The fire resulted in an estimated \$8,000 in damage to the building, with insurance covering \$5,525 of the cost. The December 10, 1901, edition of *The Conservator* notes the fire almost completely destroyed the church roof and interior, leaving only the stone walls. The one exception was the stained glass window on the north side, dedicated to Hugh McKay.

Figure 9: Fire at Knox Presbyterian Church, February 16, 1901 (*Halton Sketches*)

Figure 10: Fire at Knox Presbyterian Church, February 16, 1901 (*Halton Sketches*)

By December 1901, the congregation was able to return to their building, with the interior having been restored exactly as it was before the fire, with the re-building cost tendered at \$2,625. The article reflects on the interior of the church at that time, with dark brown terra cotta-coloured walls, a stencil fresco border, blue transept windows with gold stars done by Elliot & Son of Toronto, rich Brussels carpet, black ash seats by The Valley City Seating Co. of Dundas, brass electroliers from Keith & Fitzsimmons, and a beautiful pipe organ.

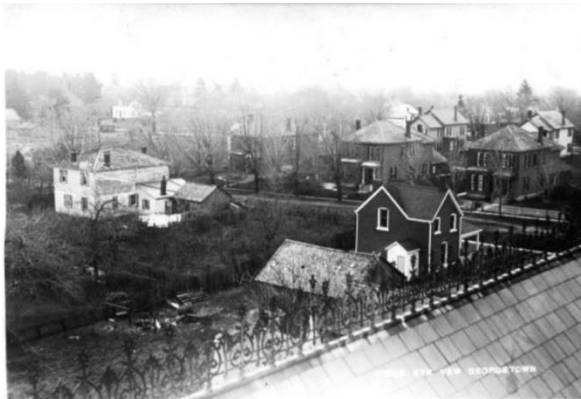
Figure 15: View of the Park District from Knox Presbyterian Church Bell Tower. The ridge of the roof with decorative iron work runs along the bottom of the photo, c.1908 (EHS26092)

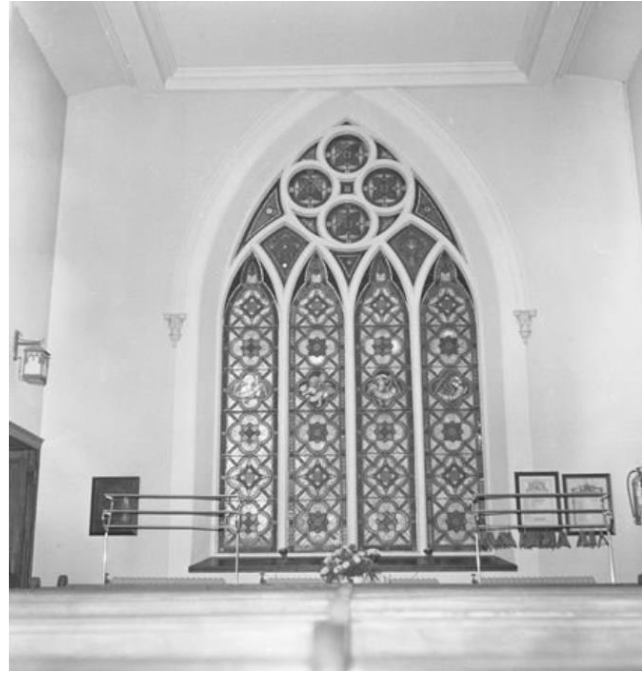
Figure 20: Back window at Knox Presbyterian Church, c.1975 (EHS01479)

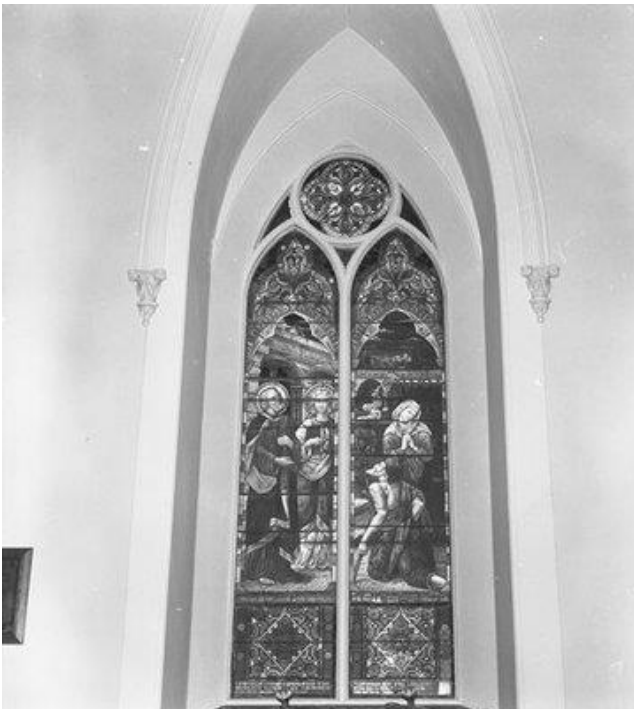
Figure 21: Stained Glass Window at Knox Presbyterian Church, c.1975 (EHS01457)

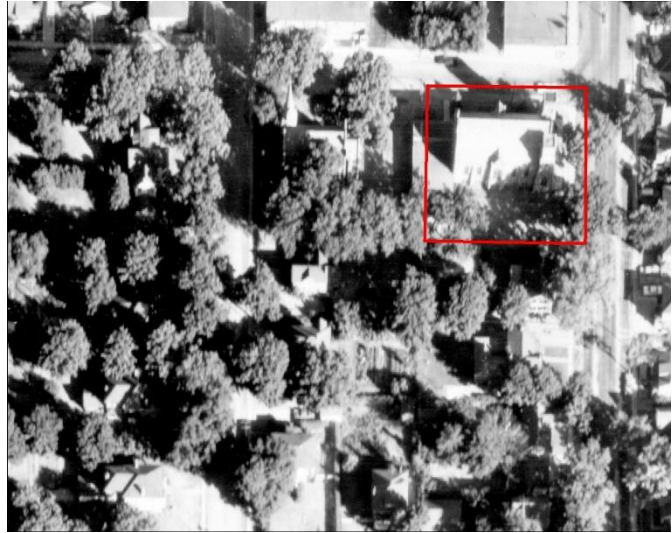
Figure 24: 1966 Aerial Photograph, subject property outlined in red

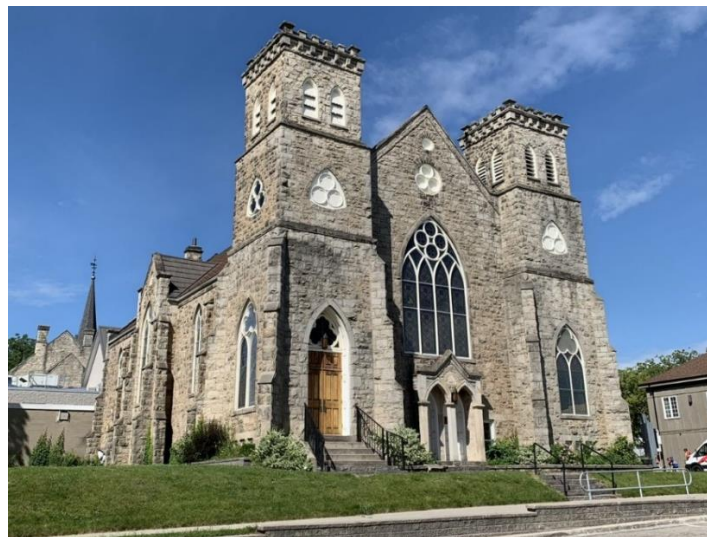
The property at 116 Main Street South is located at the intersection of Church Street and Main Street South in the community of Georgetown, Ontario. The property includes a one-storey stone church building with a raised basement in the Gothic Revival style. The church is set back from Main Street South and accessed by a paved walkway extended from the sidewalk and features a large, grassed area south of the church building along Main Street South (Figure 25).

Figure 25: Looking northwest towards Knox Presbyterian Church from Main Street South (Town of Halton Hills 2023)

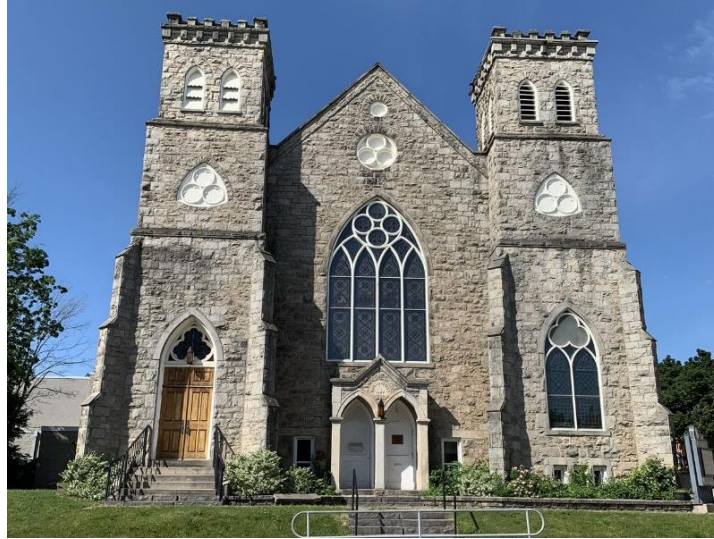
The front (northeast) elevation of the church facing Main Street South (Figure 26) is dominated by square, crenellated, flat-roofed towers at each corner of the elevation, with stone buttresses at each

Figure 26: Front (northeast) elevation of Knox Presbyterian Church at 116 Main Street South (Town of Halton Hills 2023)

The tower to the north features a large lancet window opening with wooden tracery, including trefoil tracery within the arch, with stone sill and surround. Beneath this window are three small vertical flat-headed window openings at the basement level with smooth stone surround. A stone course separates the entrance and large lancet window at grade from the upper portions of both towers. Triangular openings with stone surrounds, featuring carved wooden trefoils, each containing a quatrefoil pattern, are located above. An additional stone course is located above each of these details, and each corner of the tower at this level features stone quoining. Beneath the castellated tower parapets are louvred lancet window openings with stone sills, surrounds and voussoirs. These elements are featured on all sides of each tower.

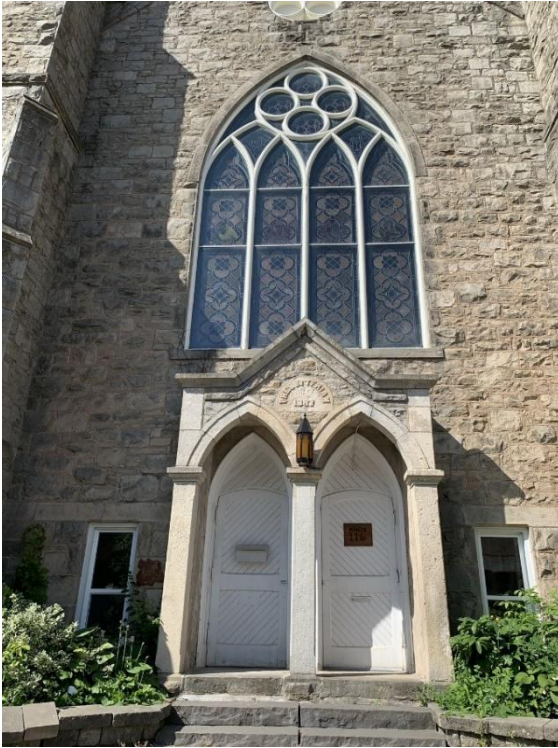
Figure 27: Detail of central entrance on the primary (northeast) elevation (Town of Halton Hills 2023)

Centered within the front elevation, a pair of wooden entrance doors within wooden surrounds are located within lancet-shaped, symmetrically placed openings. The stone entrance surround projects from the front elevation and features an engraved stone above the entrance reading “Presbyterian 1887” (Figure 27). Above the central entrance, a large lancet window opening dominates the front elevation, featuring stained glass and elaborate wooden tracery with a trefoil beneath the arch. A round window with wooden trefoil (currently covered with a storm window) is located above, with a small round detail beneath the gable peak at the roofline.

- The central entrance within projecting stone surround, including the paired wooden doors, stone detailing, and engraved stone reading "Presbyterian 1887" above;

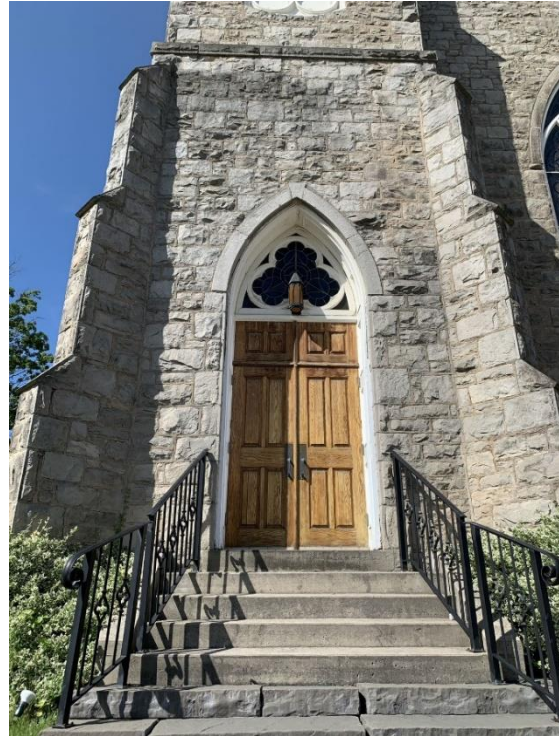
corner of the tower. The tower to the south end (Figure 28) features a lancet-arched entrance above a flight of stone steps, featuring double wooden doors with wood surround, with trefoil window with wooden tracery within the transom above. A stone lintel with keystone is located above the entrance.

Figure 28: Detail of entrance within the south tower along Main Street South (Town of Halton Hills 2023)

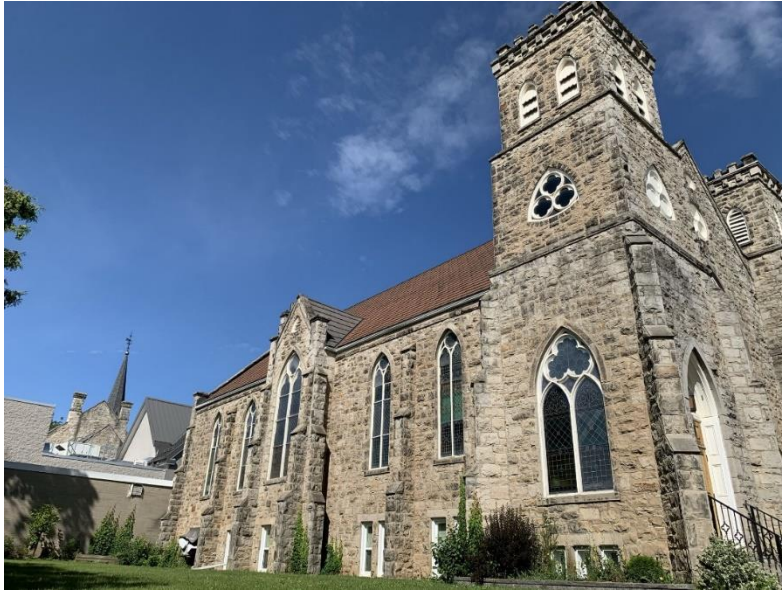
The southeast elevation of the tower features a large lancet window opening with wooden tracery, trefoil, and stained glass, above three small vertical windows with stone lintel at grade. Beyond the tower, the southeast elevation features a central bay with gable roof intersecting with the main gable roof of the church. A large lancet stained-glass window and opening are featured beneath the gable peak, featuring wooden tracery and stone stills and surrounds. A small louvered opening is located beneath the gable peak. Two paired lancet window openings with wooden tracery and stained glass are located on either side of the central bay, which features stone buttresses. The paired window openings are each separated by a stone buttress extended to the eaves. A stone course extends along the roofline. Flat-headed window openings are extant along the basement level between these buttresses. A stone chimney is visible at the roofline at the rear of the church (Figure 29).

Figure 29: South elevation of Knox Presbyterian Church (Town of Halton Hills 2023)

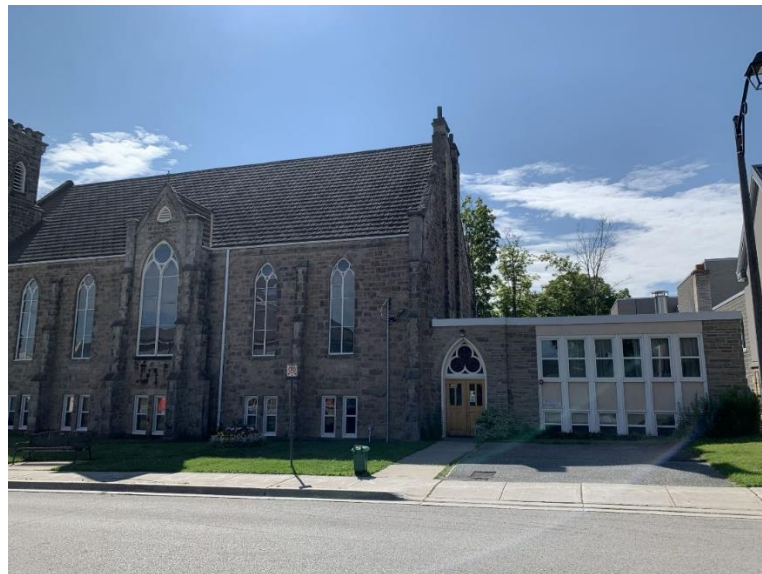
The side (northwest) elevation of the tower features an entrance above concrete steps similar to the entrance extant within the southeast tower, with wooden double doors and stained glass within the tracery above the doors. Beyond the tower, the northwest elevation reflects that of the southeast elevation in its detailing. At the rear, the one-storey flat-roofed addition, built c.1956, features a similar lancet-arched entrance with trefoil window above and double wooden doors, with stone exterior. Beyond the entrance, the elevation features a row of flat-headed window openings at the basement and first storeys, with a brick chimney above at the very rear. A paved parking pad is located in front of the rear addition (Figure 30).

Figure 30: Partial northwest elevation of Knox Presbyterian Church, showing rear hall addition (Town of Halton Hills 2023)

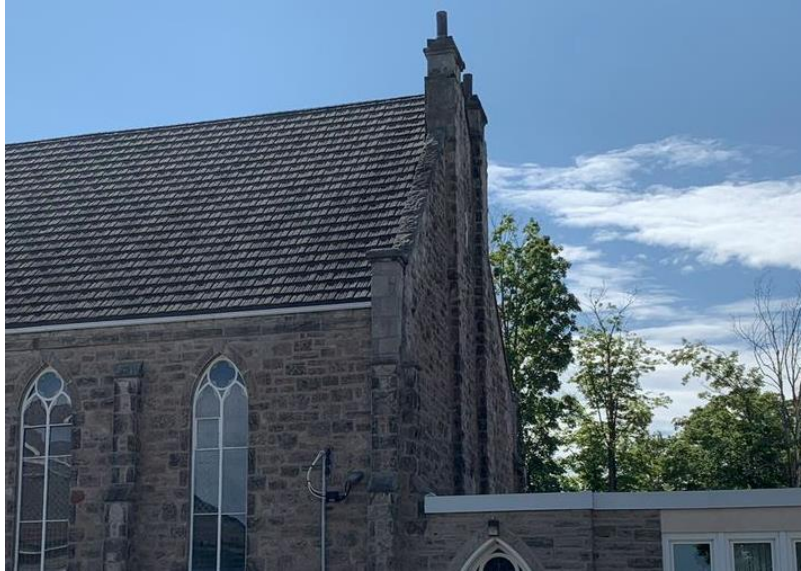
The rear elevation of the original church building (Figure 31) is partially obscured by the one-storey addition. Above the addition, the dual chimneys extend above the church roof and between them are additional circular window openings with trefoil tracery in the large window, and a lancet window opening below.

Figure 31: Partial rear elevation of Knox Presbyterian Church (Town of Halton Hills 2023)
