# Fairy Lake Water Quality Update Report, 2021-2022

**LGL Limited**  
**environmental research associates**

**May 2023**

**LGL File TA9122**

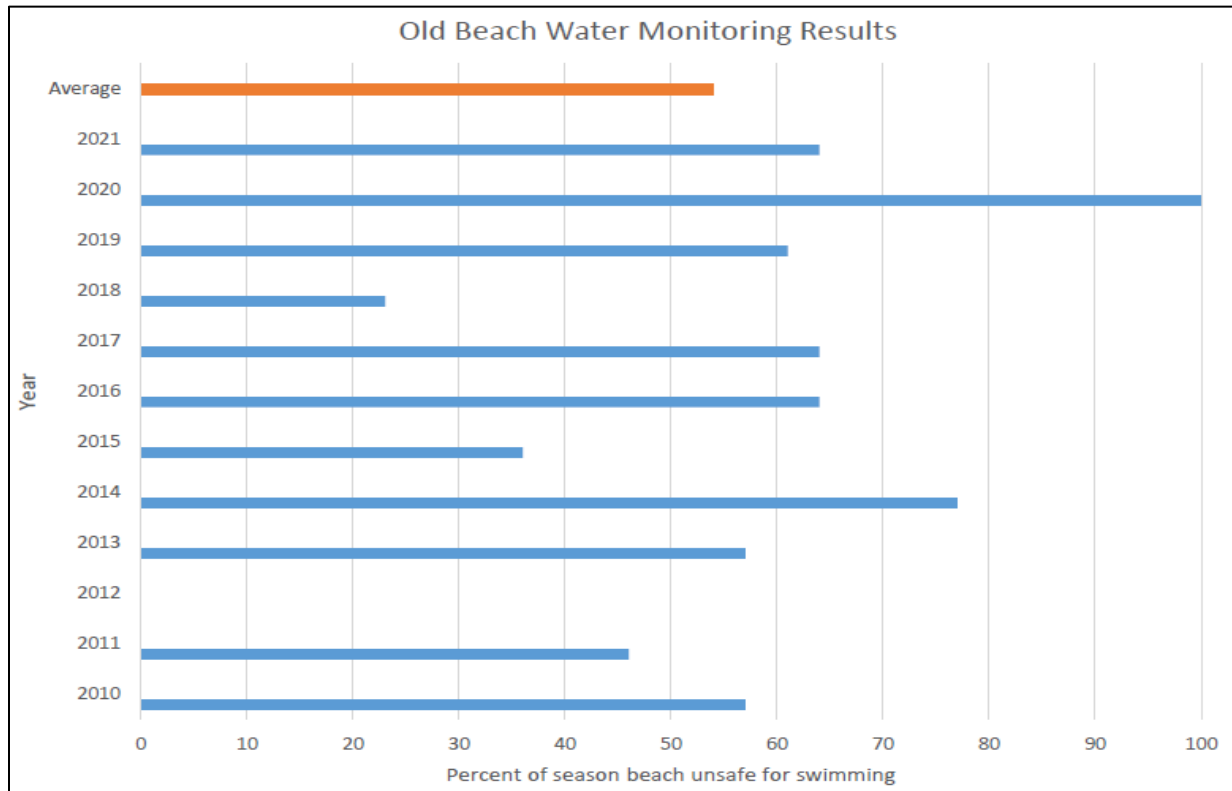
**Figure 6. Percentage of Season Old Beach is Closed (Source: Halton Region)**

in 2021 were primarily throughout June and July. The frequency of beach closures since 2019 have exceeded the 12-year average.

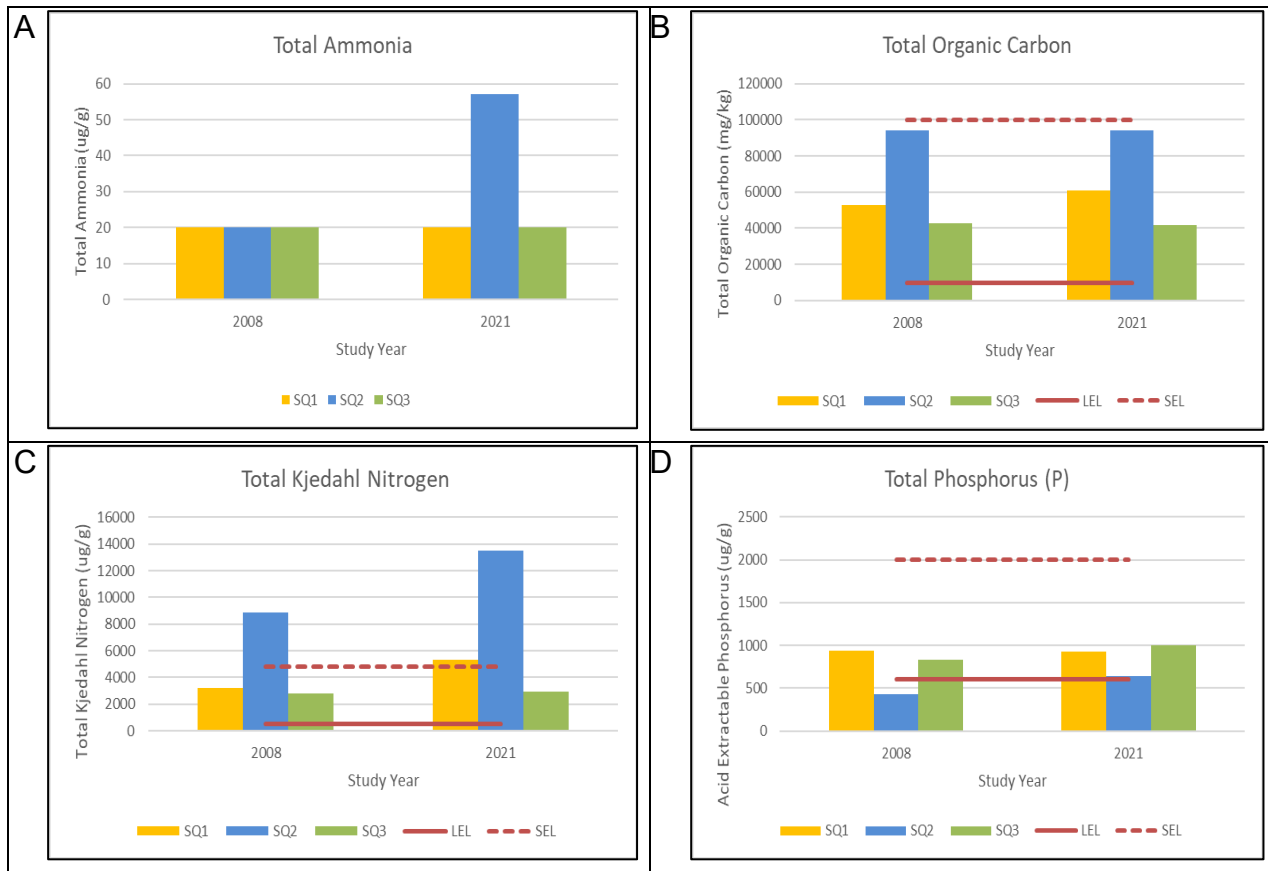
**Figure 8. Total ammonia-N (A), total organic carbon (B), total Kjeldahl nitrogen (C), and total phosphorus (D) in Fairy Lake sediments, 2008 (AECOM, 2009) and 2021.**

AECOM (2009) baseline study, TKN was found in similar concentrations at SQ3, somewhat elevated at SQ1, and was found at concentrations 1.5 times greater at SQ2 (Figure 7C). Given the limitations of comparing a single sediment TKN result from 2008 to a single result from 2021 (i.e., inherent variation in sediment quality data, lack of information available to confirm consistency in sampling location, lab methodology and detection limits from the previous study), the difference between years at SQ2 is identified along with a recommendation for further study as part of a longer term water quality monitoring program for Fairy Lake to confirm potential trends in sediment TKN at this location.

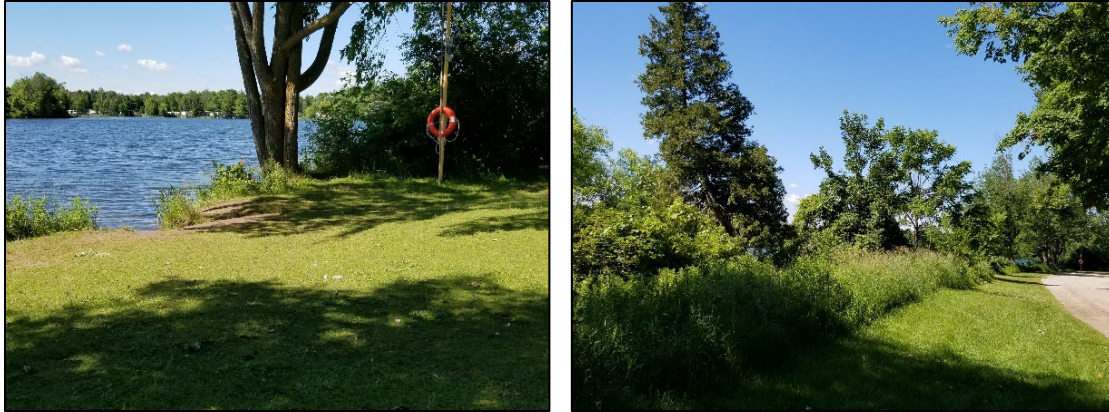
**Photo 1: Polygon 1c on the northwest shoreline of Fairy Lake – example of an area that could benefit from a planted buffer or no mow approach (left), and where effective planted buffers have been created and maintained (right).**

Landscape design around the shoreline to reduce sightlines to the point where geese are uncomfortable (<9 m) and impede access to foraging areas (Doncaster and Keller, 2009) is another option for geese management. Some examples of landscape design from Doncaster and Keller (2009) include an aquatic bench of emergent vegetation along shorelines and low shrubs and native grassland/wildflower meadows, to create a physical and visual barrier for geese. The area in Polygon 1c (see photo below) is an example of where manicured grass could be replaced by low shrubs and/or a native grassland meadow. The prevalence of ticks and mosquitos in taller grasses and natural areas can be of concern for municipalities considering the potential health risks they represent (e.g., Lyme Disease, West Nile Virus). Education is the best path forward to ensure users of the park are informed of the necessary precautions to protect themselves. Some municipalities (e.g., Kingston, ON) apply a natural, garlic based deterrent at dog parks or high use areas to deter ticks and mosquitos; these products are also purported to deter geese ([Kingston tests secret weapon against ticks: garlic | CBC News](#)).

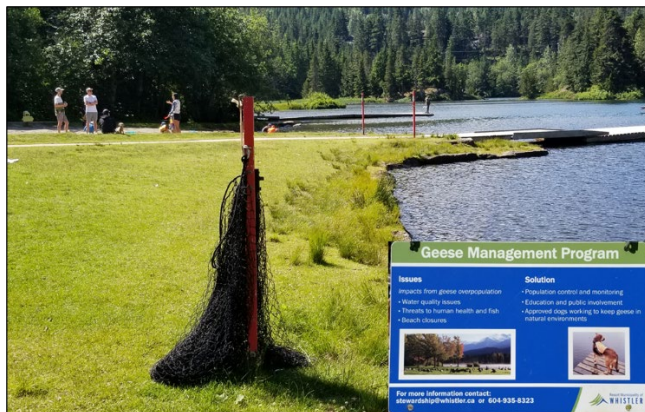
**Photo 2: Example of retractable fencing and signage in use at beaches in Whistler B.C. in Summer 2022 to deter geese from accessing the shoreline.**

Retractable fencing in areas where easy access to the lake is available may be another useful technique for deterring geese at Fairy Lake. For example, retractable fencing could be installed at the public beach to prevent geese from loafing/roosting and contributing to the feces observed at that location in spring/summer 2021. The fencing would require some maintenance (e.g., potentially opening/closing on a daily basis, seasonal storage) but could be aligned with a daily beach grooming plan to support the current recreational use and avoid beach closures.

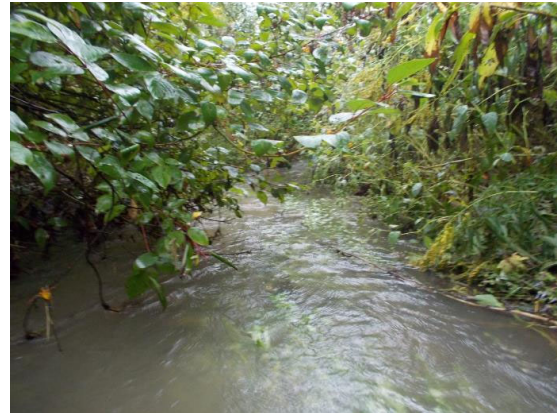
Photo 52: Station WQ4 Tyler Ave. storm outfall facing downstream, Sept. 22, 2021.

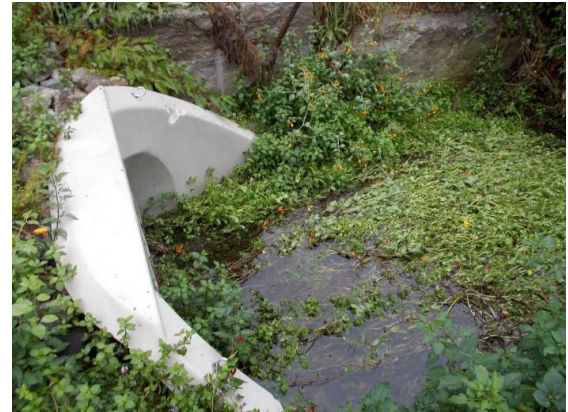
Photo 64: Station WQ8 Elmore Dr. storm outfall in wet weather, Sept. 22, 2021.
