# **Research and Evaluation Report**

# **Sunderland Villa**

55 Mill Street East, Acton, Town of Halton Hills

September 2023

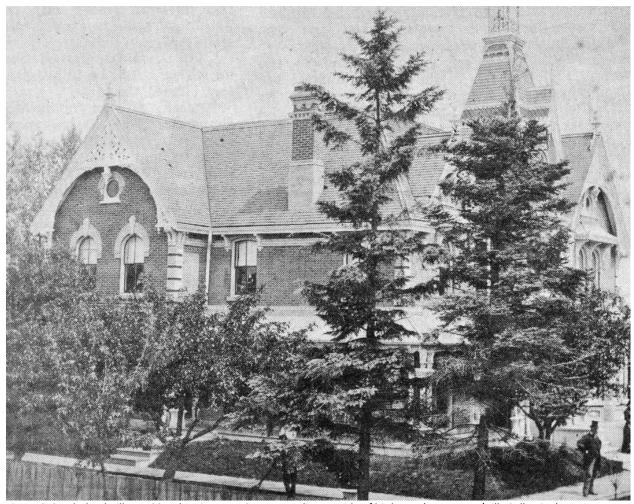
Figure 6: Sunderland Villa, c.1897, showing W.H. Storey standing outside of his home (A.T. Brown/Dills Collection)

In 1879, Sunderland Villa was constructed for Storey on Mill Street, who named the building for his home country in England. The *Acton Free Press* reported that the Storey family had moved into their residence by September 1880. The carriage house for the home was located at 7 John Street. Sunderland Villa was heated by steam piped underground from the factory to the home and was the first residence to be heated by steam in Acton.

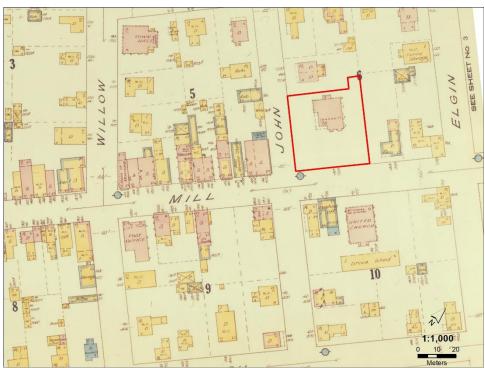
The 1934 Fire Insurance Plan (Figure 15) identifies the building as vacant and shows the building prior to its current additions.

Figure 15: Subject property identified on the 1934 Fire Insurance Plan for Acton

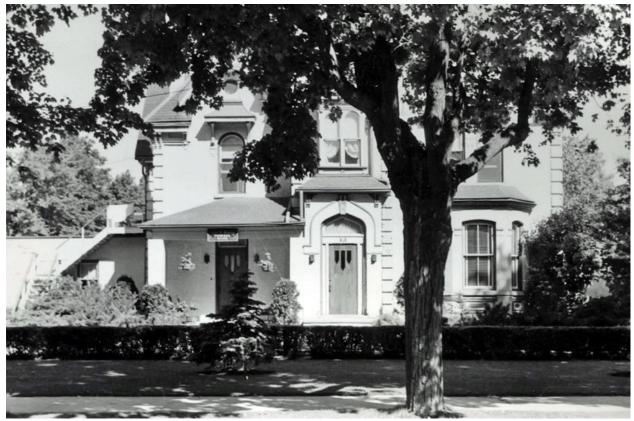
Figure 20: Sunderland Villa, c.1951, showing the front elevation prior to the construction of the one-storey addition (Dills Collection)

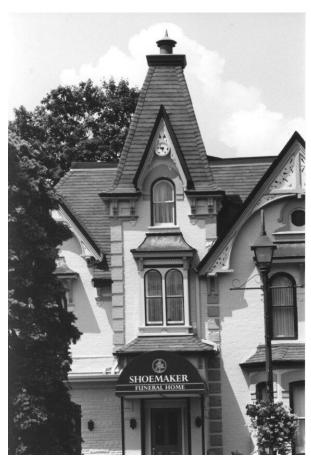
Figure 29: Detail of the centre tower, c.1996 (EHS 23535)

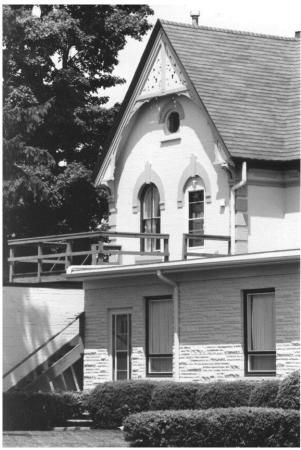
Figure 30: Detail of the west wing, c.1996 (EHS 23536)

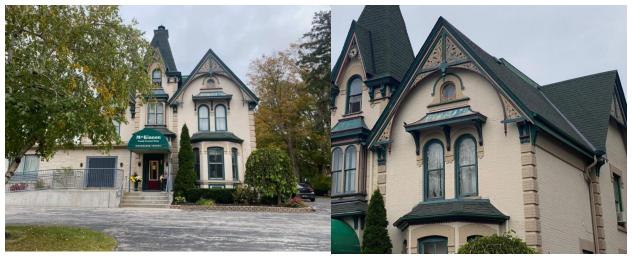
Figure 35: Partial southeast elevation of Sunderland Villa (Town of Halton Hills 2023)

Figure 36: Detail of the southeast elevation of Sunderland Villa (Town of Halton Hills 2023)

The front elevation (Figure 35 and Figure 36) features a painted brick exterior and is divided into three irregular bays. The bay furthest to the southeast is two-and-a-half storeys. At the first storey, a one-storey projecting bay with mansard-style roof is extant, containing three segmentally arched window openings with painted hood moulds above a stone course wrapping the projecting bay. The existing windows appear to be original wood, two-over-two hung windows. Above the first storey, a pair of round-arched window openings are located beneath a shallow, bracketed projecting roof, with a singular stone sill below and rounded stone hood moulds above the openings. Above the shallow projecting roof is a circular window with decorative surround. The gable peak features intricate bargeboard/vergeboard beneath the eaves. The corners of the projecting bay feature brick quoining which has been painted a contrasting colour to the main façade.

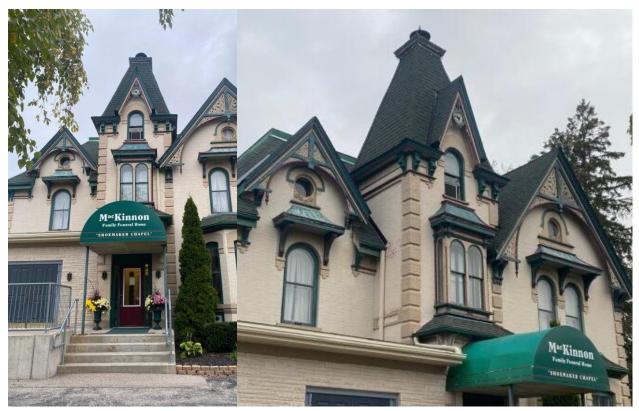
Figure 37: Partial southeast elevation showing the entrance and central tower (Town of Halton Hills 2023)

Figure 38: Detail of the central tower on the southeast elevation (Town of Halton Hills 2023)

The front elevation steps back to its central bay with a two-and-a-half storey tower which contains the front entrance with wooden door surround, transom, and sidelights beneath a contemporary canopy (Figure 37 and Figure 38). At the second storey are paired, round-arched windows with one-over-one wood windows and a decorative projecting roof above. At the upper storey, a singular round-arched window opening with stone sill and decorative hood mould is located beneath the gable peak which features decorative additional carved detailing and bargeboard. The tower with pyramidal roof features returning, bracketed eaves, decorative brickwork and quoining on either side, and a finial at the tower peak.

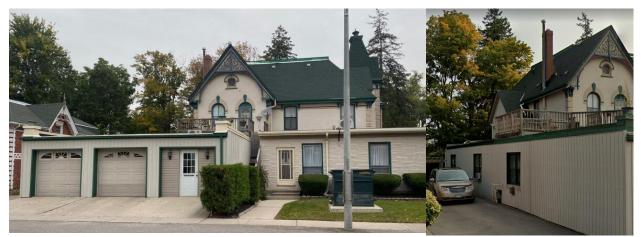
Figure 41: Southwest elevation of Sunderland Villa (Town of Halton Hills 2023)

The original southwest elevation along John Street North (Figure 41) is also obscured by the flat-roofed addition which is met further to the rear by a flat-roofed, three-bay garage. At the second storey, the asymmetrical elevation features two single window openings beneath the bracketed eaves with two-over-two windows above the one-storey addition. To the rear of the elevation, a pair of single window openings is centered beneath the decorative gable peak which features similar details to that of the front elevation. A wooden deck extends from these window openings, one of which has been modified into a door opening. A tall brick chimney with contemporary stack is visible beyond the side elevation. The rear (northwest) elevation of the building (Figure 42) is mostly obscured by the one storey garage addition and features the unpainted brick chimney and gable-roofed feature towards the northwest corner of the building.

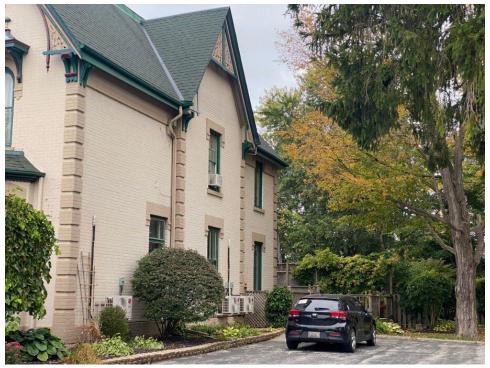
Figure 43: Side (northeast) elevation of Sunderland Villa (Town of Halton Hills 2023)

The side (northeast) elevation (Figure 43) is less decorative than the southeast and southwest elevations facing Mill Street East and John Street North, respectively. At the first storey, the elevation is divided into

three bays, with brick quoining defining each bay and single, flat-headed window opening extant throughout. A dormer is extant within the roofline along this elevation as well. Additional parking spaces extend along this elevation.
