Research and Evaluation Report

Perryman-Mainprize Building
46 Mill Street East, Acton, Town of Halton Hills

December 2023

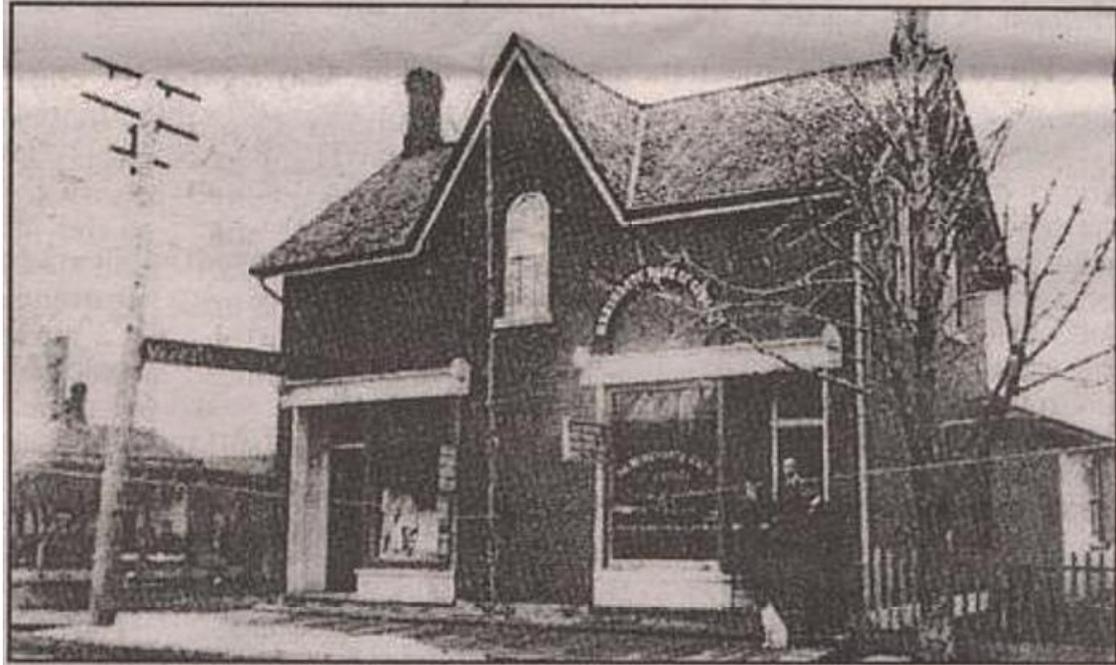
Figure 8: Acton Merchants' Bank (Acton's first bank) at the corner of Mill and John Streets -- April 6th, 1900 (EHS)

Early photographic evidence of the existing building reveals a symmetrical front elevation with dual storefronts that reflects the symmetry of more typical examples of this style (namely a central entrance with symmetrically placed window openings on either side). The existing composition, although modified from its original configuration, reflects the original division of the front elevation into two bays at grade. The materials, as well as the scale, form, and massing of the building reflects the characteristics typical of the style (demonstrated in *The Canadian Farmer* in 1865). The extant side gable roof, centre gable with window beneath the gable peak, round-arched and segmentally arched window openings are also typical of this style.

The modified first storey of the front elevation has not been identified as an attribute, however photographic evidence of the building c.1900 provides an opportunity to restore the original configuration in future. The interiors, rear elevation of the original one-and-a-half storey building, and rear additions are not identified as heritage attributes as part of this report.

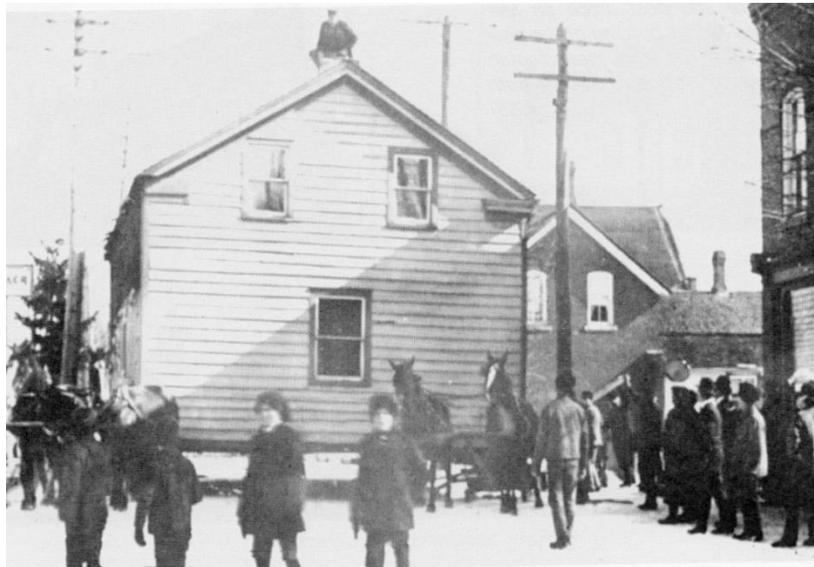
Figure 9: Moving Ransom Adams's House along Mill Street; the subject building is shown to the right of the house being moved, c.1905 (Courtesy of Vintage Acton)

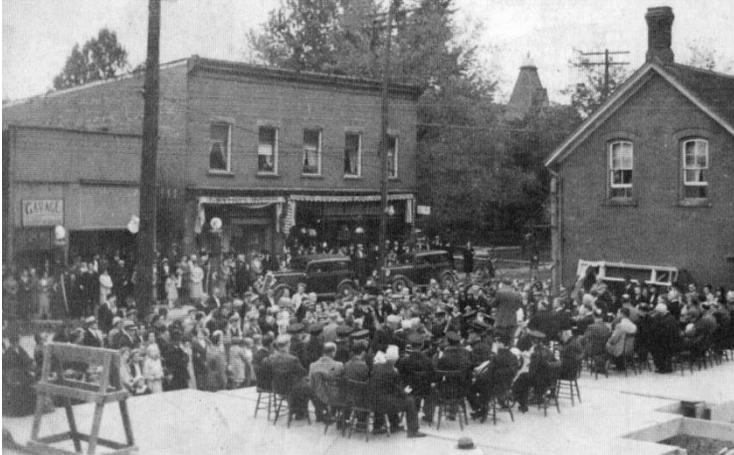
Figure 10: Laying the cornerstone for the YMCA on Mill Street East in Acton; the subject property is visible on the right of the photograph, c.1934 (Historic Acton/Scott Brooks, courtesy of Vintage Acton)

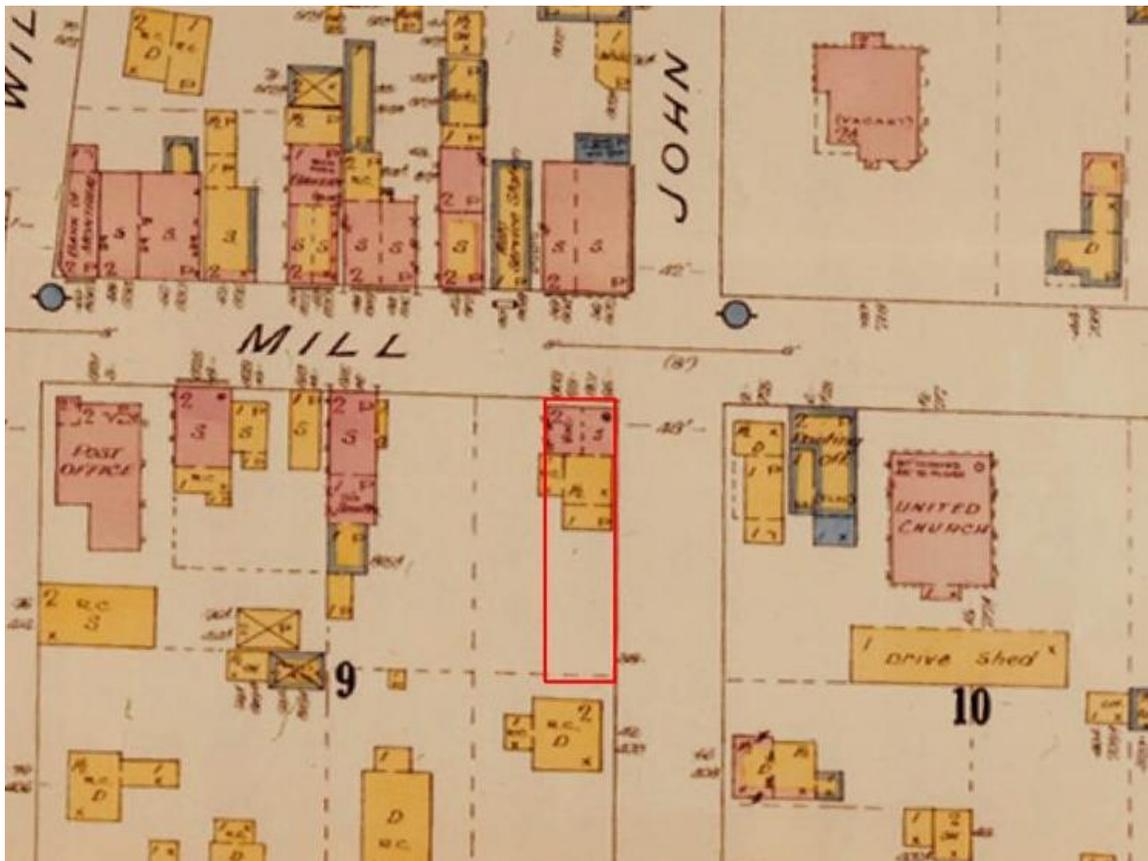
Figure 12: Subject property identified on the 1934 Fire Insurance Plan, showing the two units within the brick building and rear 1 ½ and 1-storey additions. The YMCA, for which construction began in 1934, is not yet identified.

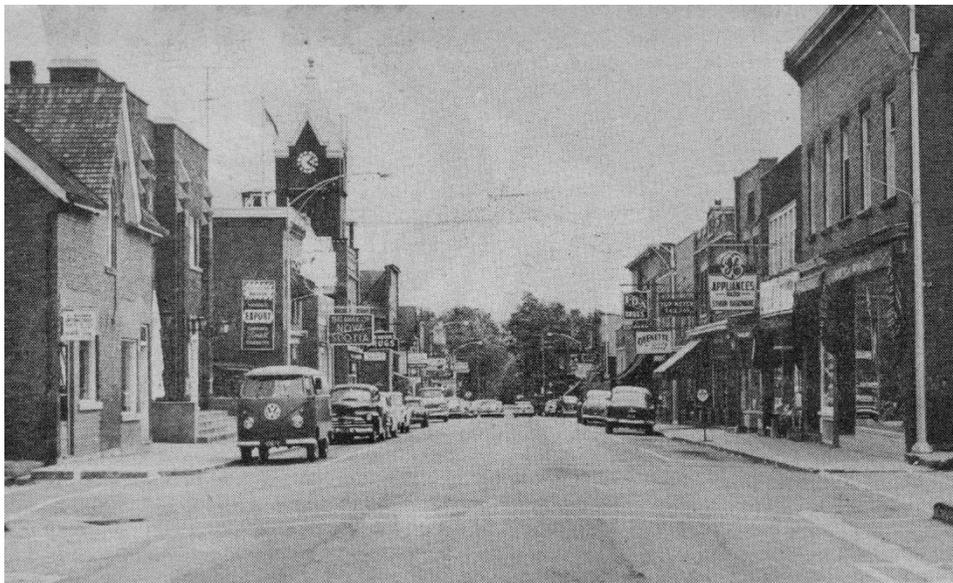
Figure 14: Mill Street East in Acton c.1960s, subject property on the far left; the dual storefronts are extant in this photograph however appear modified based on earlier photographs (Dills Collection Courtesy of Vintage Acton)

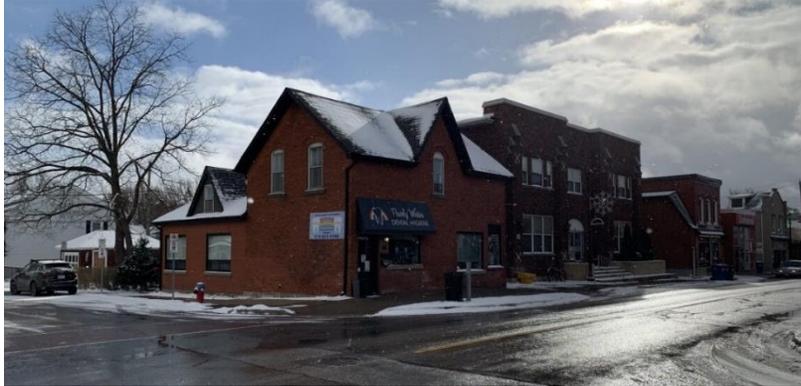
Figure 17: Looking towards the subject property along Mill Street East in Acton (Town of Halton Hills 2023)

The property is located at 46 Mill Street East along the south side of the roadway in Halton Hills and contains a one-and-a-half storey brick residential building with rear addition (Figure 17). The property is legally known as PT LT 13, BLK 13, PL 31, AS IN 352765, S/T 352765; HALTON HILLS.

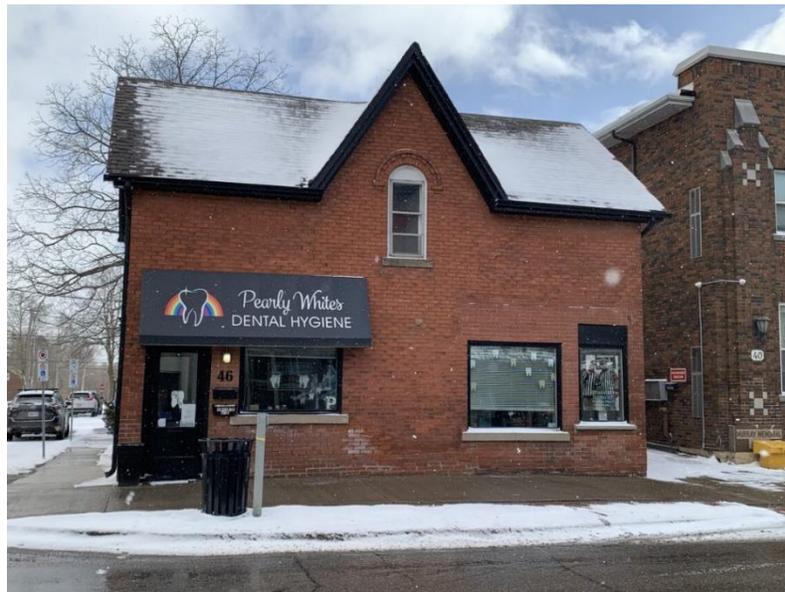
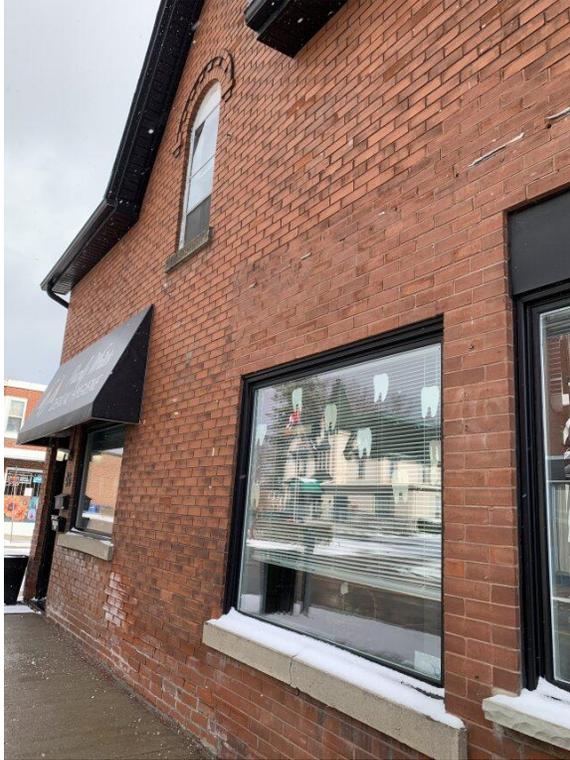
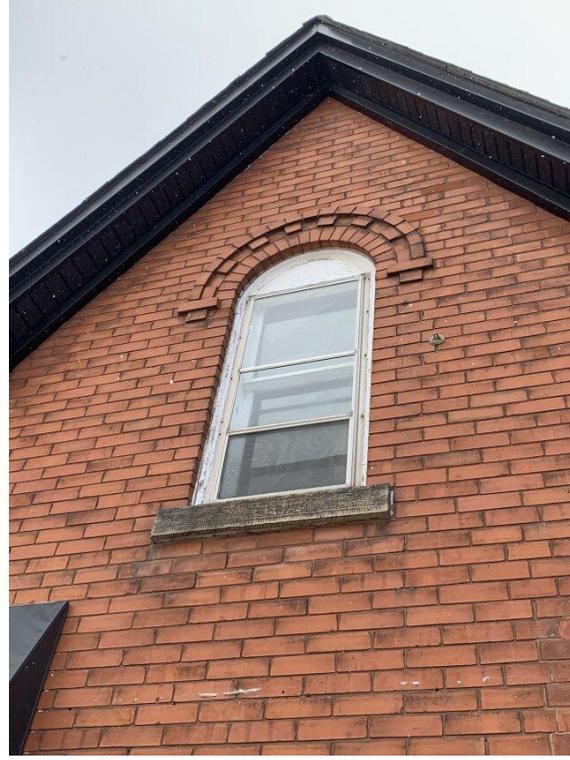
Figure 18: Front (northwest) elevation of 46 Mill Street East (Town of Halton Hills 2023)

The front (northwest) elevation of the existing one-and-a-half storey building (Figure 18 through Figure 20) faces Mill Street East and features a red-brick façade. Evidence of the original openings pictured in 1900 is extant. One flat-headed entrance remains at the east end of the façade beside a wider single window opening with concrete sill. A wider rectangular window opening with a concrete sill and narrower window beside it sit in the same location as the west side entrance pictured in 1900. A round-headed window opening with stone sill and brick arch above is located at the upper storey beneath the centre gable peak. The stone foundation is not visible at the front elevation due to the existing sidewalk.

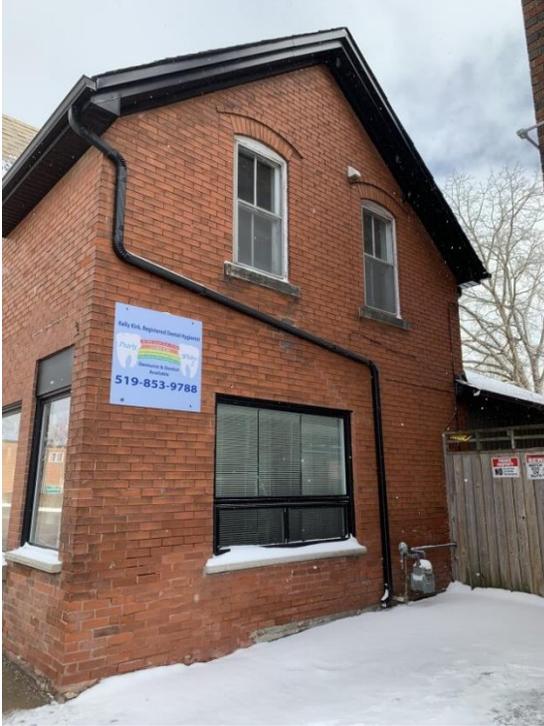
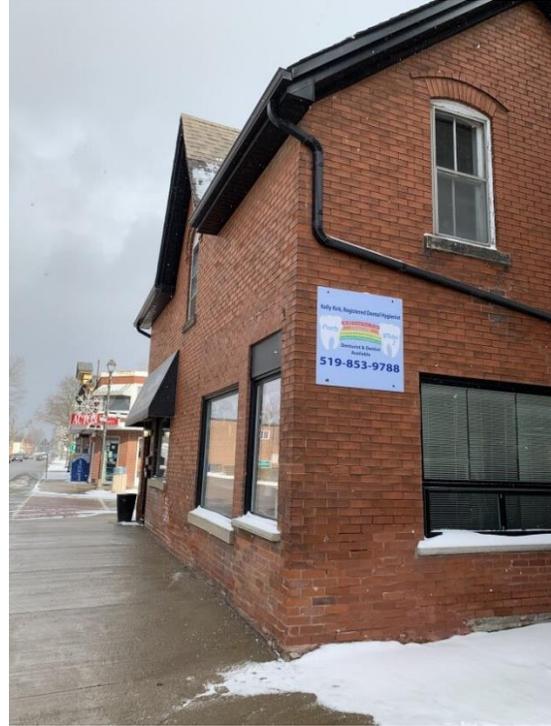
Figure 21: Side (southwest) elevation of 46 Mill Street East (Town of Halton Hills 2023)

The side (southwest) elevation of the existing building (Figure 21 and Figure 22) features a contemporary window opening at the first storey. At the second storey are two symmetrically placed, segmentally arched window openings with stone sills below and brick voussoirs above.

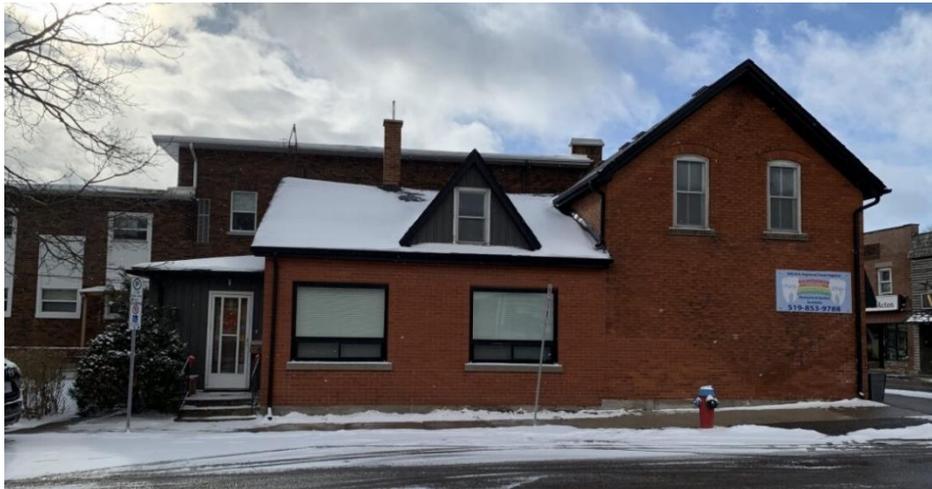
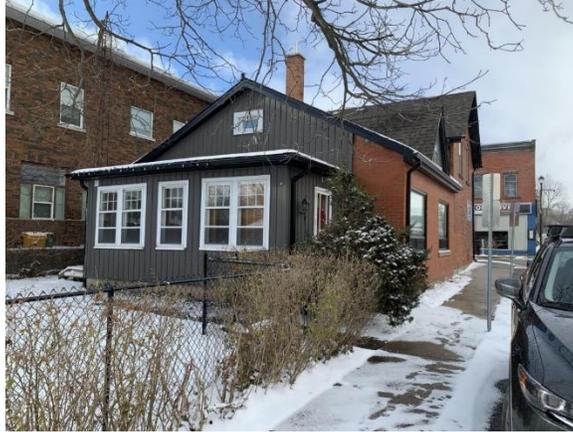
Figure 23: Side (northeast) elevation of 46 Mill Street East (Town of Halton Hills 2023)

The side (northeast) elevation along John Street South (Figure 23 and Figure 24) includes both the original one-and-a-half storey building as well as a rear one-storey brick exterior addition and one-storey sun porch and entrance at the rear. The stone foundation is partially visible along this elevation. The side elevation of the one-and-a-half storey original building has no openings at the first storey and two window openings at the upper storey, as can be observed on the southwest elevation on the other side of the building. Two contemporary rectangular window openings are located within the rear one-storey portion of the addition with a gable dormer and small brick chimney above.
