# Research and Evaluation Report

## Roe Block

49-57 Main Street South, Georgetown, Town of Halton Hills

December 2023

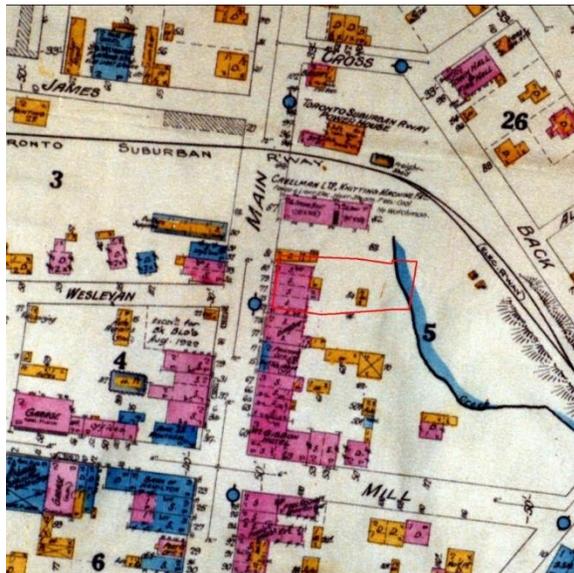
Figure 5: The Roe Block is outlined in red on this 1922 fire insurance survey. The colour red denotes buildings built of brick. Wood is yellow and blue is stone (EHS 00121)

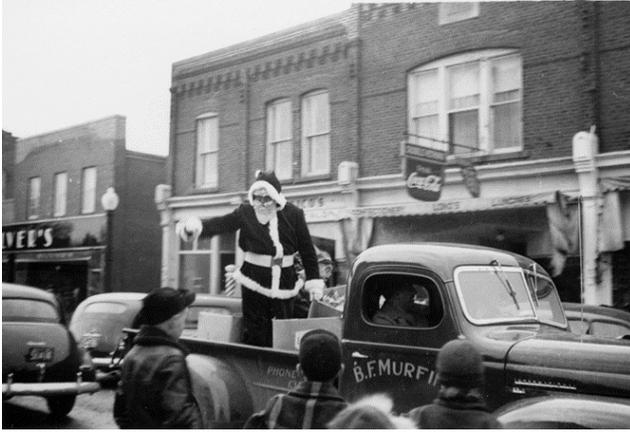
Figure 9: Santa Claus parade in 1949, shows #49 Clark Electrical, #51 Lilloco Beauty Parlour and #53 Long's Restaurant (EHS 00018)

The ground floor facades are each headed with a large wooden fascia with tenant signage. The individual storefronts feature recessed entrance doors, glass display windows, and glass side panels in varying configurations. Unit #1 at 49 Main Street South retains most of the original design; one covered bracket remains under the cornice molding. The façade also retains the wood molding transitioning from the first to second storey. The 1949 photograph (Figure 9) shows the original decorative elements.

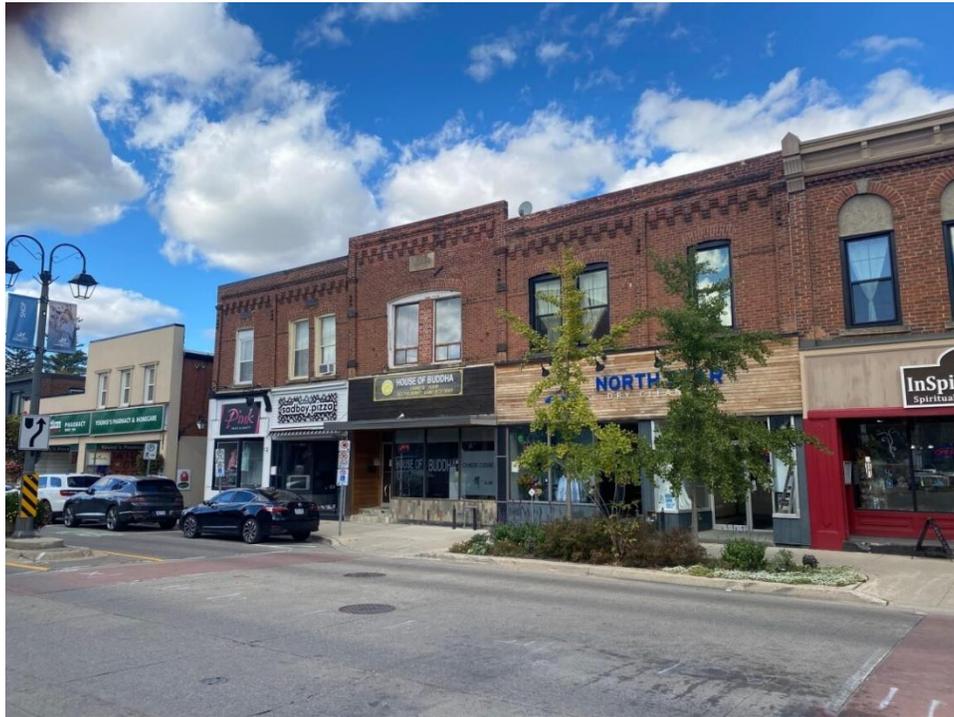
Figure 18: Looking towards the southwest elevation of the subject property (Town of Halton Hills 2023)

The 1888 commercial building comprised of 49-57 Main Street South in Georgetown is located along the east side of Main Street South, north of Mill Street. The existing two-storey red brick building has running bond red clay bricks with a centre block wider than the flanking blocks. Along the front (southwest) elevation, the building has a raised parapet over the centre unit and a date stone engraved with “Roe Block 1888.”

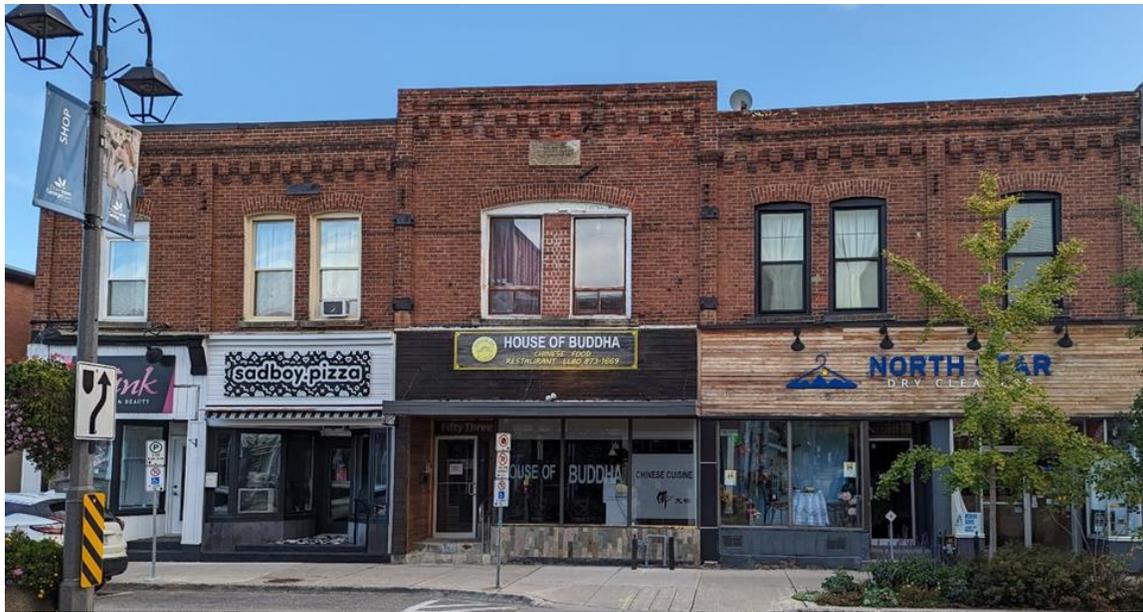
Figure 19: Roe Block at 49-57 Main Street South (John Mark Rowe 2023)

The parapet on all three sections of the building has a stepped, crenellated brick cornice. A brick buttress separates the centre block from each flanking block, and each flanking block has a brick buttress separating the blocks into two distinct sections each, creating a visual demarcation of the five units.

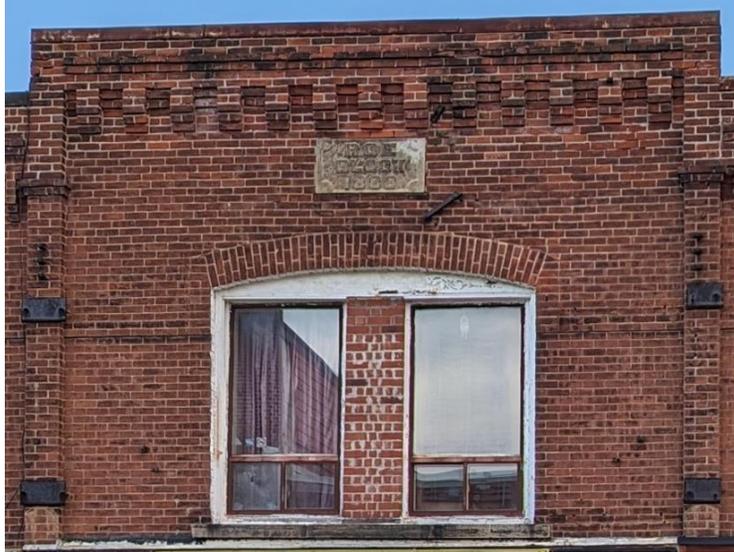
Figure 20: Detail of the upper centre block, being #53 Main Street South in 2023 (John Mark Rowe 2023)

The upper storeys on the flanking units feature brick voussoirs over each window. The centre unit features a large centre window opening on the second storey with a single voussoir over the opening. Historically, there were three windows in the opening that were, at some point after 1949, reduced to two windows separated by red brick infilling. A cut stone sill sits under each window opening. Upon close inspection, traces of scrollwork on the central window heading are still visible. The second storey of the building has a total of seven window openings with a total of eight windows. Prior to exterior alterations, there would have been nine windows; the extant windows are of varying styles and materials.

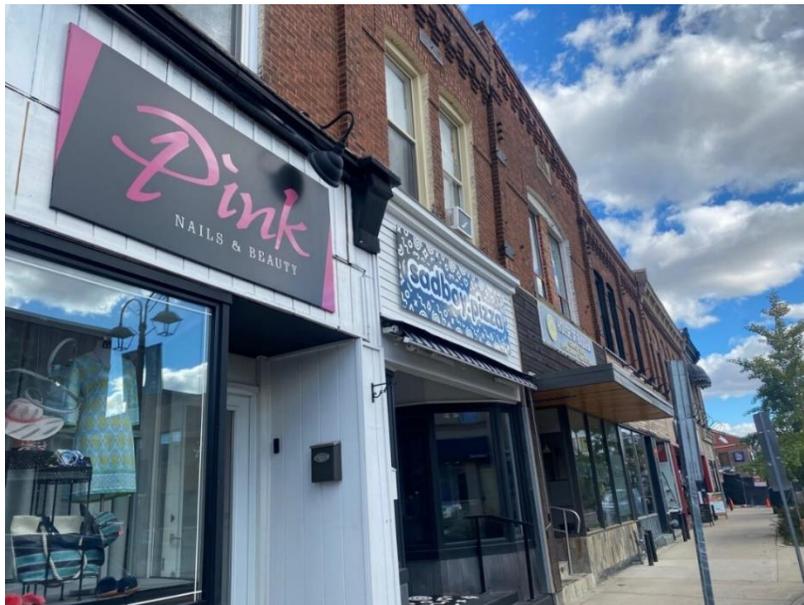
Figure 21: Looking along the front elevation of the subject building (Town of Halton Hills 2023)

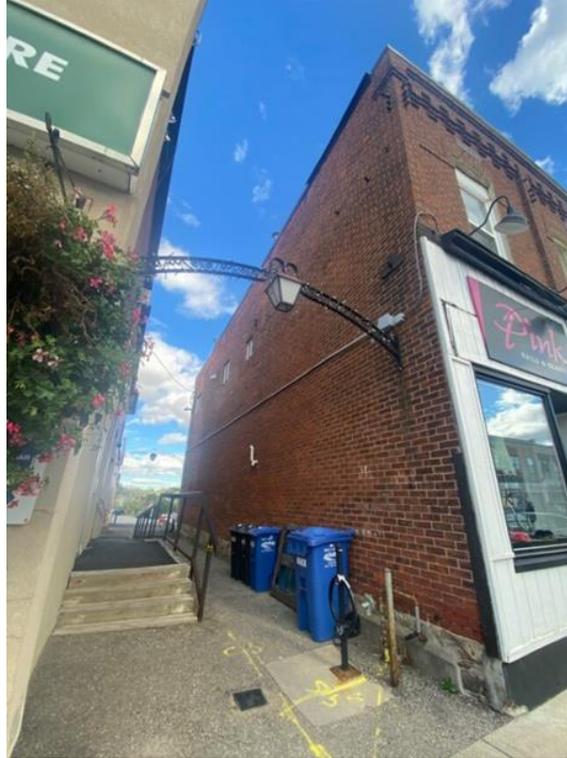
Figure 22: Looking along the north elevation of the existing building (Town of Halton Hills 2023)

The north side of the building abuts an alley. Visible through the alley is a continuation of the running bond red brick pattern and the original stone rubble foundation. Three windows and a vent can be seen and appear to be later additions to the building based on style and material.

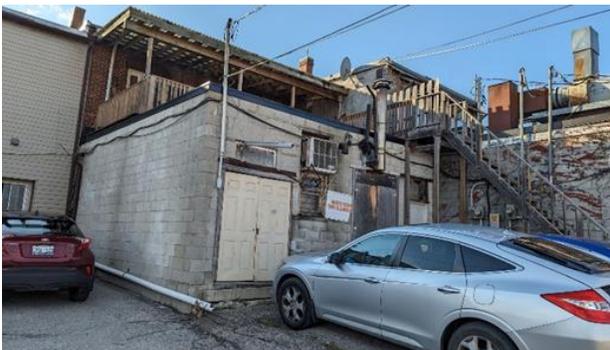
Figure 23: Rear of #55 and 57 Main Street South, showing the 1946 addition in 2023 (John Mark Rowe 2023)

On the back of the original building, Unit #1 has the most of its original structure visible. The unit has voussiors above openings for doors on both the first and second storey, as well as a first storey window that has been closed with plywood. The rear of the other ground floor units are obscured by additions. The rear of Units #2 and #3 are covered by a single storey concrete block addition with vinyl siding on the north face. Units #4 and #5 have a concrete block addition, built in 1946 by Barranger as a dry-cleaning facility.

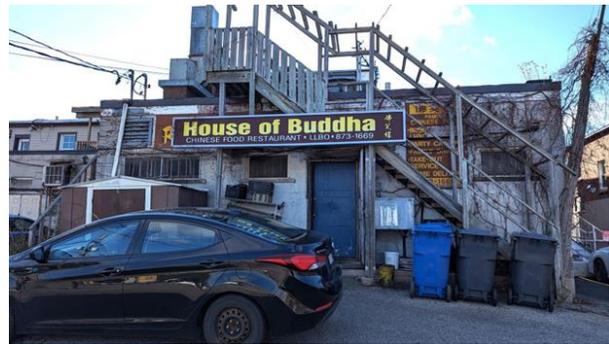
Figure 24: Rear view of House of Buddha addition in 2023 (John Mark Rowe 2023)

From the ground level the original rear brickwork is mostly intact, with some former rear windows being changed into doorways. A wooden balcony spans the building, with a metal fire escape stairway on the north side and a wooden staircase at the centre of the *House of Buddha* addition.

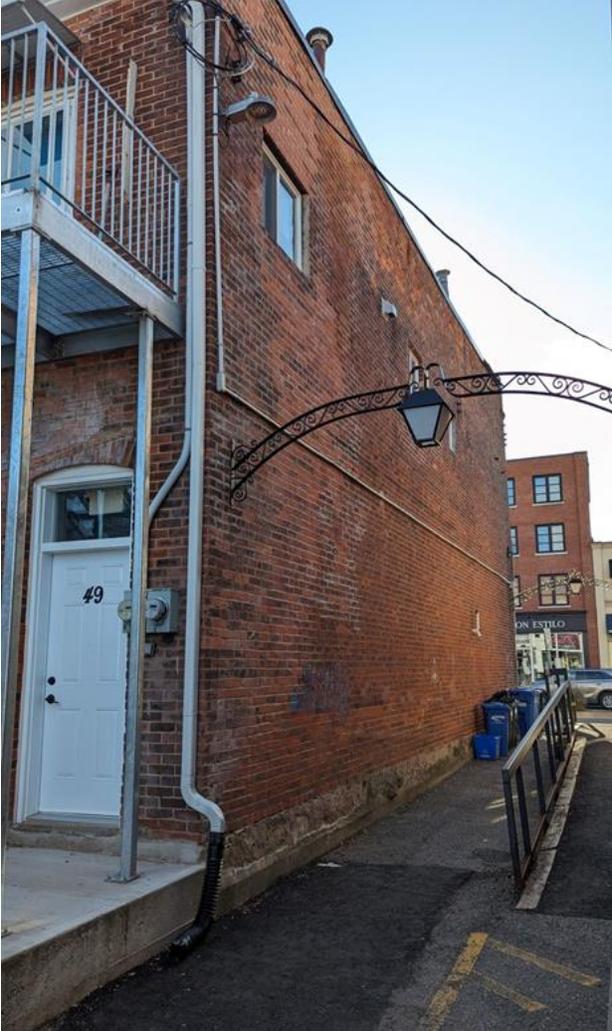
Figure 25: North alley wall in 2023. J.M. Rowe photo

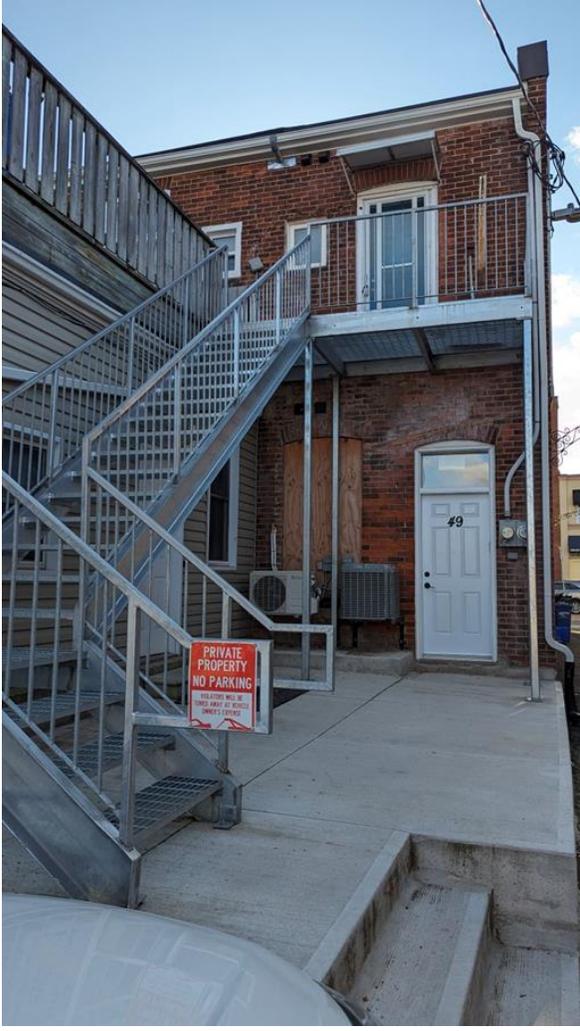
Figure 26: Rear of #49 Main Street South in 2023. J.M. Rowe photo
