Research and Evaluation Report

Currie Farmhouse
9156 Trafalgar Road, Town of Halton Hills

January 2024

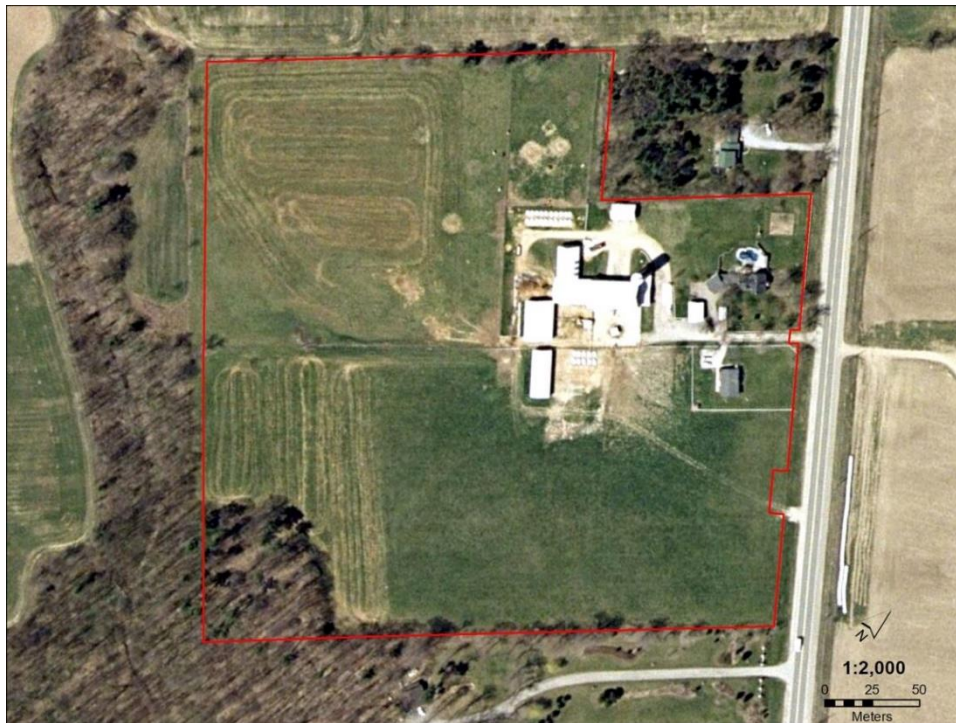
Figure 17: Subject property identified on the 1999 aerial photograph, showing several outbuildings associated with the primary residential building on the site

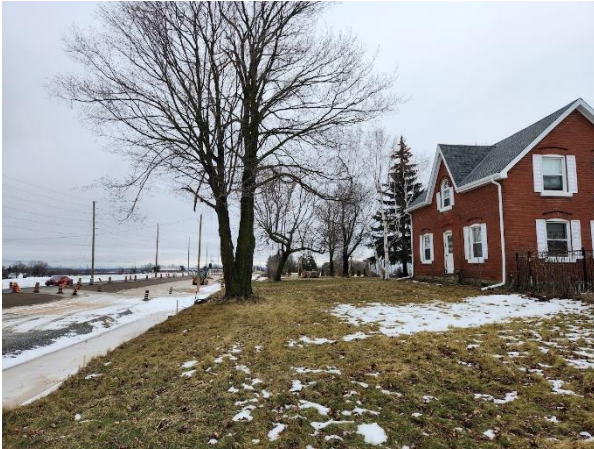
Figure 22: Looking southeast along Trafalgar at 9156 Trafalgar Road (Town of Halton Hills 2024)

The property at 9156 Trafalgar Road is an irregular-shaped parcel along the southwest side of Trafalgar Road in Halton Hills. The property contains a one-and-a-half storey farmhouse with rear additions, a contemporary bungalow, and several associated outbuildings within an agricultural landscape. The property is accessed via Trafalgar Road.

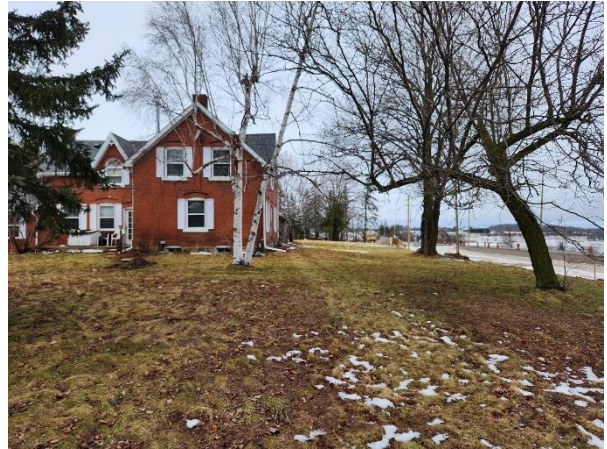
Figure 23: Looking northwest along Trafalgar at 9156 Trafalgar Road (Town of Halton Hills 2024)

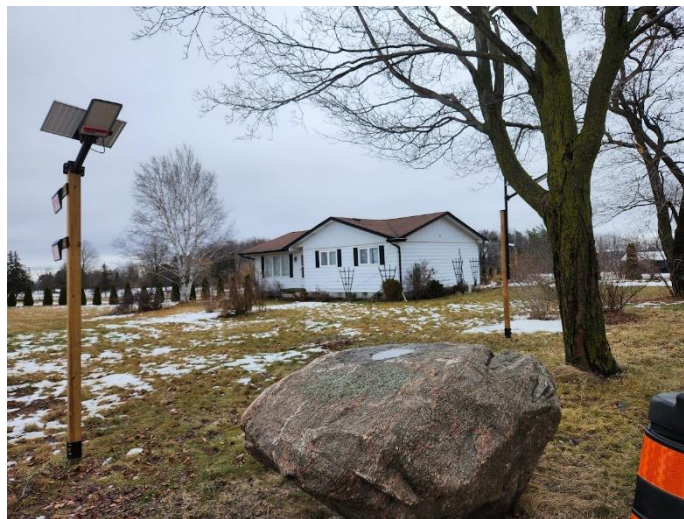
To the south of the original farmhouse is a one-storey bungalow with gable roof (built between 1980 and 1985 according to available aerial photography).

Figure 24: Looking south from the existing driveway towards the bungalow on the property (Town of Halton Hills 2024)

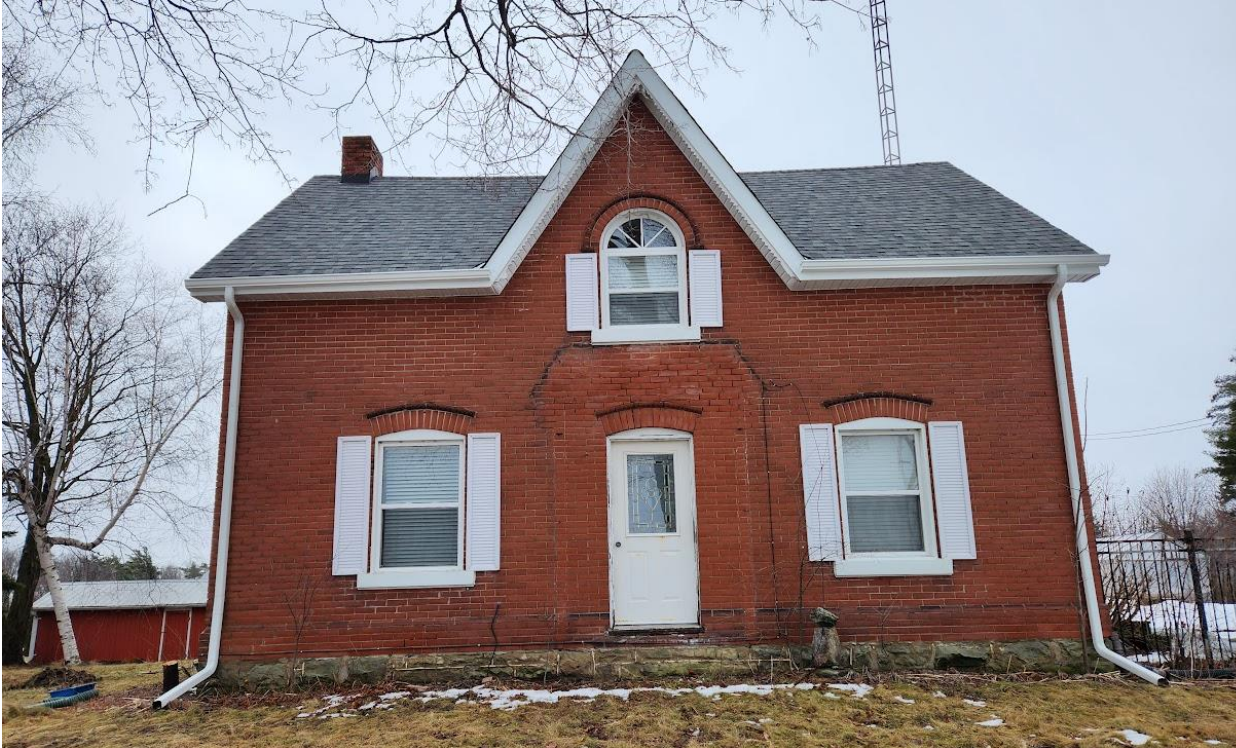
The existing brick farmhouse is a one-and-a-half storey brick building on a stone foundation with rear contemporary additions. The three-bay front (east) elevation features a central entrance within a segmentally arched opening with brick voussoirs and decorative brick hood mould, and single window openings with segmentally arched openings and brick voussoirs and decorative brick hood moulds on

either side; the original windows are no longer extant and have been replaced with contemporary hung windows, and the entry door is also contemporary.

Below the central gable peak is a round-headed window opening with brick voussoirs, which is unusual for the style, as well as the decorative brick hood moulds that are extant above openings throughout. The front elevation is otherwise unadorned and is quite modest, and features evidence of a former porch that is no longer extant.

Figure 25: Front (northeast) elevation of the existing residence at 9156 Trafalgar Road (Town of Halton Hills 2024)

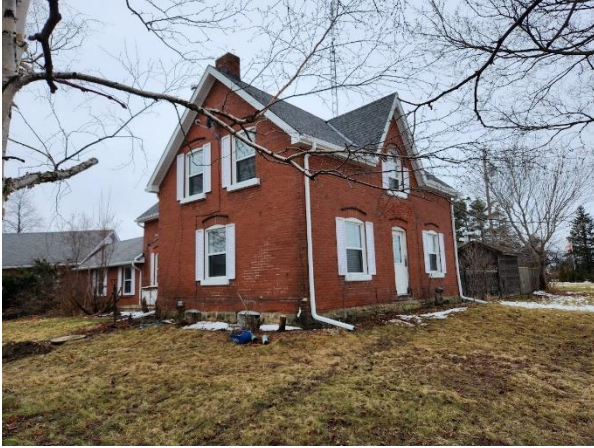
Figure 26: Southeast corner of the existing residence (Town of Halton Hills 2024)

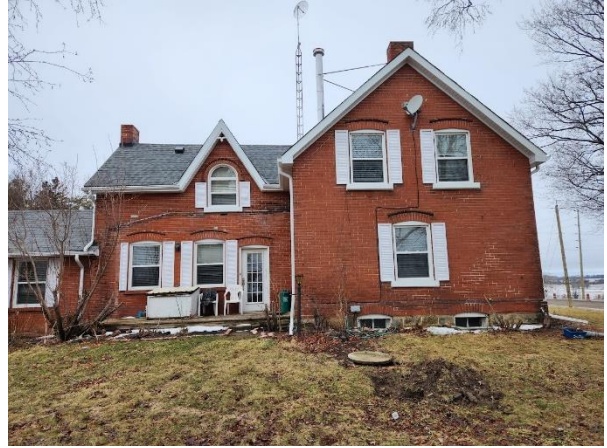
Figure 27: Partial southeast elevation of the existing residence (Town of Halton Hills 2024)

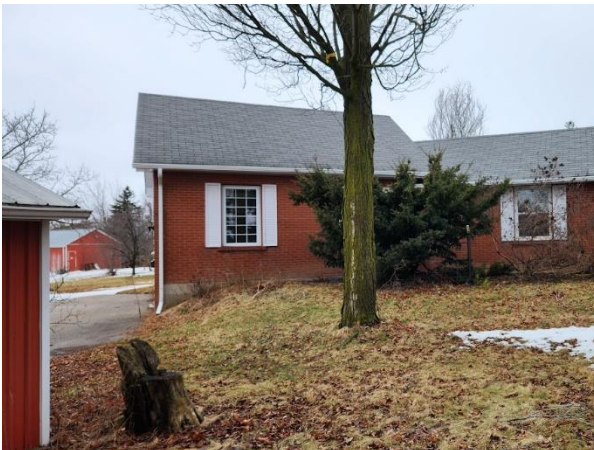
The original farmhouse features a cross gabled roof which extends above the rear portion of the T-shaped building. A brick chimney is located within the gable peak of the one-and-a-half storey portion of the addition. A contemporary one-storey addition then extends to the rear perpendicular to the farmhouse and adjoins a one-and-a-half storey garage addition.

Figure 28: Partial southeast elevation of the addition to the existing residence (Town of Halton Hills 2024)

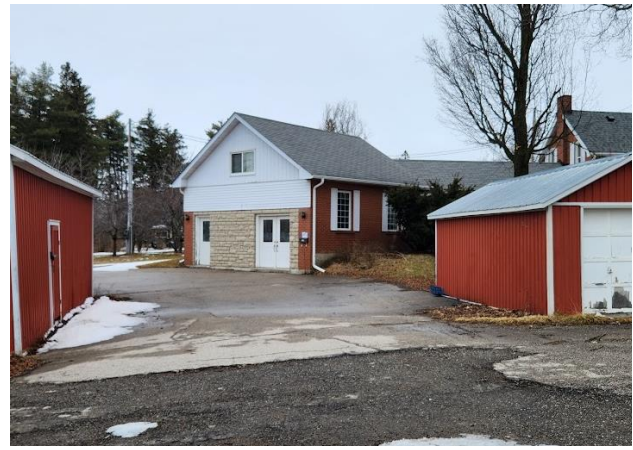
Figure 29: Looking towards the rear garage addition from within the existing driveway (Town of Halton Hills 2024)

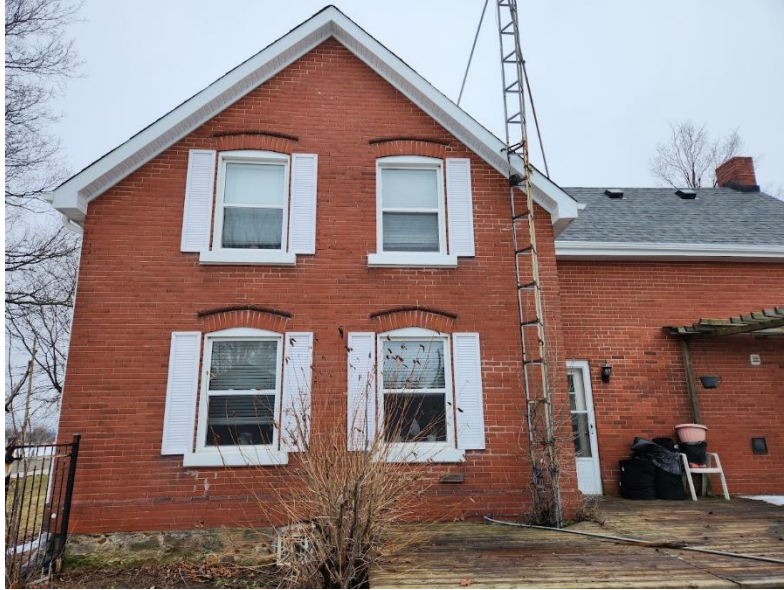
The northeast elevation of the one-and-a-half storey farmhouse features a single segmentally arched window opening centered within the first storey and two single window openings centered beneath the gable peak at the upper storey. A brick chimney projects above the gable roof at this end of the house. The northwest elevation features two segmentally arched window openings at each storey, centered on the elevation.

Figure 30: Partial northeast elevation of the existing residence (Town of Halton Hills 2024)

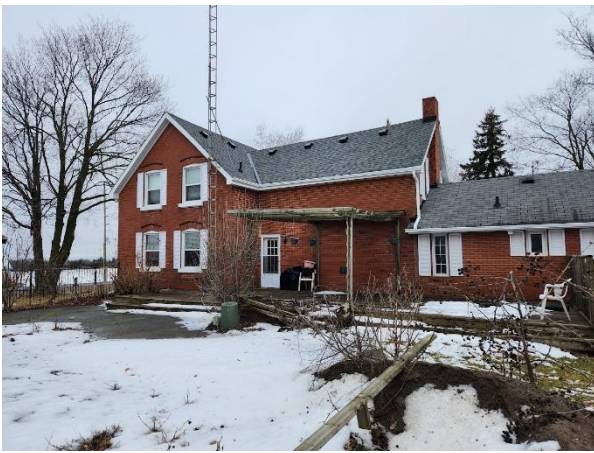
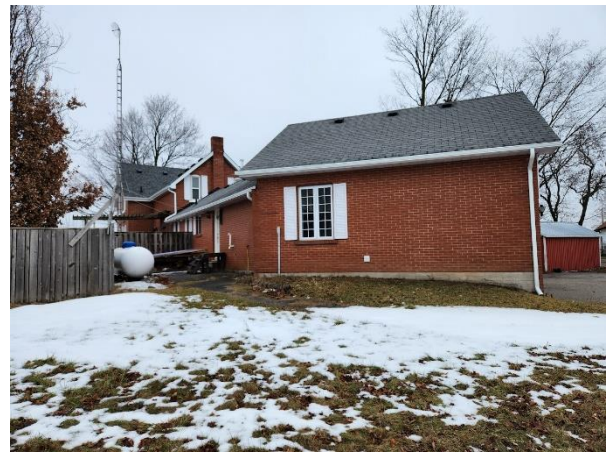
Figure 31: Looking towards the northeast elevation of the existing residence, showing the rear addition (Town of Halton Hills 2024)

Figure 32: Looking towards the northeast elevation of the existing residence, showing the rear addition (Town of Halton Hills 2024)

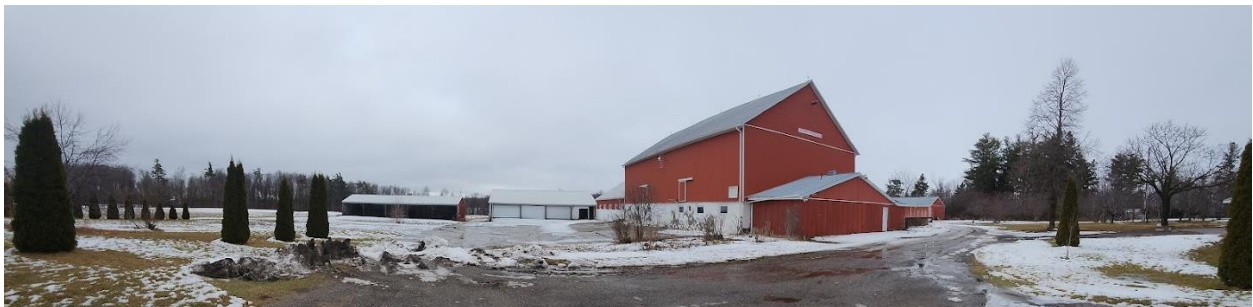
Agricultural buildings including a large gable roof barn are located to the west of the residence as well as several smaller outbuildings throughout the property. Beyond the agricultural buildings are open fields, as well as orchards along the northeast lot line.

Figure 33: Looking southwest along the driveway at 9156 Trafalgar Road (Town of Halton Hills 2024)

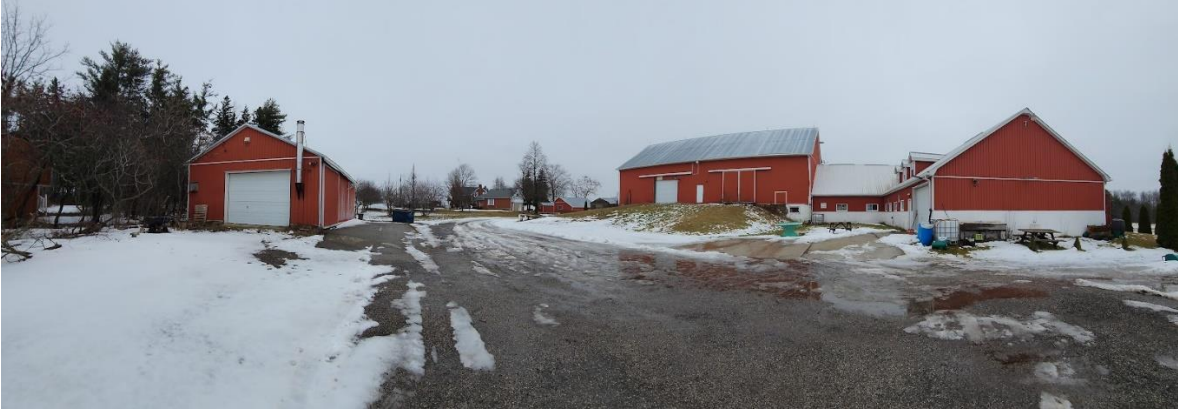
Figure 34: Looking north from the driveway showing the complex of outbuildings with the residence in the background (Town of Halton Hills 2024)
