Research and Evaluation Report

Barraclough House

25 Mountain Street, Glen Williams, Town of Halton Hills

February 2024

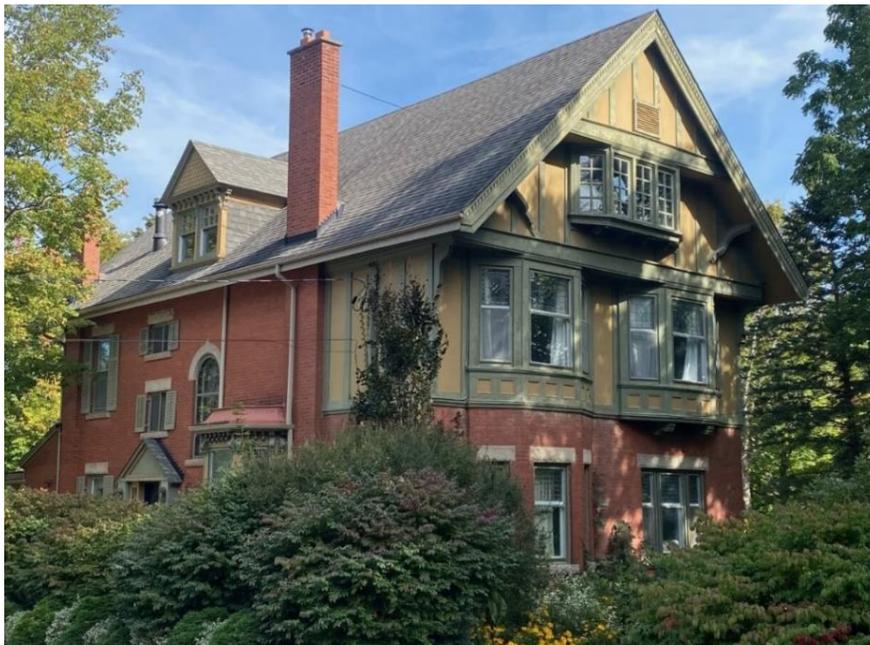
Barraclough House is a two-and-a-half storey residence, with triple-wythe red brick construction and significant architectural detailing throughout.

Figure 32: Northwest corner of Barraclough House at 25 Mountain Street (Town of Halton Hills 2023)

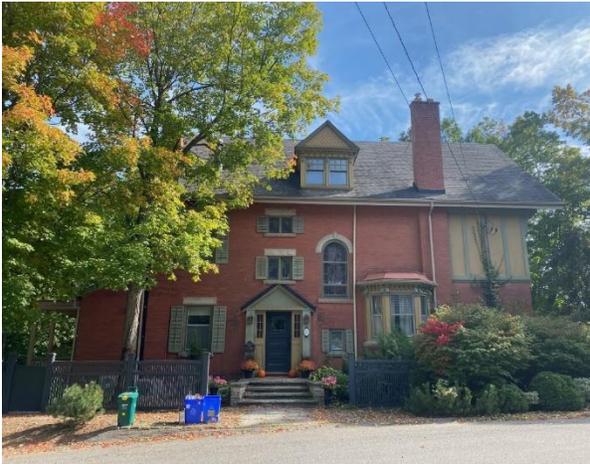
The front (north) elevation of Barraclough House faces the intersection of Tweedle Street and Mountain Street in Glen Williams. The elevation is asymmetrical yet balanced in its composition, with openings of various sizes and architectural detailing providing interest throughout. At the first storey, the central entrance, accessed via an open stone porch, features a detailed wooden surround with sidelights. A large flat-headed window opening with stone sill and lintel with wooden shutters is located adjacent to the entrance on one side, with a smaller rectangular opening with brick voussoirs above and stone sill below flanked by wooden shutters on the other side. The western half of the front (north) elevation is defined by a bay with mansard roof at the first storey, with a brick base, wooden detailing, and flat-headed windows beneath the bracketed bay roof. This bay is flanked by a brick chimney that extends well above the gable roof.

Figure 33: Front (north) elevation of Barraclough House at 25 Mountain Street, partially obscured by foliage (Town of Halton Hills 2023)

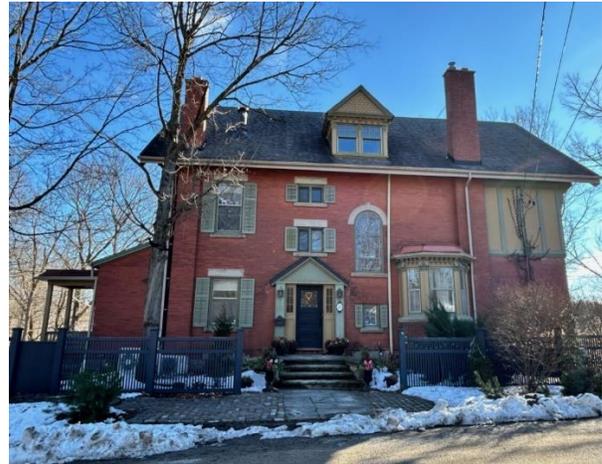
Figure 34: North elevation of 25 Mountain Street (Kindbom 2024)

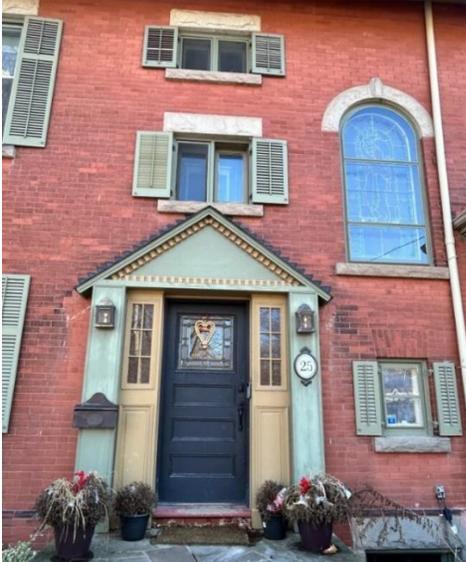
Above the first storey, the eastern half of the front (north) elevation features a vertical flat-headed window opening with stone sill, lintel, and shutters; two horizontal flat-headed window openings with stone sills, lintels, and wooden shutters centered above the front elevation, and arched window opening with stone sill and stone hood mould above. This window opening features an elaborate stained-glass window which is best appreciated from the interior (Figure 37). At the second storey, half-timbering wraps around the corner to the side elevation on the other side of the chimney.

Figure 35: Detail of the front (north) elevation of Barraclough House (Kindbom 2024)

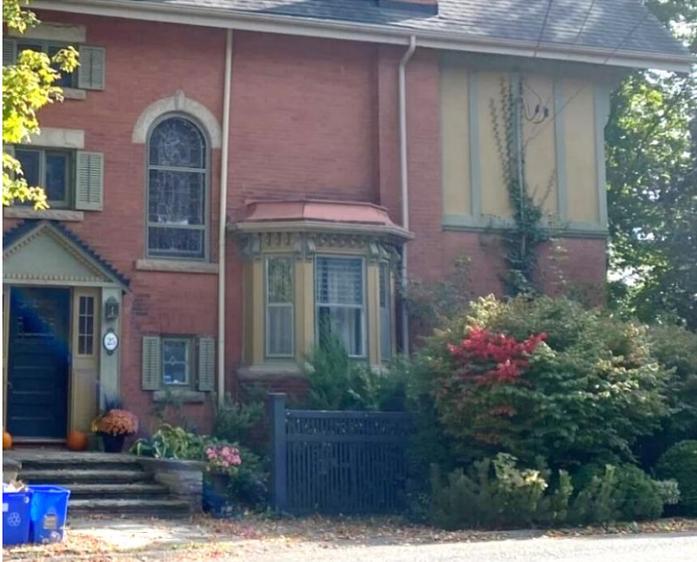
Figure 36: Detail of the front (north) elevation of Barraclough House (Town of Halton Hills 2023)

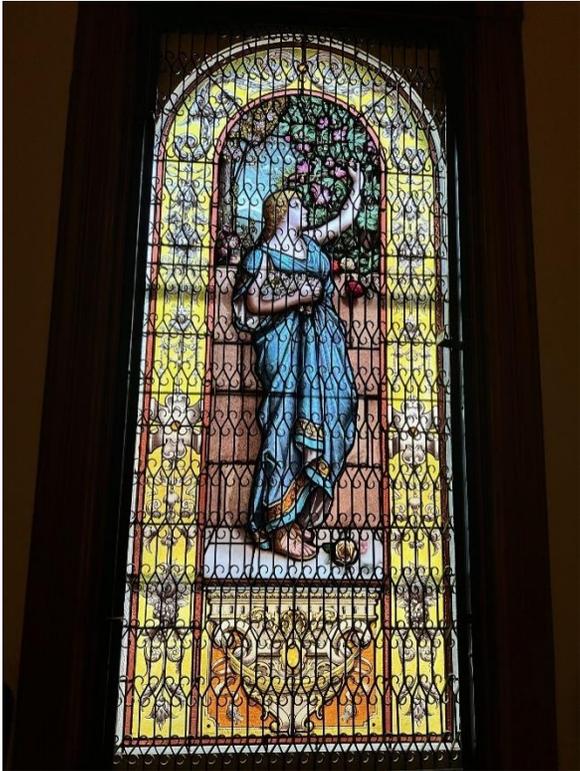
Figure 37: Stained glass window on the primary elevation, shown from the interior (Kindbom 2024)

- The vertical flat-headed window opening with stone sill, lintel, and shutters; two horizontal flat-headed window openings with stone sills, lintels, and wooden shutters centered above the front elevation, and arched window opening with stone sill and stone hood mould above, including the stained-glass window within;

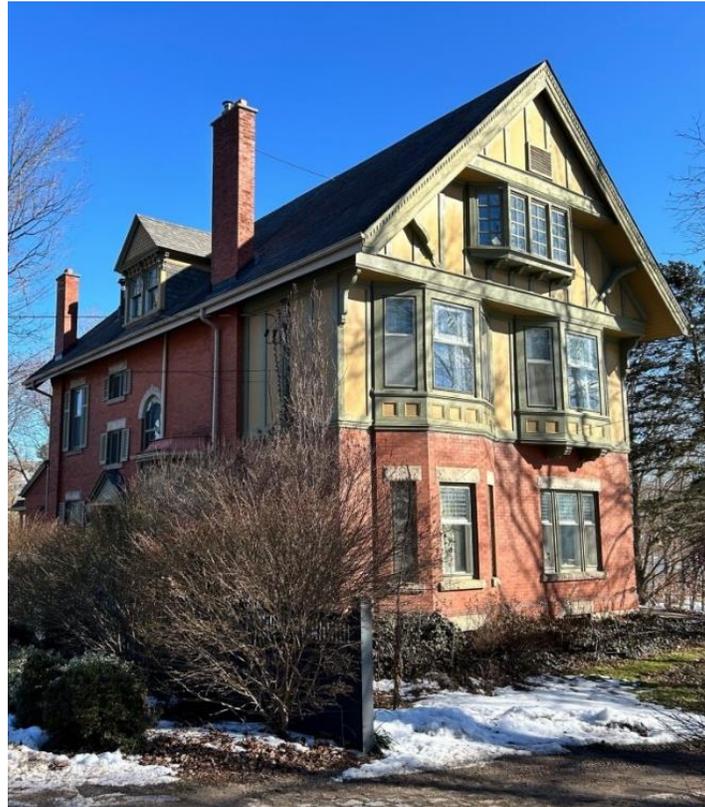
Figure 38: Southwest corner of Barraclough House (Kindbom 2024)

The side (southwest) elevation of Barraclough House reads as an extension of the front elevation in its detailing and orientation towards Mountain Street. At the first storey, the stone foundation is punctuated by flat-headed window openings with stone sills. A projecting bay extends upwards from a brick base at the first storey and features three symmetrically placed flatheaded window openings with stone sills and lintels. Adjacent to the bay at the first storey is a large window opening with three hung windows, stone lintel, and sill. At the second storey, two projecting bays mirror one another with wooden architectural detailing throughout, with the southernmost bay supported by wooden brackets. Above the second storey, half-timbering and stucco define the façade with a wooden projecting bay with multi-divided windows beneath the centre gable with wooden detailing along the eaves.

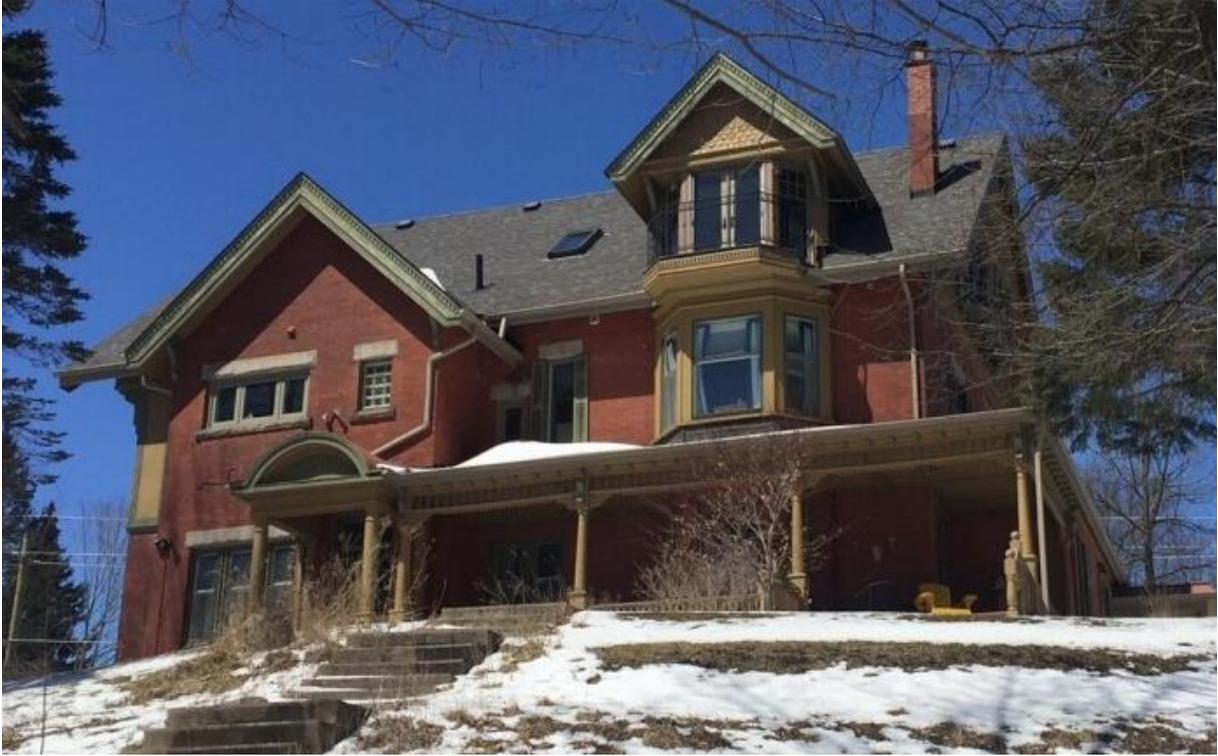
The rear (south) elevation of Barraclough House facing the Credit River is arguably the most elaborate and detailed elevation of the home, originally oriented towards the Glen Woollen Mill for its manager E.Y. Barraclough. Built into the hill, this elevation is dominated by a large covered verandah featuring elaborate wooden architectural detailing throughout.

At the southwest end of this elevation, a portion façade projects forward beneath a gable peak. The main wrap-around verandah is flanked by an elaborately detailed covered, round-arched porch with Doric columns over a flat-headed entrance which is accessed via a flight of wooden steps. A flat-headed tripartite window openings with stone lintel and sill is located directly adjacent to the rear entrance. On the other side of the entrance at the first storey beneath the main verandah is another flat-headed window opening with two hung windows within. The façade steps back again beyond this elevation to reveal brick at the first elevation and half-timbering at the second storey above.

A projecting bay extends along the southeast portion of this elevation through the first and second storeys and above the existing roofline into an elaborate dormer. At the first storey the bay is brick with symmetrically placed window openings, and smaller openings within the paneled portion of the bay at the second storey. Above the roofline the bay features a gable roof and smaller rectangular window openings beneath the bracketed roof which also features detailed woodwork and shingles. A brick chimney is located directly beside this dormer.

Figure 39: Southeast elevation of Barraclough House (Kindbom 2024)

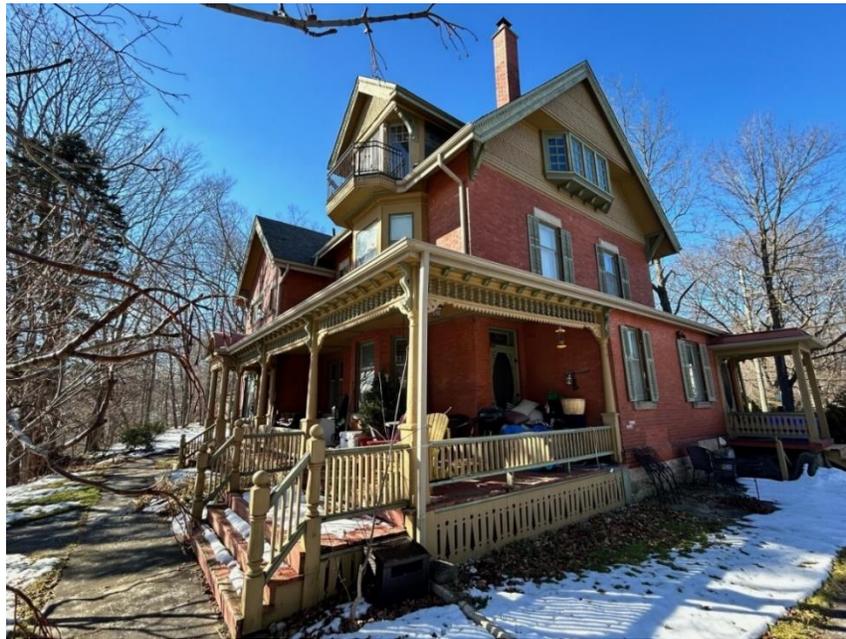
Figure 40: Southeast corner of Barraclough House (Kindbom 2024)

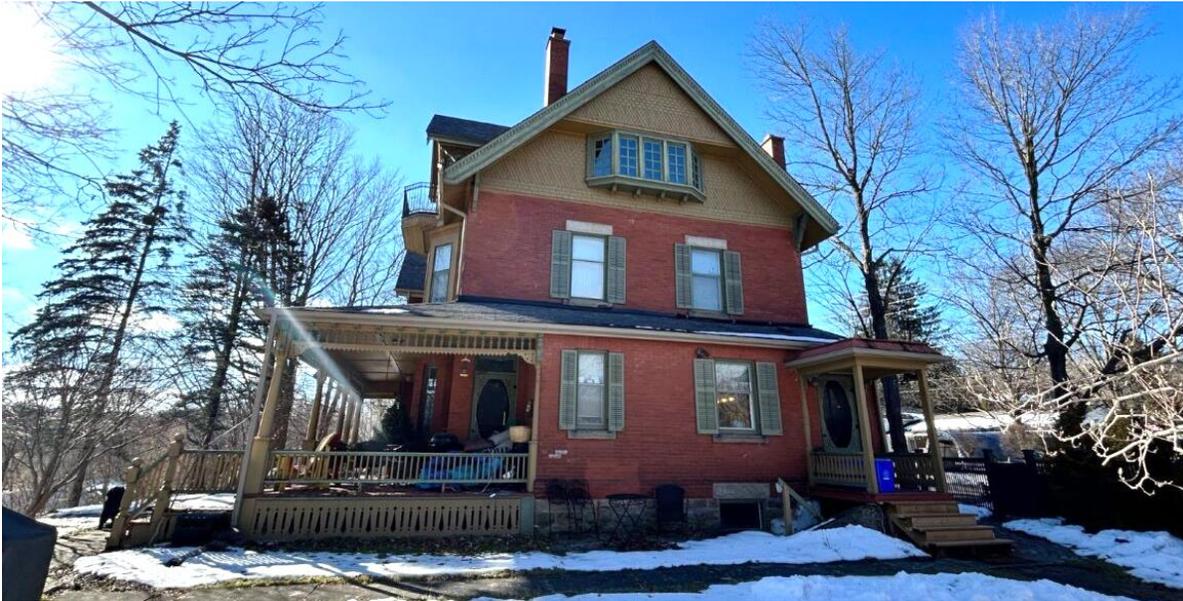
The side (northeast) elevation features two entrances at grade, one within the wrap-around verandah portion and another towards the front corner with a small covered wooden porch. The first storey of this elevation projects from the main elevation wall and features two smaller window openings with wooden shutters and brick voussoirs beneath the eaves of the porch roof. Two symmetrically placed flatheaded window openings with stone sills, lintels and wooden shutters are located at the second

storey. Like the southwest elevation, a wooden, bracketed projecting bay is located at the upper storey and is located within the shingled façade beneath the decorative bracketed eaves.

Figure 41: Northeast elevation of Barracough House (Kindbom 2024)
