Research and Evaluation Report

Chisholm House

9094 Regional Road 25, Town of Halton Hills

March 2024

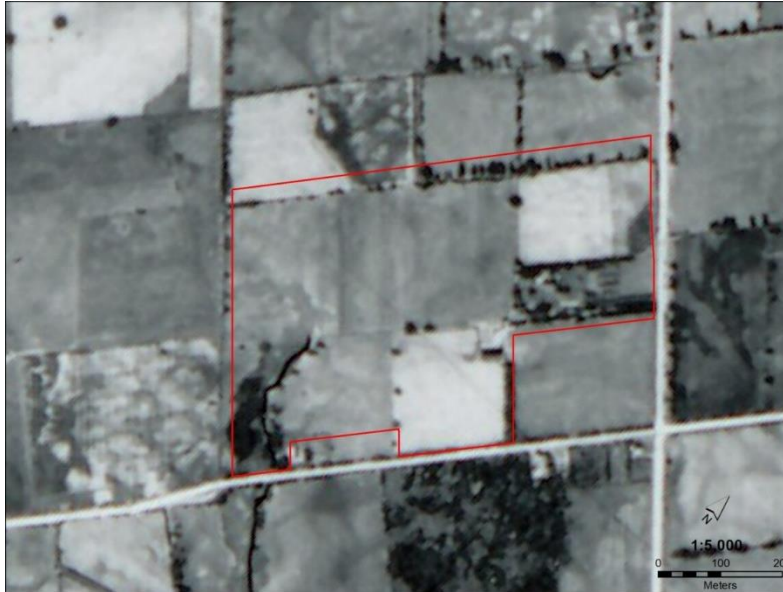
1954 aerial photography (Figure 14) shows most of the subject property with farm fields. The existing house is visible at the end of the drive extending from Regional Road 25 and shows the trees along the drive and within the orchard as identified in 1877 mapping, as well as the woodlot shown on early mapping.

Figure 14: Subject property identified in 1954 aerial photography

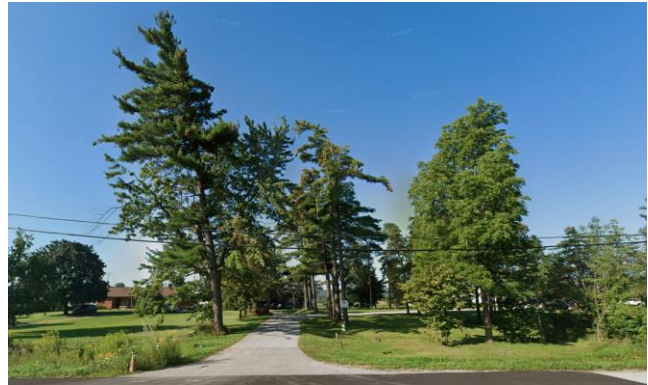
Figure 26: Existing driveway during late summer 2023, showing the driveway lined with mature trees and the neighbouring lot with bungalow (left) (Google Streetview Sept 2023)

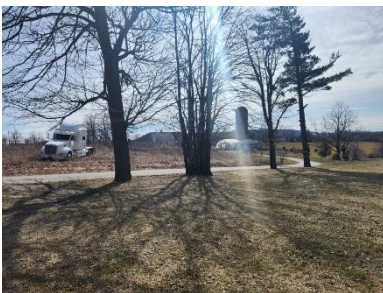
Figure 30: Looking towards the southwest within the subject property, showing the Bob Rumball Centre (left) and extant silo and shed structure (centre) (Town of Halton Hills 2024)

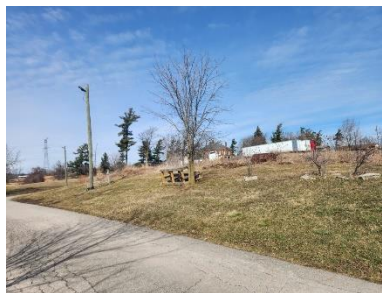
Figure 31: Looking towards the northeast within the subject property towards Chisholm House (Town of Halton Hills 2024)

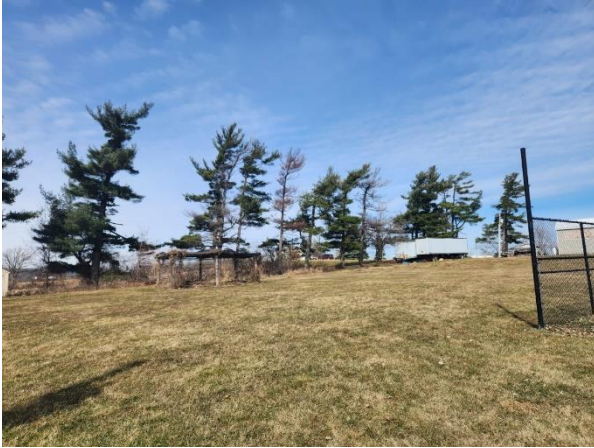
Figure 33: Mature coniferous trees along the northwest property line (Town of Halton Hills 2024)

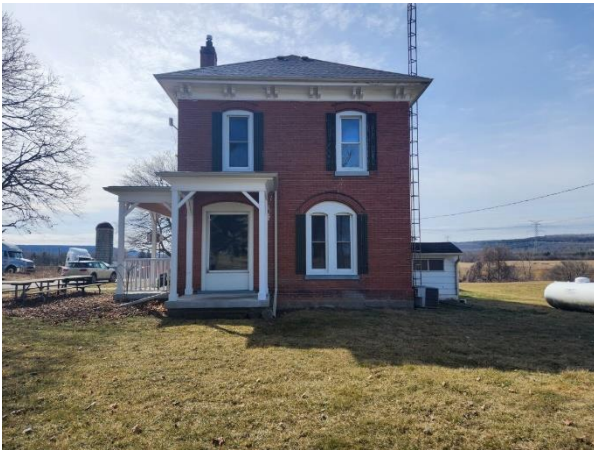
The late nineteenth century residence identified as Chisholm House is located within the east half of the lot and is accessed from Regional Road 25 at the end of a tree-lined drive. The L-shaped, two-storey building features a cut stone foundation and hipped roof, with bracketed eaves (Figure 35 and Figure 36). The front elevation facing Regional Road 25 features a covered porch which has replaced the original porch over the segmentally arched door opening with contemporary window within as the entrance is no longer in use. Adjacent to the entrance is a round arched double window opening with brick hood mould and wooden shutters. Two symmetrically placed, segmentally arched single window openings with sills and wooden shutters are located at the second storey.

Figure 35: Northeast elevation (Town of Halton Hills 2024)

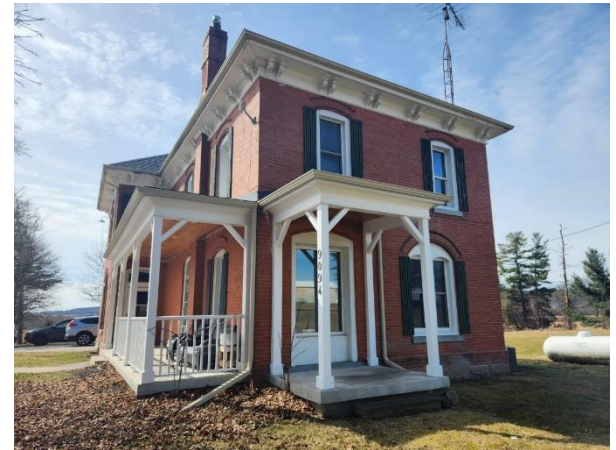
Figure 36: Southeast corner (Town of Halton Hills 2024)

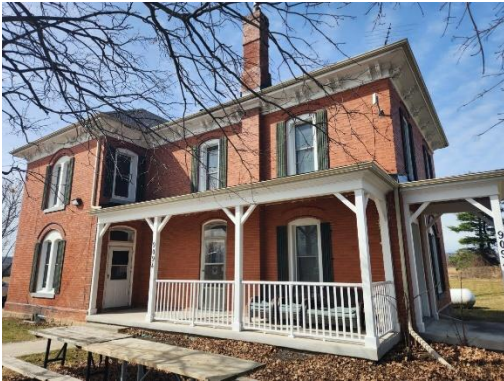
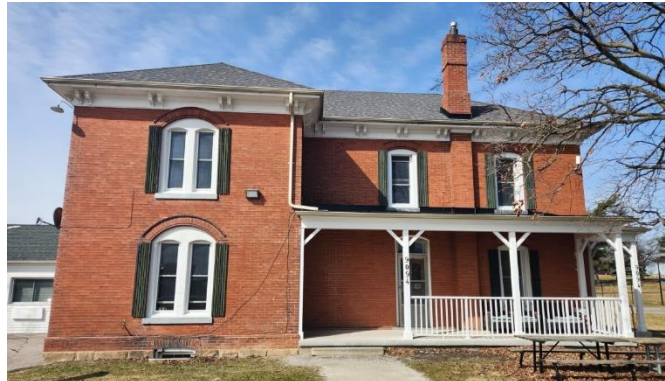
The side (southeast) elevation features a covered wooden porch that extends along the building from the front elevation to the rear where the building projects further south. At grade there are two segmentally arched window openings with brick hood moulds (one of these likely modified from an original window opening) and a single segmentally arched window opening with wooden shutters towards the east end of the elevation. The two entry doors feature wooden surrounds with glass transoms. Single segmentally arched window openings are located at the second storey with a brick chimney extending up from the first storey and rising above the roofline; the eaves are bracketed throughout the existing roof.

The west end of the southeast elevation features centrally located round-arched paired window openings with brick hood moulds.

Figure 37: Looking towards the southeast elevation (Town of Halton Hills 2024)

Figure 38: Southeast elevation (Town of Halton Hills 2024)

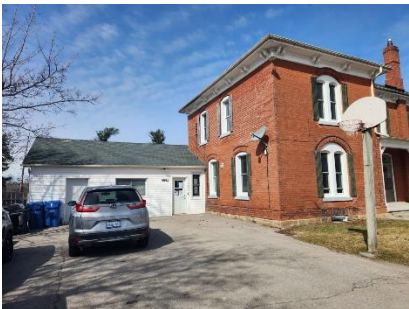
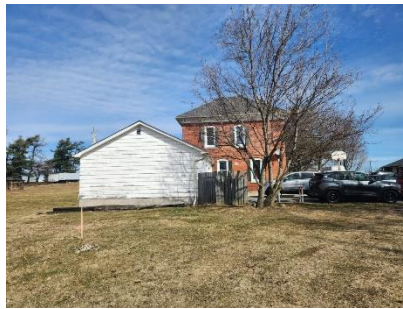
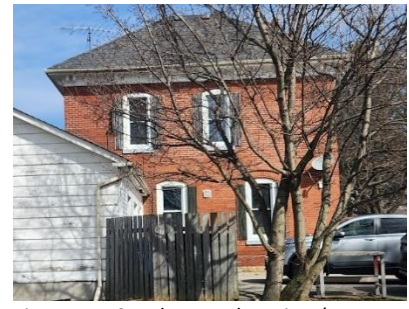
The rear (southwest) elevation is partially obscured by a one-storey garage addition. The elevation appears to have been modified with evidence of infill brick, however two segmentally arched window openings with brick hood moulds and sills are extant at the first and second storeys.

Figure 39: Looking towards the southwest corner with one-storey attached garage (Town of Halton Hills 2024)

Figure 40: Southwest elevation with rear of the one-storey garage (Town of Halton Hills 2024)

Figure 41: Southwest elevation (Town of Halton Hills 2024)

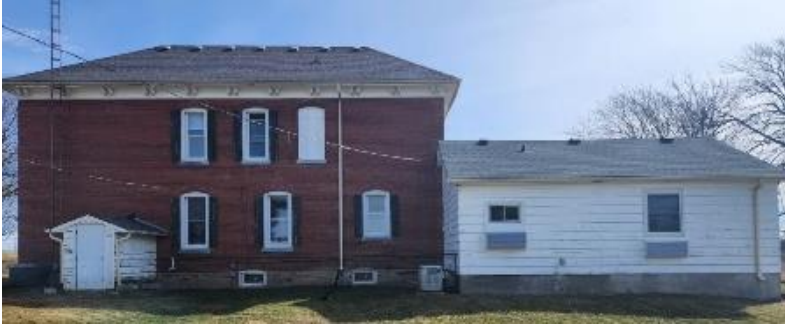
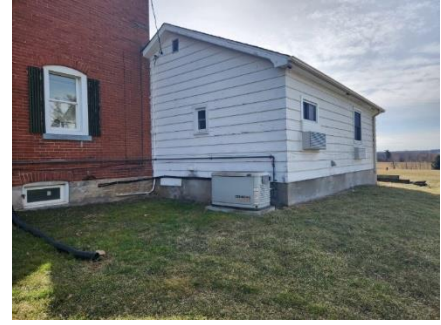
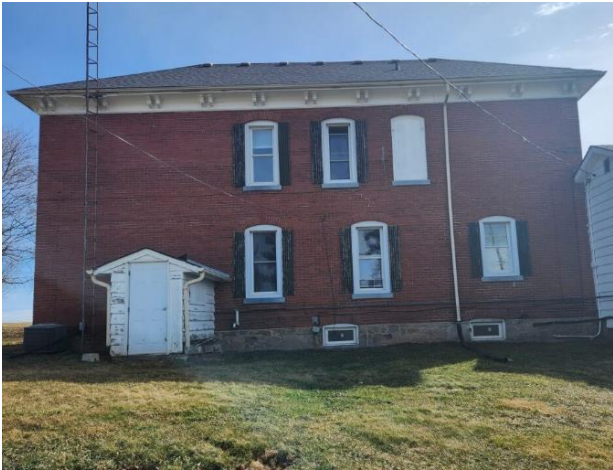
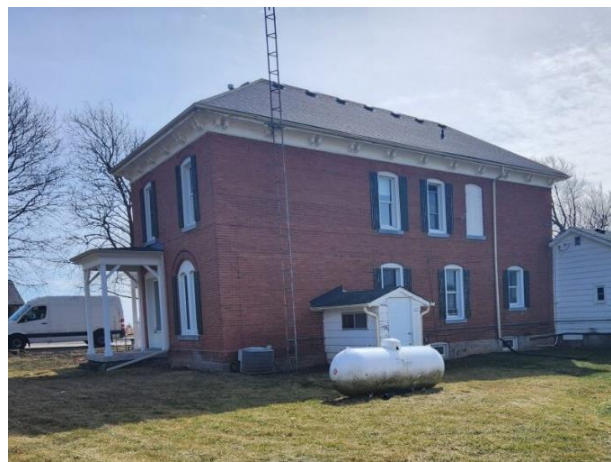
The side (northwest) elevation features the one-storey garage addition at the rear. Segmentally arched window openings are extant within the cut-stone foundation at the basement level. At the first storey, three segmentally arched window openings feature brick voussoirs and sills, with three openings at the second storey above although one has been infilled. A one-storey frame addition provides access to the building along this elevation.

Figure 42: Northwest elevation with one-storey garage addition (Town of Halton Hills 2024)

Figure 43: Looking towards the one-storey garage addition (Town of Halton Hills 2024)

Figure 44: Northwest elevation (Town of Halton Hills 2024)

Figure 45: Looking towards the northwest corner (Town of Halton Hills 2024)

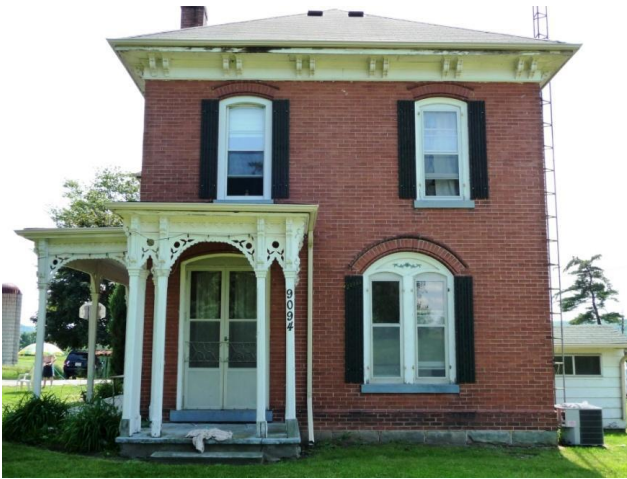
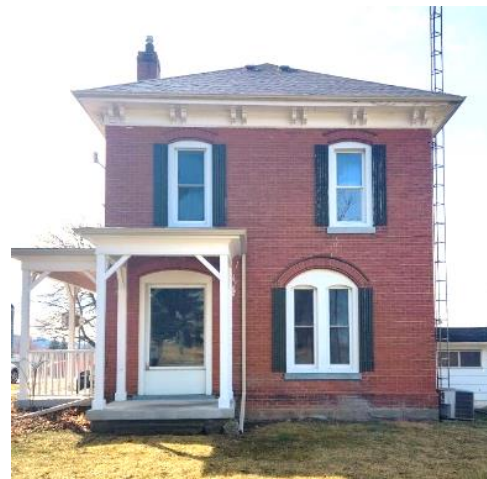
Earlier photographs of the existing house show the original porch which has since been removed (Figure 46 and Figure 47).

Figure 46: Front elevation of Chisholm House, c.2009 (Heritage Listing Report 2009)

Figure 47: Front elevation of Chisholm House (Town of Halton Hills 2024)
