Research and Evaluation Report

Barraclough House

25 Mountain Street, Glen Williams, Town of Halton Hills

February 2024

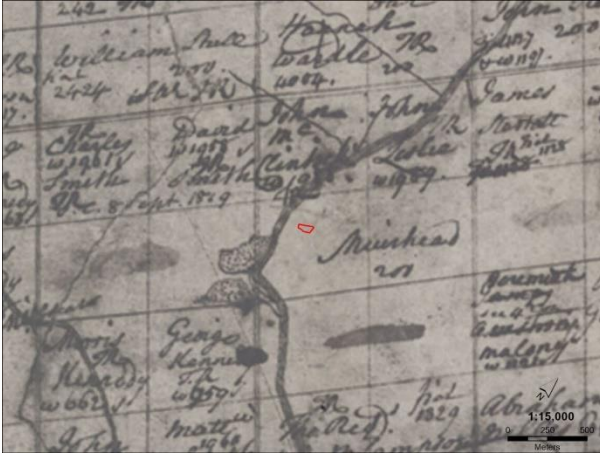
Figure 3: 25 Mountain Street identified on the 1819 Patent Plan

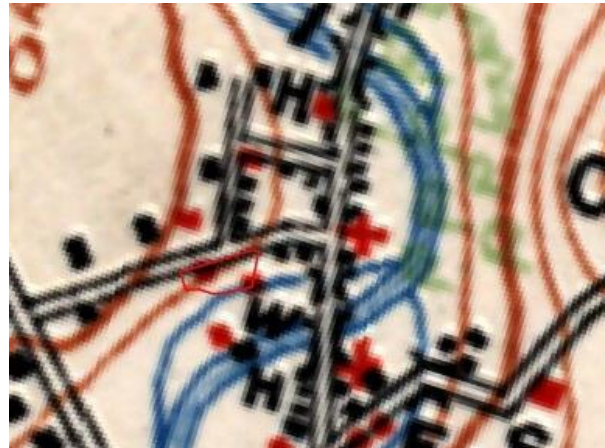
Figure 11: 25 Mountain Street identified on the 1909 National Topographic Map

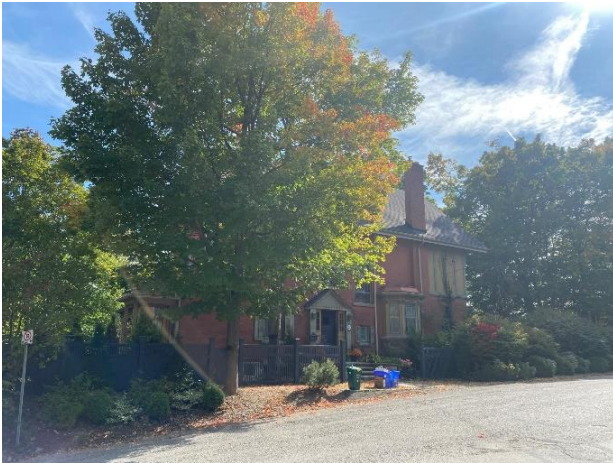
Figure 30: Looking south towards 25 Mountain Street from Tweedle Street, partially obscured by foliage (Town of Halton Hills 2023)

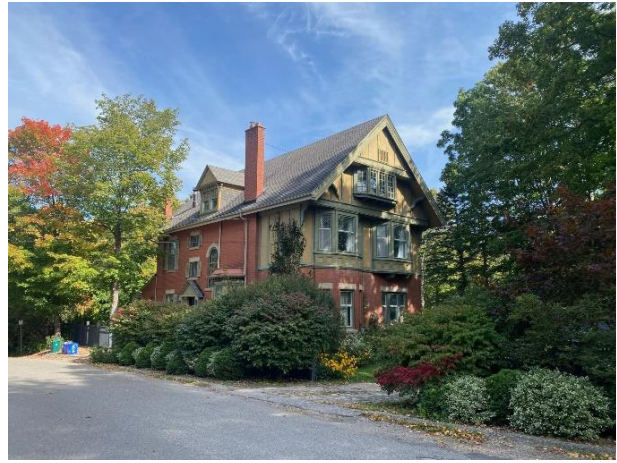
Figure 31: Looking east towards 25 Mountain Street along Mountain Street, partially obscured by foliage (Town of Halton Hills 2023)

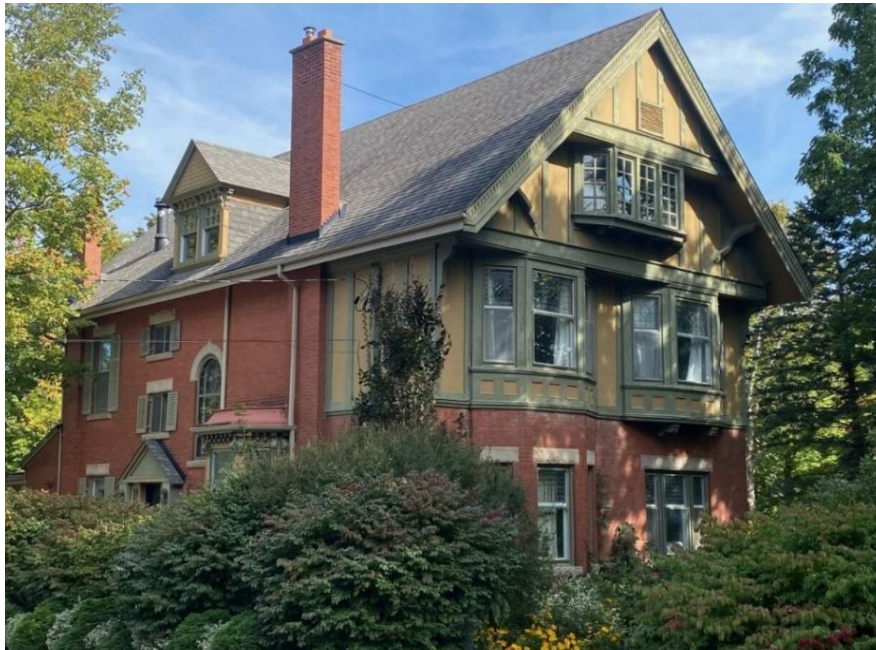
Figure 32: Northwest corner of Barraclough House at 25 Mountain Street (Town of Halton Hills 2023)

Barraclough House is a two-and-a-half storey residence, with triple-wythe red brick construction and significant architectural detailing throughout.

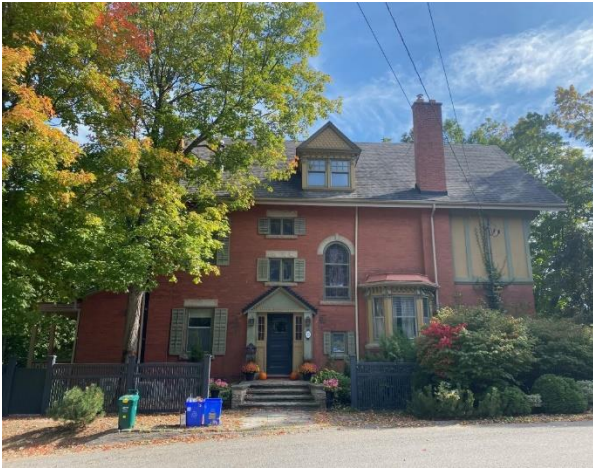
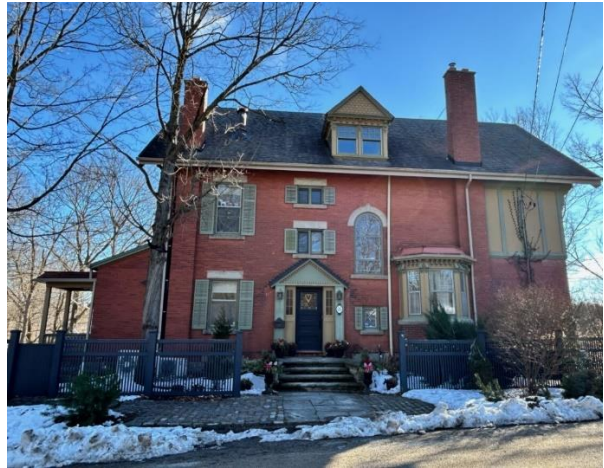
Figure 33: Front (north) elevation of Barraclough House at 25 Mountain Street, partially obscured by foliage (Town of Halton Hills 2023)

Figure 34: North elevation of 25 Mountain Street (Property Owner 2024)

The front (north) elevation of Barraclough House faces the intersection of Tweedle Street and Mountain Street in Glen Williams. The elevation is asymmetrical yet balanced in its composition, with openings of various sizes and architectural detailing providing interest throughout. At the first storey, the central entrance, accessed via an open stone porch, features a detailed wooden surround with sidelights. A large flat-headed window opening with stone sill and lintel with wooden shutters is located adjacent to the entrance on one side, with a smaller rectangular opening with brick voussoirs above and stone sill below flanked by wooden shutters on the other side. The western half of the front (north) elevation is defined by a bay with mansard roof at the first storey, with a brick base, wooden detailing, and flat-headed windows beneath the bracketed bay roof. This bay is flanked by a brick chimney that extends well above the gable roof.

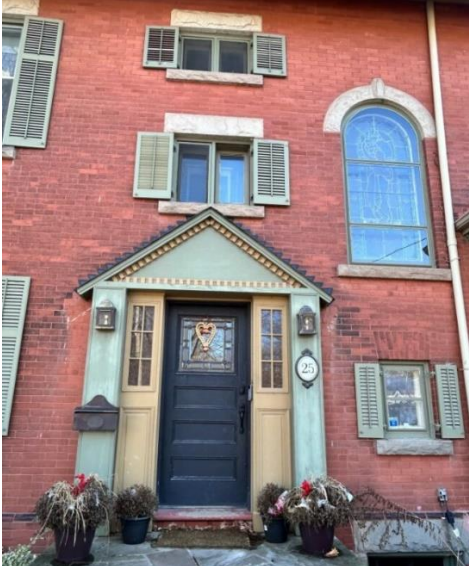
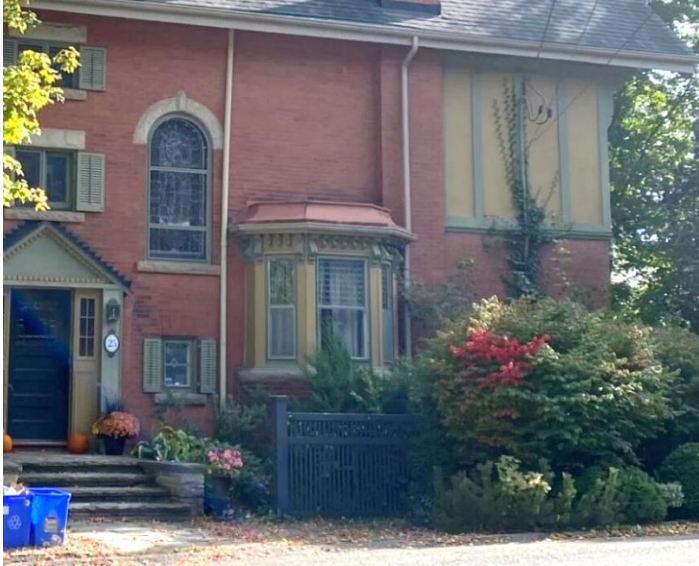
Figure 35: Detail of the front (north) elevation of Barraclough House (Property Owner 2024)

Figure 36: Detail of the front (north) elevation of Barraclough House (Town of Halton Hills 2023)

Above the first storey, the eastern half of the front (north) elevation features a vertical flat-headed window opening with stone sill, lintel, and shutters; two horizontal flat-headed window openings with stone sills, lintels, and wooden shutters centered above the front elevation, and arched window opening with stone sill and stone hood mould above. This window opening features an elaborate stained-glass window which is best appreciated from the interior (Figure 37). At the second storey, half-timbering wraps around the corner to the side elevation on the other side of the chimney.

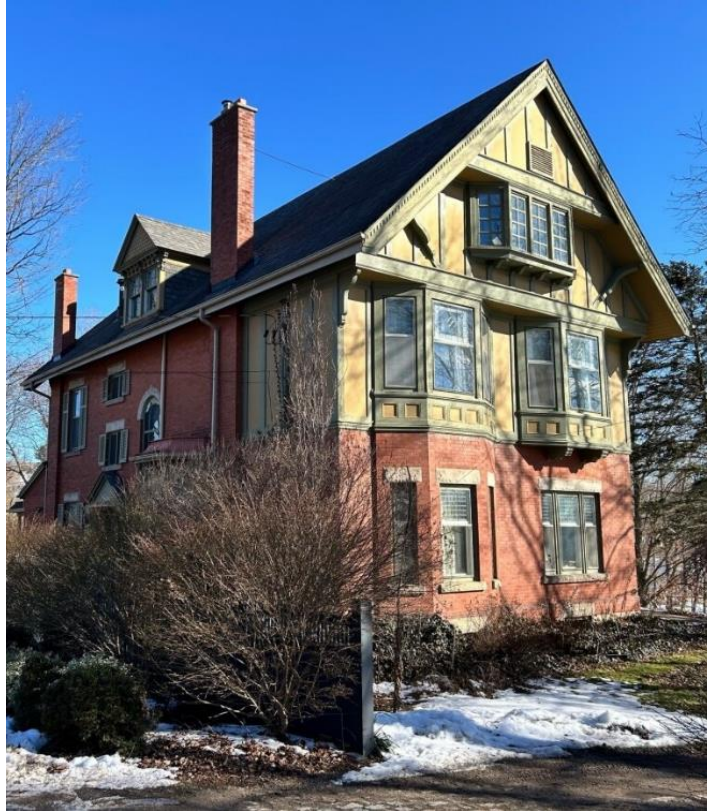
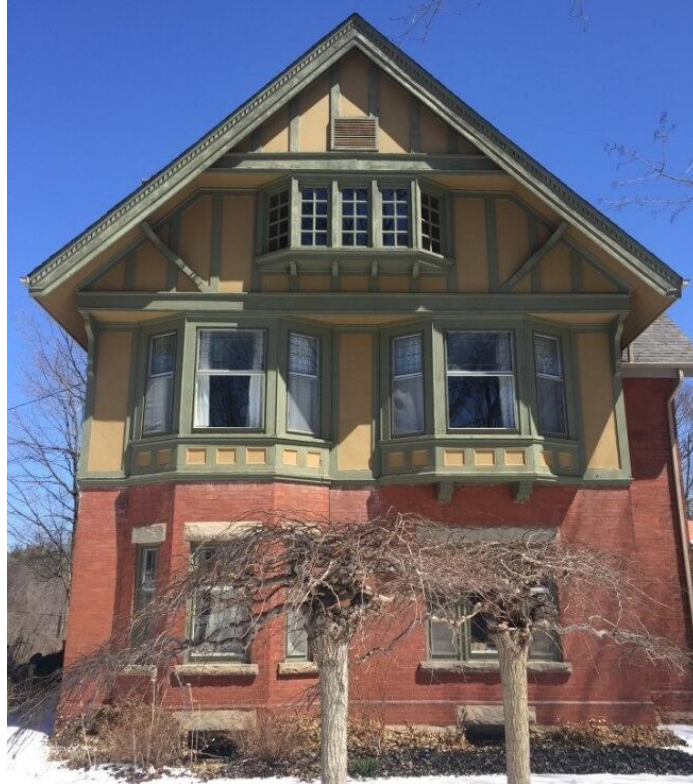
Figure 38: Southwest corner of Barraclough House (Property Owner 2024)

Figure 39: Southwest elevation of Barraclough House (Owner 2024)

The side (southwest) elevation of Barraclough House reads as an extension of the front elevation in its detailing and orientation towards Mountain Street. At the first storey, the stone foundation is punctuated by flat-headed window openings with stone sills. A projecting bay extends upwards from a brick base at the first storey and features three symmetrically placed flatheaded window openings with stone sills and lintels. Adjacent to the bay at the first storey is a large window opening with three hung windows, stone lintel, and sill. At the second storey, two projecting bays mirror one another with wooden architectural detailing throughout, with the southernmost bay supported by wooden brackets. Above the second storey, half-timbering and stucco define the façade with a wooden projecting bay with multi-divided windows beneath the centre gable with wooden detailing along the eaves.

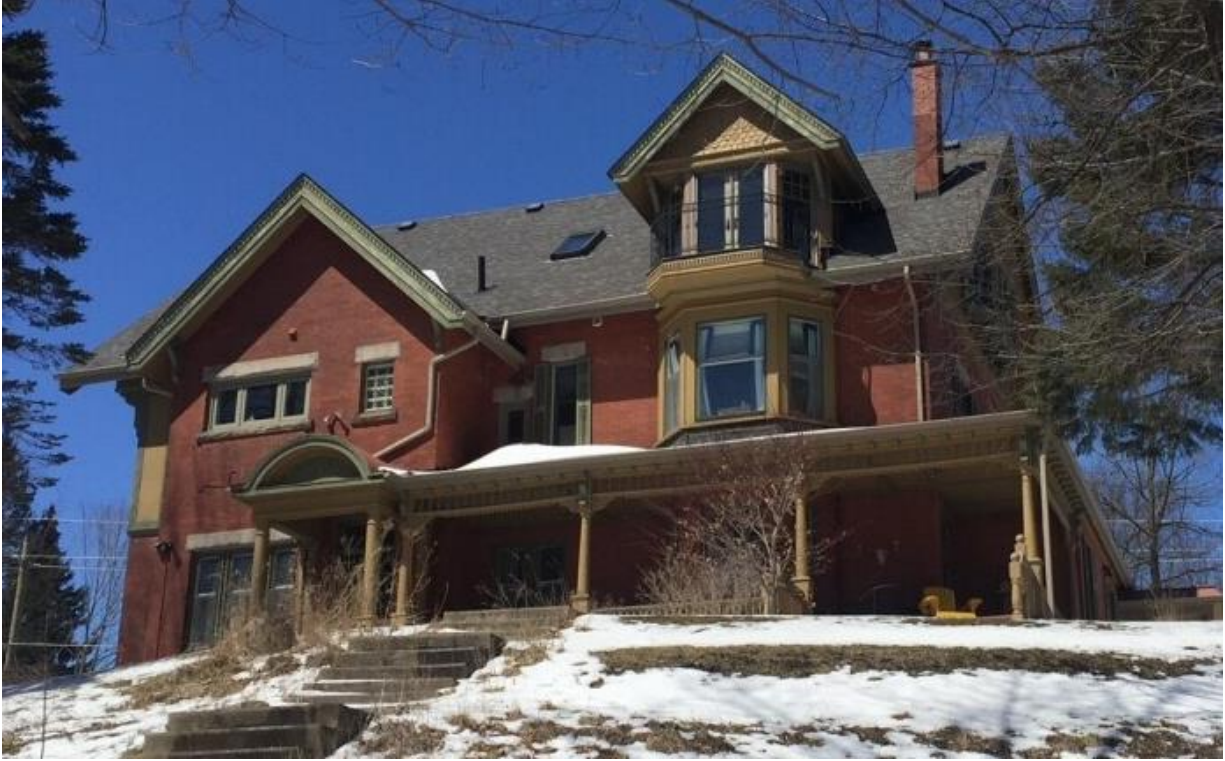
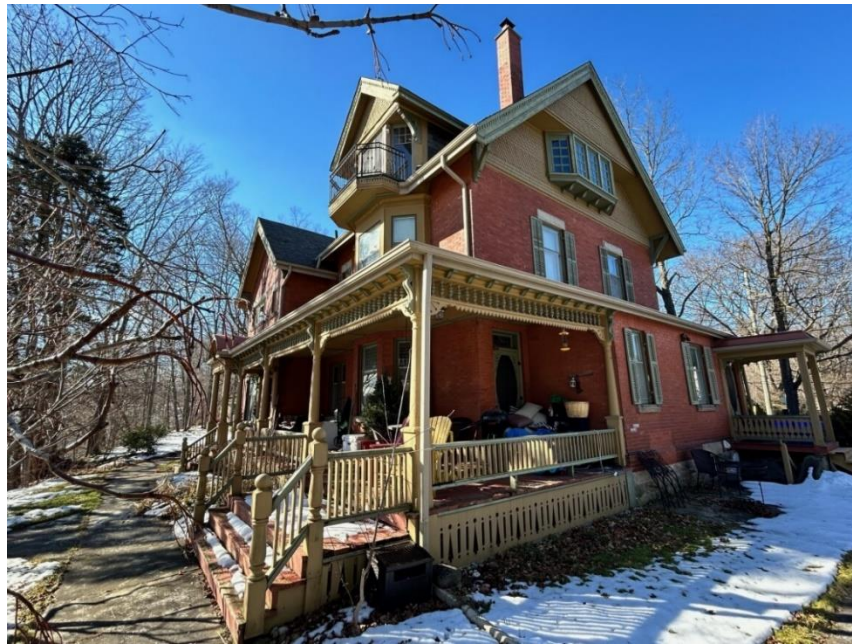
Figure 40: Southeast elevation of Barraclough House (Property Owner 2024)

Figure 41: Southeast corner of Barraclough House (Property Owner 2024)

The rear (south) elevation of Barraclough House facing the Credit River is arguably the most elaborate and detailed elevation of the home, originally oriented towards the Glen Woollen Mill for its manager E.Y. Barraclough. Built into the hill, this elevation is dominated by a large, covered verandah featuring elaborate wooden architectural detailing throughout.

At the southwest end of this elevation, a portion façade projects forward beneath a gable peak. The main wrap-around verandah is flanked by an elaborately detailed covered, round-arched porch with Doric columns over a flat-headed entrance which is accessed via a flight of wooden steps. A flat-headed tripartite window openings with stone lintel and sill is located directly adjacent to the rear entrance. On the other side of the entrance at the first storey beneath the main verandah is another flat-headed window opening with two hung windows within. The façade steps back again beyond this elevation to reveal brick at the first elevation and half-timbering at the second storey above.

A projecting bay extends along the southeast portion of this elevation through the first and second storeys and above the existing roofline into an elaborate dormer. At the first storey the bay is brick with symmetrically placed window openings, and smaller openings within the paneled portion of the bay at the second storey. Above the roofline the bay features a gable roof and smaller rectangular window openings beneath the bracketed roof which also features detailed woodwork and shingles. A brick chimney is located directly beside this dormer.

The southwest portion of the elevation at the second storey features an additional horizontal window opening with stone still and lintel with three windows within, and a smaller window opening infilled with glass blocks beside.

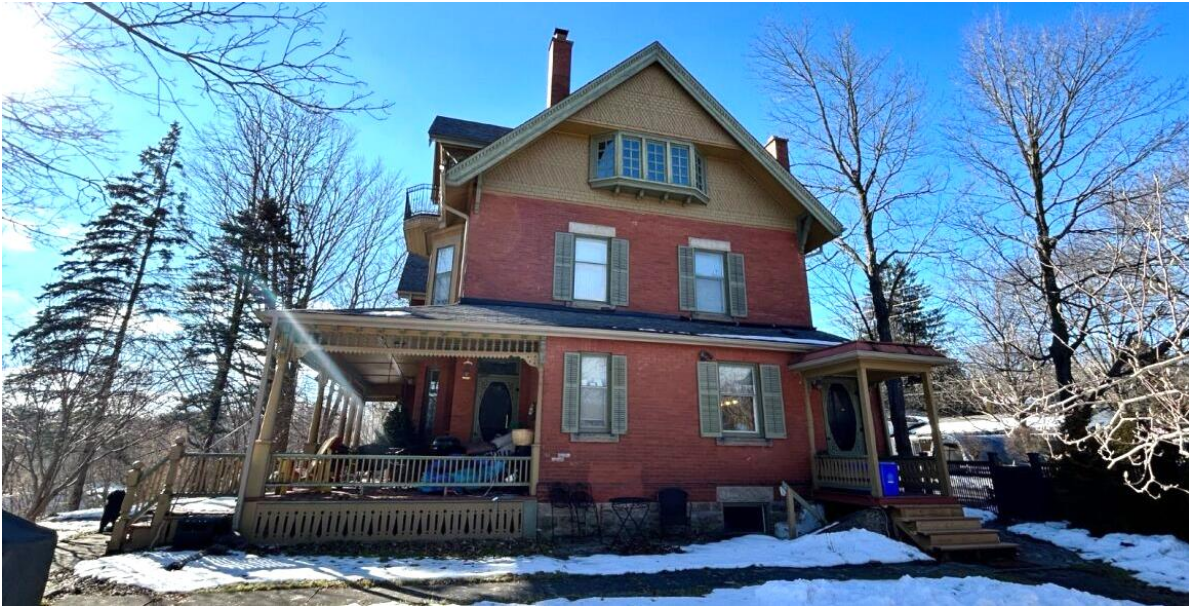
Figure 42: Northeast elevation of Barraclough House (Property Owner 2024)

The side (northeast) elevation features two entrances at grade, one within the wrap-around verandah portion and another towards the front corner with a small covered wooden porch. The first storey of this elevation projects from the main elevation wall and features two smaller window openings with wooden shutters and brick voussoirs beneath the eaves of the porch roof. Two symmetrically placed flatheaded window openings with stone sills, lintels and wooden shutters are located at the second

storey. Like the southwest elevation, a wooden, bracketed projecting bay is located at the upper storey and is located within the shingled façade beneath the decorative bracketed eaves.
