TECHNICAL MEMORANDUM

Re: Heritage Screening, 13552 10 Side Road, Halton Hills, Ontario

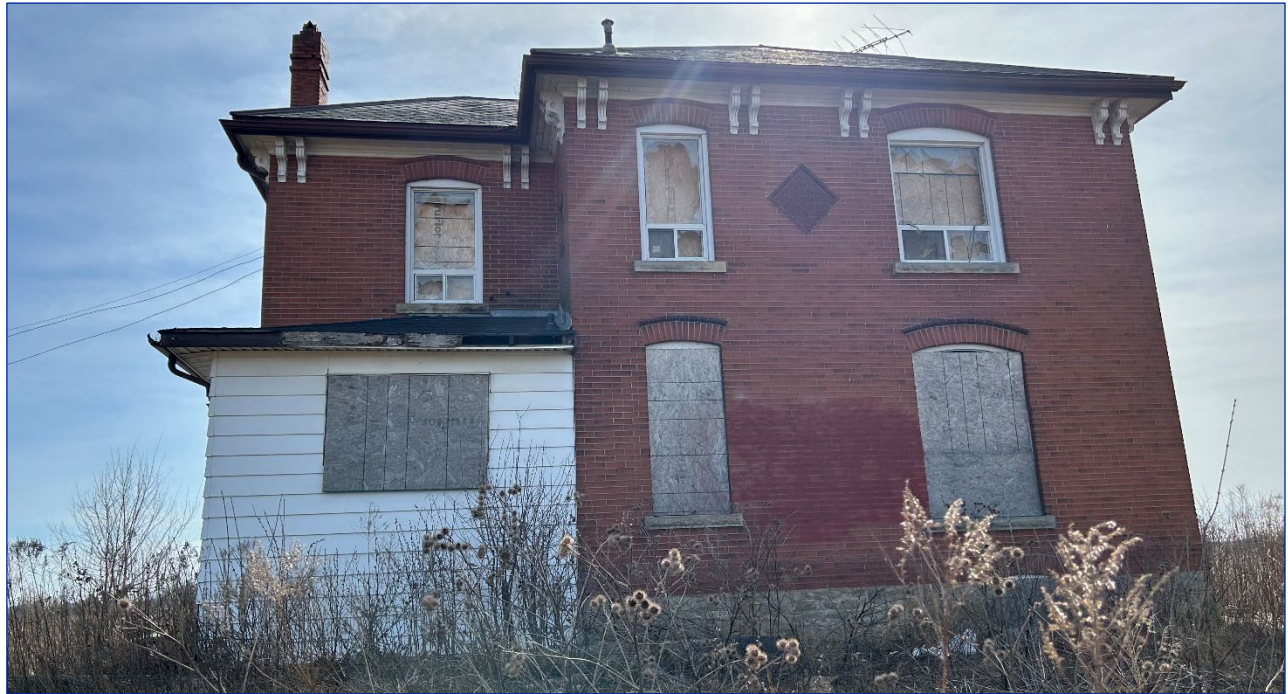
Photo 1: View of the facade

The residence is a single detached, rectangular plan building with a projecting bay on the west side of the north elevation and a brick rectangular addition on the east elevation. Several porches have been enclosed, including a small concrete-clad porch on the north elevation, two small aluminum siding clad porches on the north elevation, and a vinyl siding clad porch on the north elevation of the east addition. The residence is two-storeys in height and has a full below grade basement. Both the main residence and east addition have a fieldstone foundation and red brick exterior cladding laid in stretcher bond. An integral wall decoration matching the other exterior elements is located on the facade. The main building has a truncated hip roof, overhanging eaves, and paired brackets while the east addition has a front facing gable roof with a small belvedere at the eastern end. The enclosed porch along the northern elevation has a shed roof. The other porches have hip roofs. Single flue brick chimneys with projecting string courses are found on the north, south, and east elevations of the main building (Photo 1 to Photo 4).

Windows on the main building typically have a segmentally arched opening with a brick voussoir and projecting string course, and a cut stone lug sill. Most windows are boarded up; however, those that are visible are one fixed window over a two part sliding window. A flat-headed window with a single fixed pane at the top and a two part sliding pane at the bottom and a concrete lug sill is found offset to the south side of the second storey on the east elevation. The east elevation of the east addition has a flat-headed window fit into a segmental window opening with a cut stone lug sill and a brick voussoir. Windows on the enclosed porches are boarded up but appear to be generally flat-headed in a variety of sizes (Photo 1 to Photo 4).

The main building displays elements of the Italianate architectural style through its paired eave brackets; tall, narrow segmentally arched windows; wide overhanging eaves; square/L-shaped plan; low hipped roof; two storeys; and belvedere on the east addition. However, these elements seem to be gradual additions or modifications that are lacking the overall cohesion and design typical of the Italianate architectural style. This is especially evident in the irregular spacing of the paired brackets, the larger windows on the south side of the façade, and the frieze cut out to accommodate the brick voussoirs over the second storey windows (Photo 1 to Photo 4).

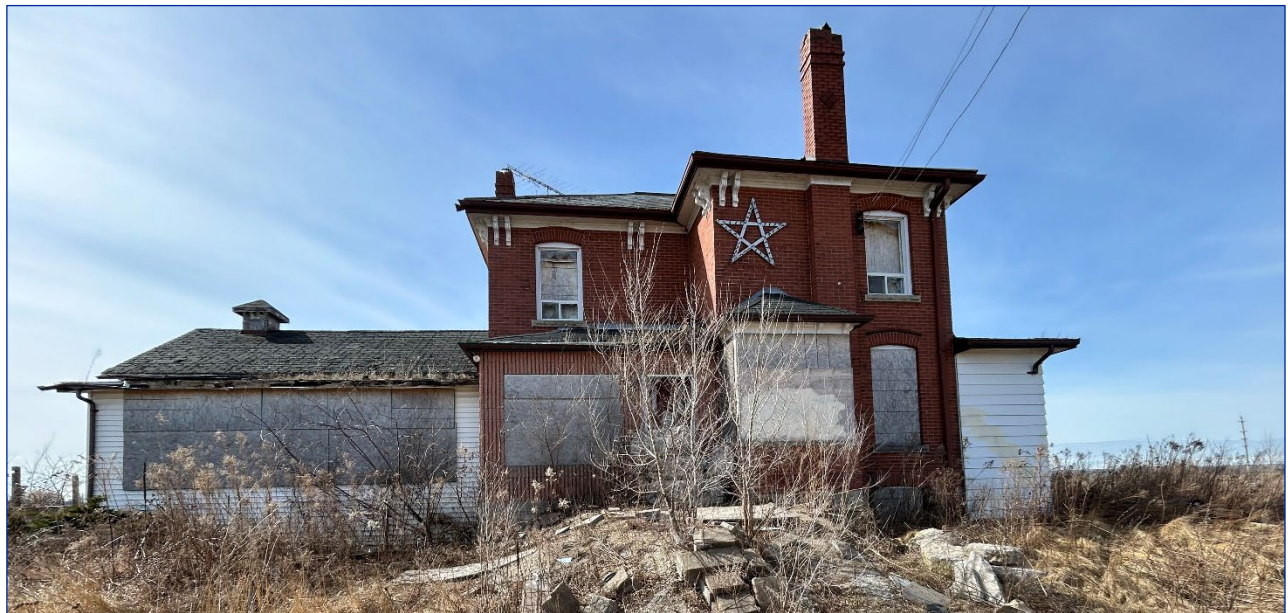
Photo 2: View of the north elevation

Two entrances provide access to the building. The main entrance is located on the west side of the concrete-clad porch on the north elevation. It is a single flat-headed door with several panels – some of which are frosted diamond glass panels – and is covered up with stacked stones (Photo 2). The second entrance is located on the south elevation of the east addition. It is a single flat-headed door frame set into a segmental opening and surrounded by a covered porch. The covered porch is accessed by a wooden stair (Photo 4).

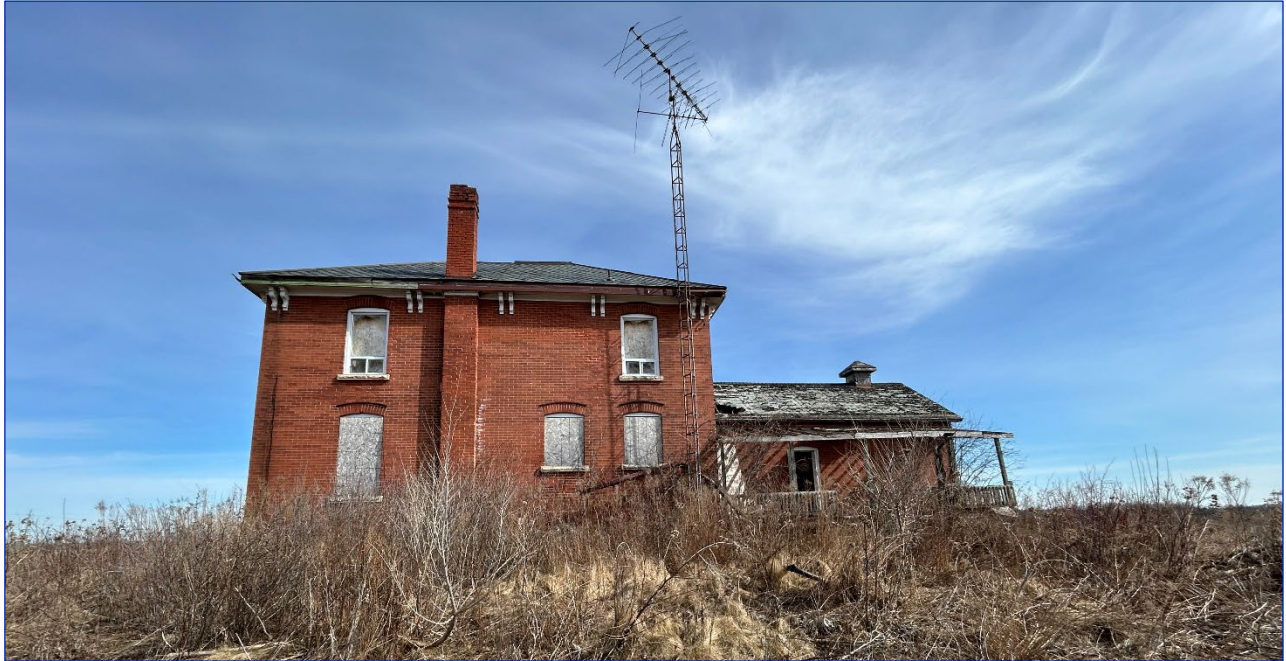
Photo 3: View of the south elevation

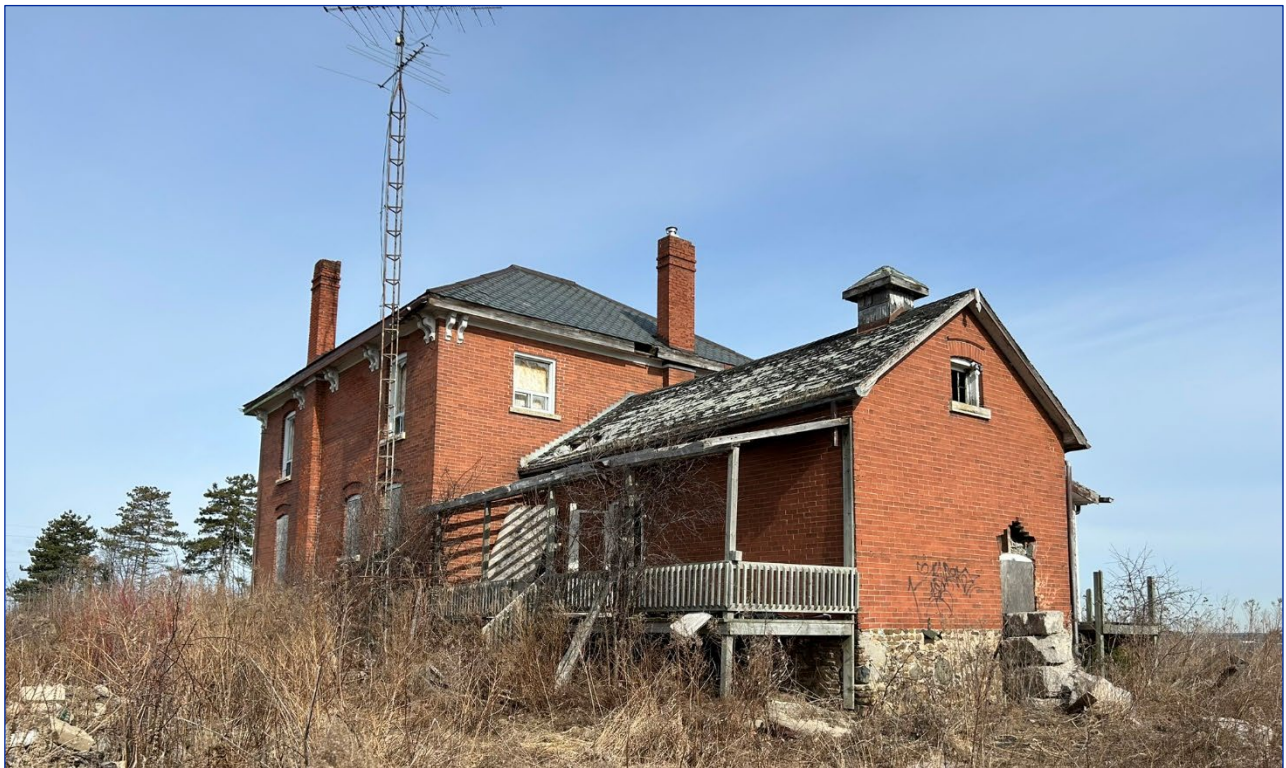
Photo 4: View of the south and east elevations

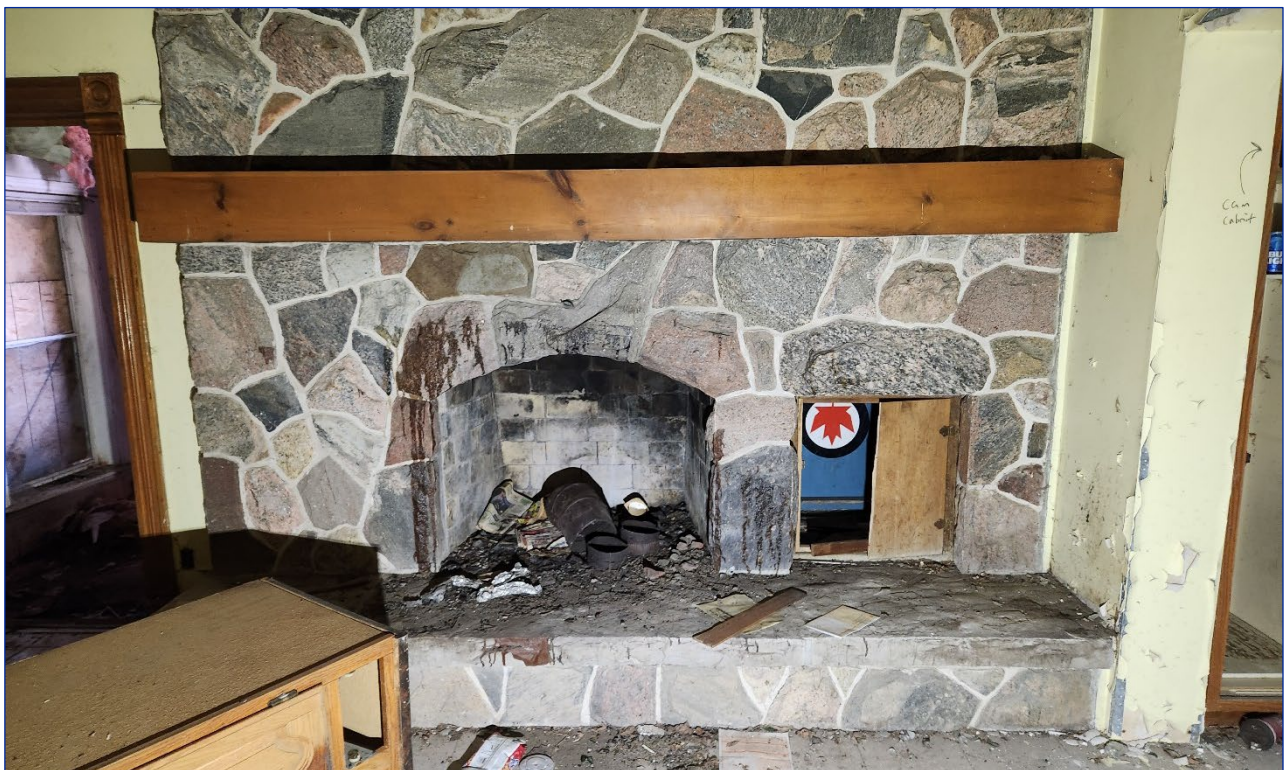
Photo 6: View of the fireplace

The residence is vacant, and the interior is deteriorating. Elements of the interior remain intact including the floor joists and a mid- to late 20th century stone fireplace with accompanying bread oven and wood mantle (Photo 5 and Photo 6).

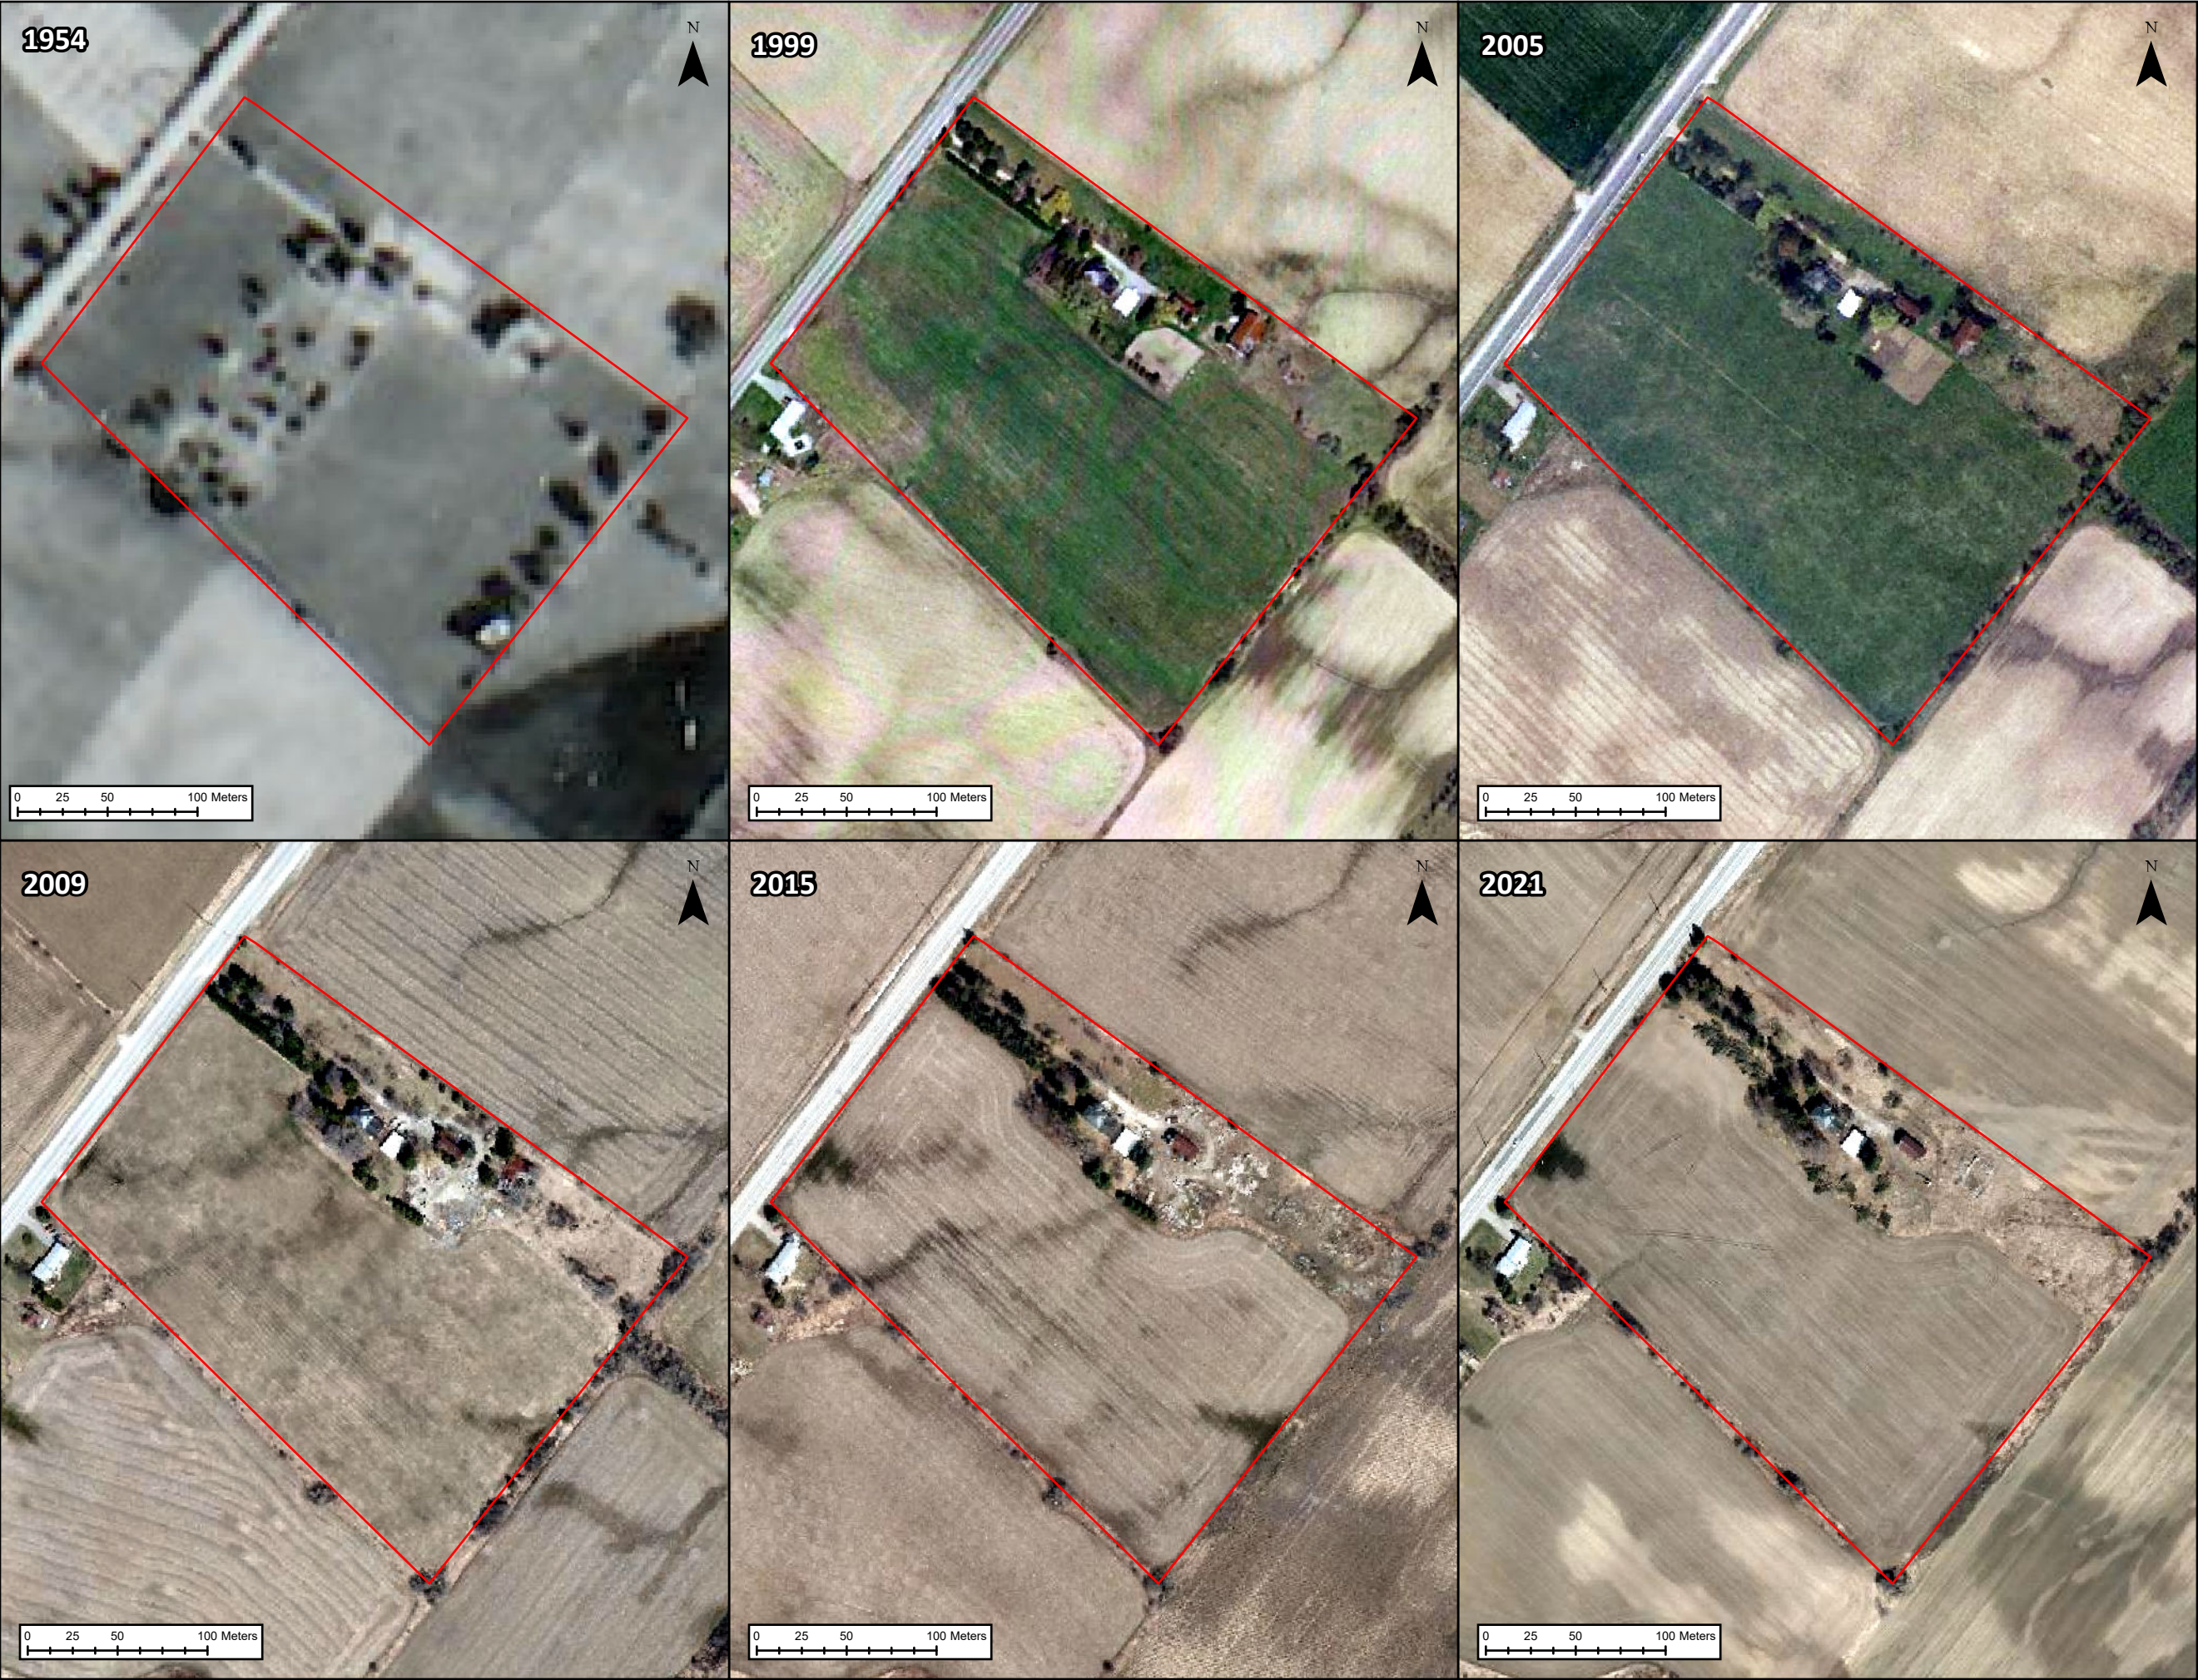
FIGURE # 5

TITLE
1954, 1999, 2005, 2009, 2015, and 2021 Aerial
Photographs Showing the Property

- The barn is depicted again in the 1994 topographic map and in the 1999 aerial image. Two other small accessory buildings are depicted in the 1999 aerial image between the house and the barn (Figure 4 and Figure 5);

- By 2005, the barn is starting to be removed in sections with the barn completely removed by 2015 (Figure 5).
- The other two detached accessory buildings were removed between 2021 and 2023.
