TECHNICAL MEMORANDUM

Re: Heritage Screening, 13552 10 Side Road, Halton Hills, Ontario

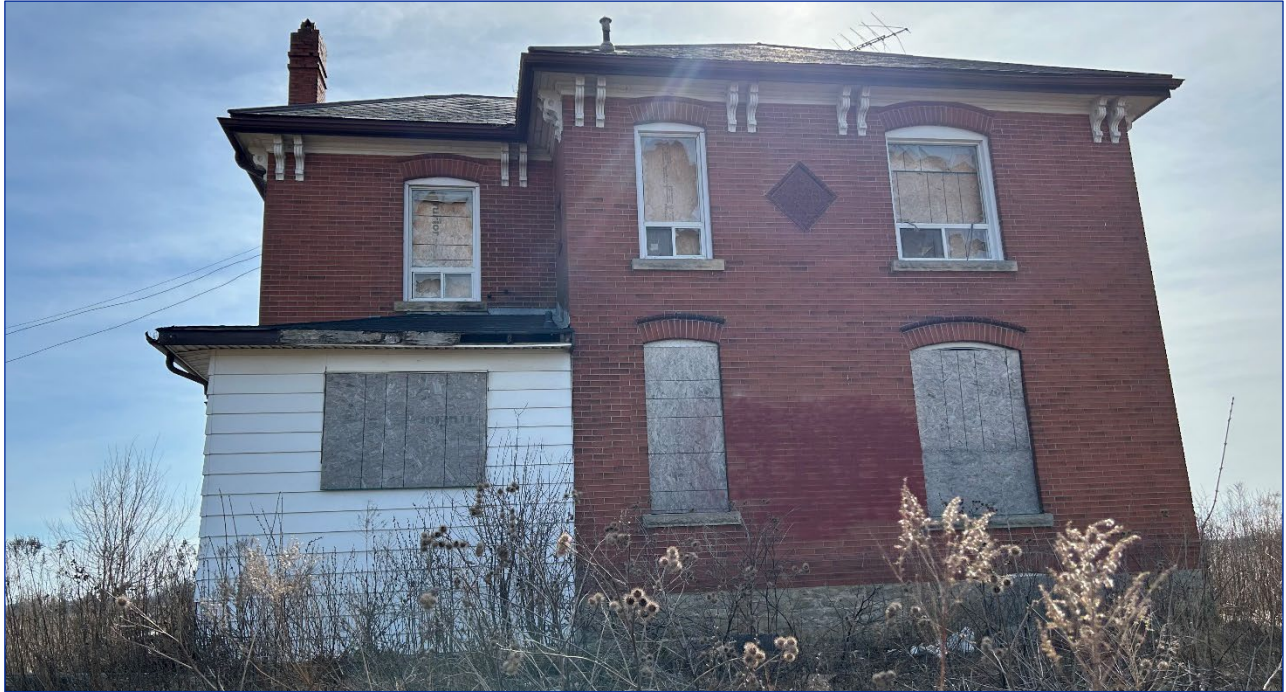
Photo 1: View of the facade

The residence is a single detached, rectangular plan building with a projecting bay on the west side of the north elevation and a brick rectangular addition on the east elevation. Several porches have been enclosed, including a small concrete-clad porch on the north elevation, two small aluminum siding clad porches on the north elevation, and a vinyl siding clad porch on the north elevation of the east addition. The residence is two-storeys in height and has a full below grade basement. Both the main residence and east addition have a fieldstone foundation and red brick exterior cladding laid in stretcher bond. An integral wall decoration matching the other exterior elements is located on the facade. The main building has a truncated hip roof, overhanging eaves, and paired brackets while the east addition has a front facing gable roof with a small belvedere at the eastern end. The enclosed porch along the northern elevation has a shed roof. The other porches have hip roofs. Single flue brick chimneys with projecting string courses are found on the north, south, and east elevations of the main building (Photo 1 to Photo 4).

Windows on the main building typically have a segmentally arched opening with a brick voussoir and projecting string course, and a cut stone lug sill. Most windows are boarded up; however, those that are visible are one fixed window over a two part sliding window. A flat-headed window with a single fixed pane at the top and a two part sliding pane at the bottom and a concrete lug sill is found offset to the south side of the second storey on the east elevation. The east elevation of the east addition has a flat-headed window fit into a segmental window opening with a cut stone lug sill and a brick voussoir. Windows on the enclosed porches are boarded up but appear to be generally flat-headed in a variety of sizes (Photo 1 to Photo 4).

The main building displays elements of the Italianate architectural style through its paired eave brackets; tall, narrow segmentally arched windows; wide overhanging eaves; square/L-shaped plan; low hipped roof; two storeys; and belvedere on the east addition. However, these elements seem to be gradual additions or modifications that are lacking the overall cohesion and design typical of the Italianate architectural style. This is especially evident in the irregular spacing of the paired brackets, the larger windows on the south side of the façade, and the frieze cut out to accommodate the brick voussoirs over the second storey windows (Photo 1 to Photo 4).

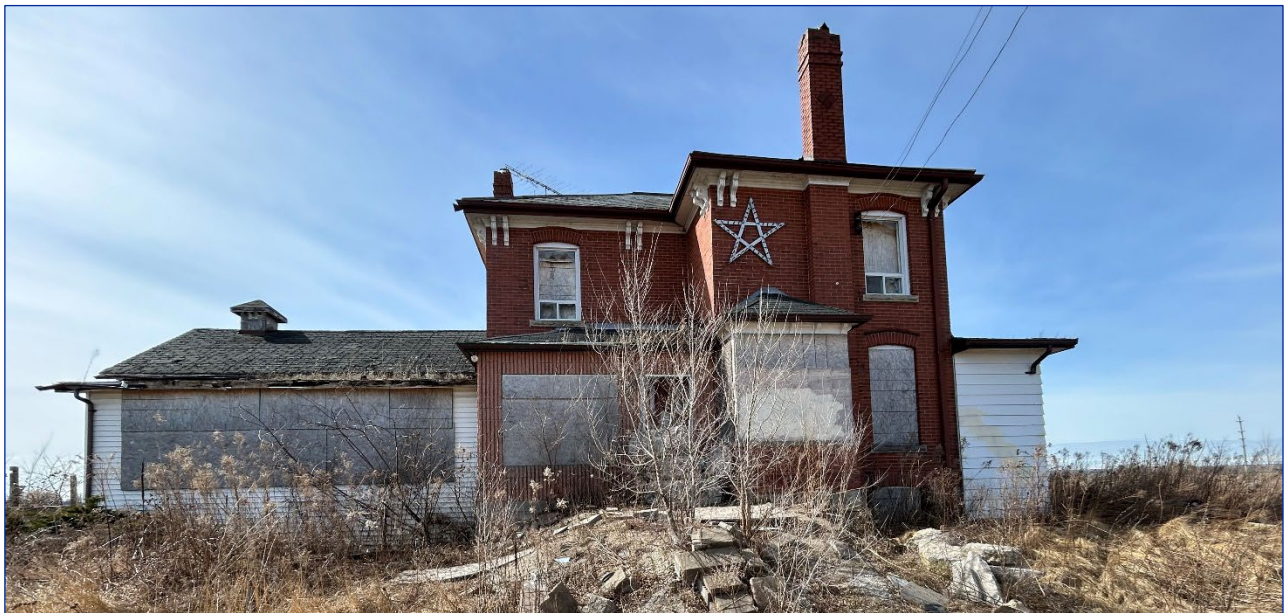
Photo 2: View of the north elevation

Two entrances provide access to the building. The main entrance is located on the west side of the concrete-clad porch on the north elevation. It is a single flat-headed door with several panels – some of which are frosted diamond glass panels – and is covered up with stacked stones (Photo 2). The second entrance is located on the south elevation of the east addition. It is a single flat-headed door frame set into a segmental opening and surrounded by a covered porch. The covered porch is accessed by a wooden stair (Photo 4).

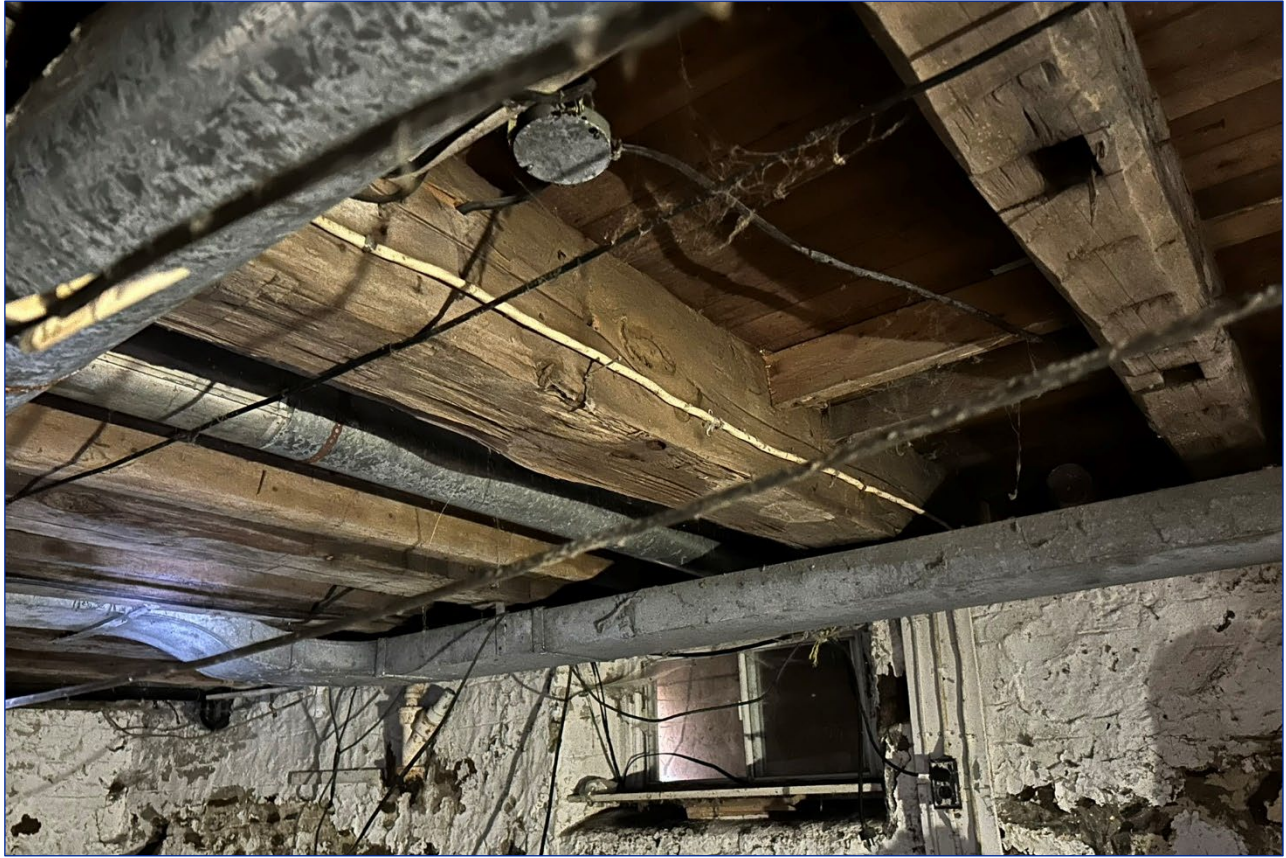
Photo 5: View of the floor timbers

The residence is vacant, and the interior is deteriorating. Elements of the interior remain intact including the floor joists and a mid- to late 20th century stone fireplace with accompanying bread oven and wood mantle (Photo 5 and Photo 6).

The material difference in the existing house and the house indicated in the 1861 census suggests that either the frame house was replaced with the existing house, the frame house was in a different location on the Property, or materials from the frame house were reused for the new house. Mapping supports all three options (Figure 3 and Figure 4); however, the floor joists suggest that the materials of the first house were reused in the second (Photo 5).

The Property is currently vacant and plans for redevelopment have not been proposed. In this preliminary review, LHC found that the Property meets one of the nine criteria of *O. Reg. 9/06* and some additional research is required to confirm its historical or associative value. Should demolition of the house on the Property be allowed, it is recommended that an inventory of potentially salvageable materials should be compiled, and materials of the house be salvaged - if possible - as an environmental and sustainability measure.

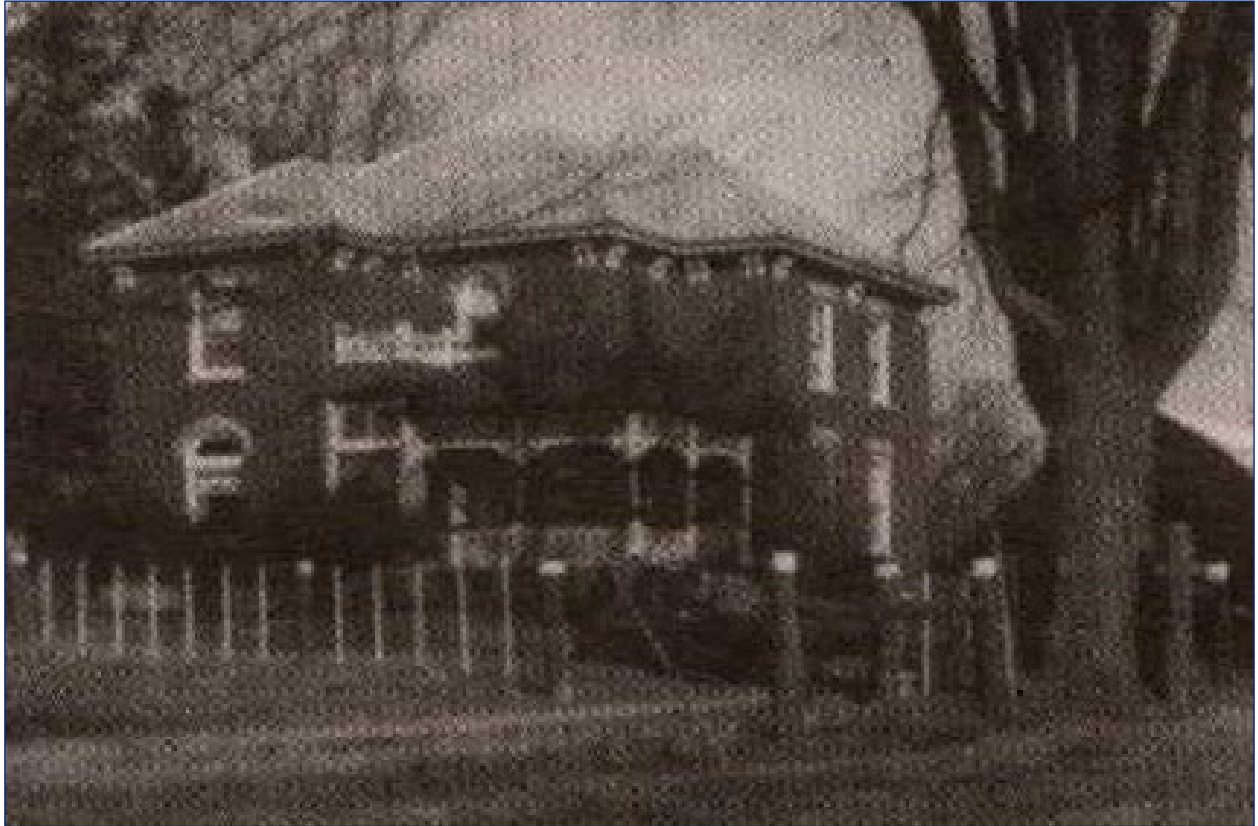
Photo 7: Image of the Wilson family farmhouse on the adjacent 100 acres in 1963

A Halton newspaper article includes an image of a house from 1963 that is attributed as the Wilson family homestead (Photo 7). It has many similar elements to the existing house; however, it is different in many ways including orientation, layout, and massing. The 1887 map indicates that the adjacent (southwest) 100 acres of Lot 10 Concession 8 was owned by Margaret Wilson until her death in 1895 (Figure 3).²⁶ The 100 acres then passed to John Wilson.²⁷ Given that the house on the Property is smaller in scale than the house pictured in 1963 and the house indicated in the 1891 census, it is believed that the 1963 house is the house on the adjacent 100 acres (Figure 6). Aerial imagery shows the Wilson homestead depicted in the 1963 photo on the adjacent 100 acres (Figure 7). The Wilson family homestead was removed some time after 1999.

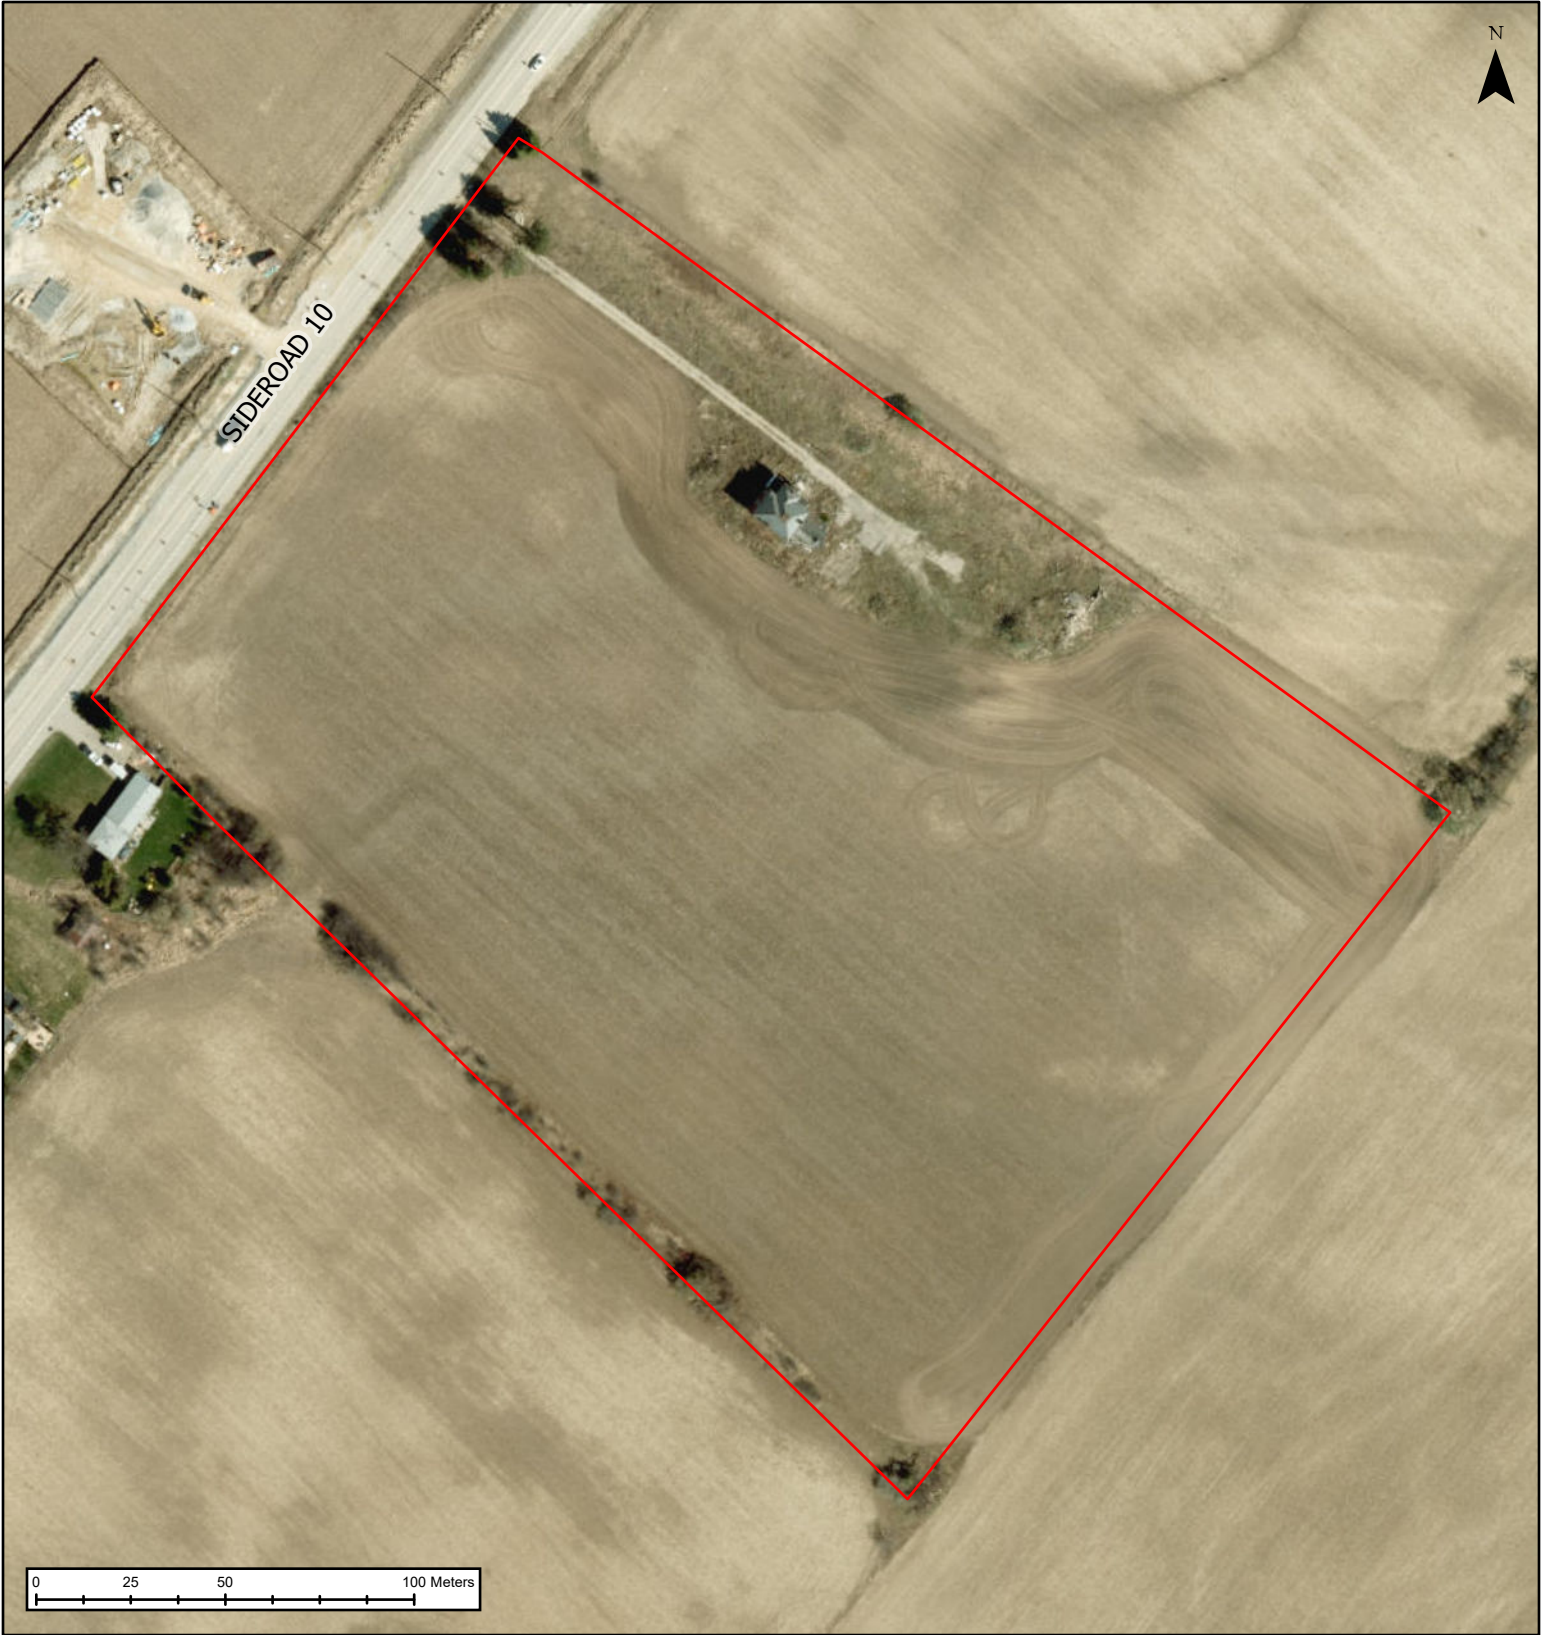
YYYY-MM-DD	4/3/2024
	FIGURE #	2

The Property is located at 13552 10 Side Road in the Town of Halton Hills, Ontario (Figure 1). The Property is on the south side of 10 Side Road between Trafalgar Road and Eighth Line. It is approximately 6.25 hectares (ha) in size and is generally rectangular in shape. The Property is bound by 10 Side Road to the north and agricultural and residential land to the south, east, and west. There is currently one structure on the Property: a two-storey brick residence with a one storey brick addition – known as the John Wilson House (Figure 2).

TITLE Current Conditions of the Property		
CLIENT 1620076 Ontario Limited		
PROJECT Heritage Screening, 13552 10 Side Road, Halton Hills, Ontario		PROJECT NO. LHC0427

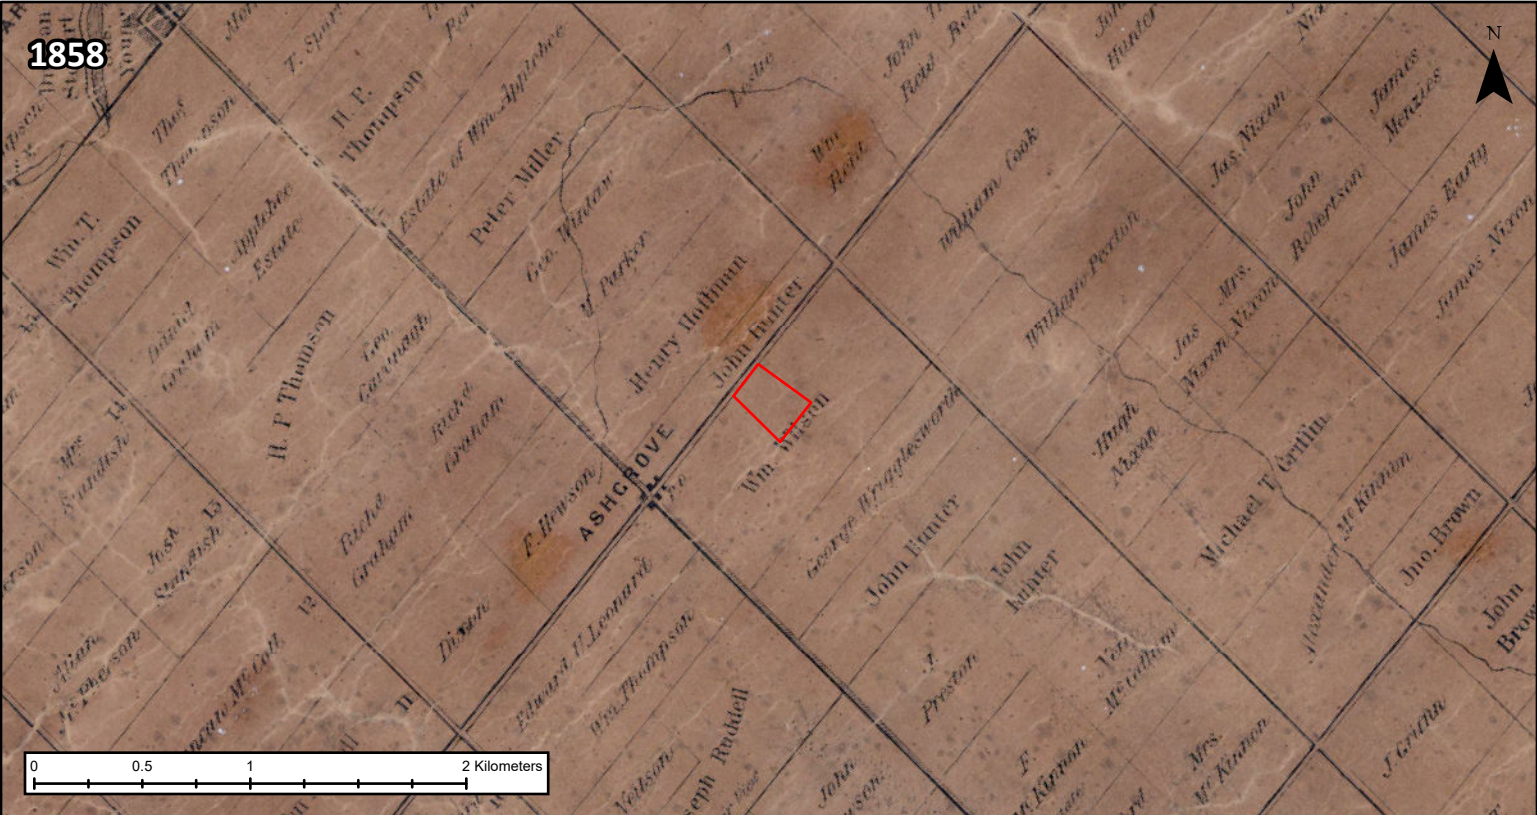
YYYY-MM-DD	4/3/2024
	FIGURE #	3

- The 1858 historic map does not indicate buildings, only names. William Wilson's name is indicated on this lot (Figure 3);

- The 1887 historic map indicates John Wilson on the northwest portion of the lot (this Property). A house and either orchards or farmlands are depicted. The adjacent southeast portion of the lot indicates Margaret Wilson along with another house and farmlands – the house depicted in Photo 7 (Figure 3);

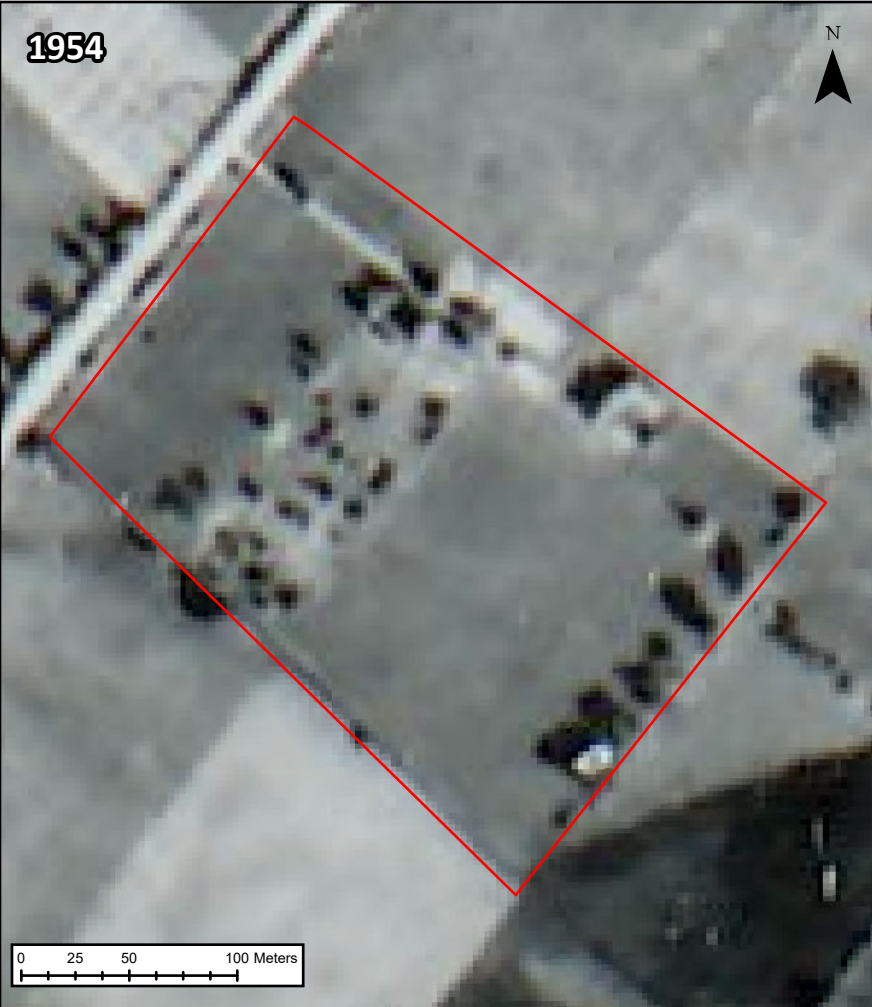
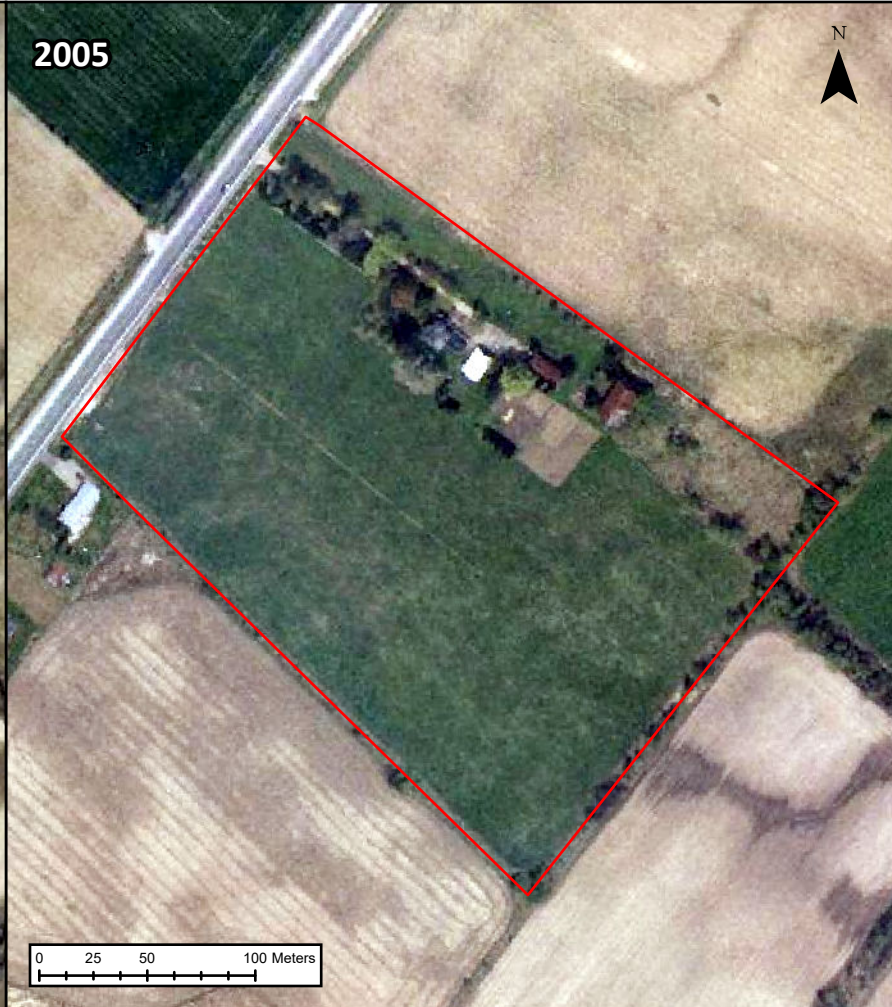
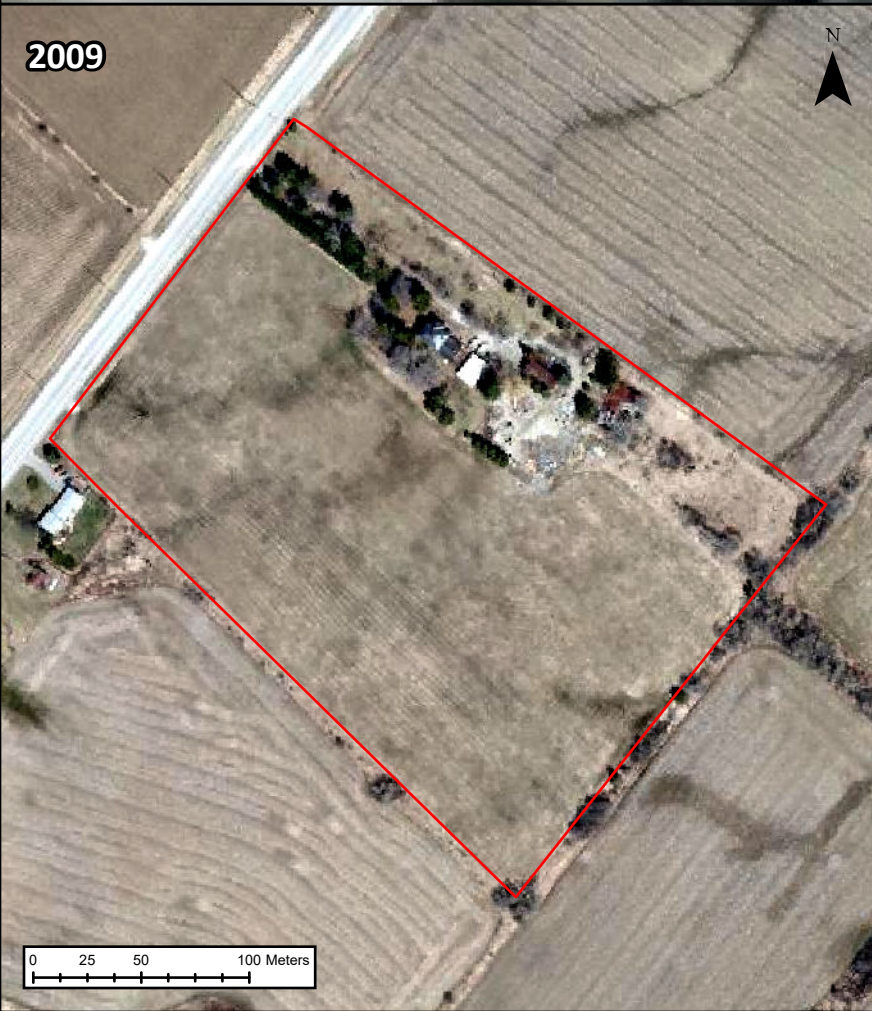
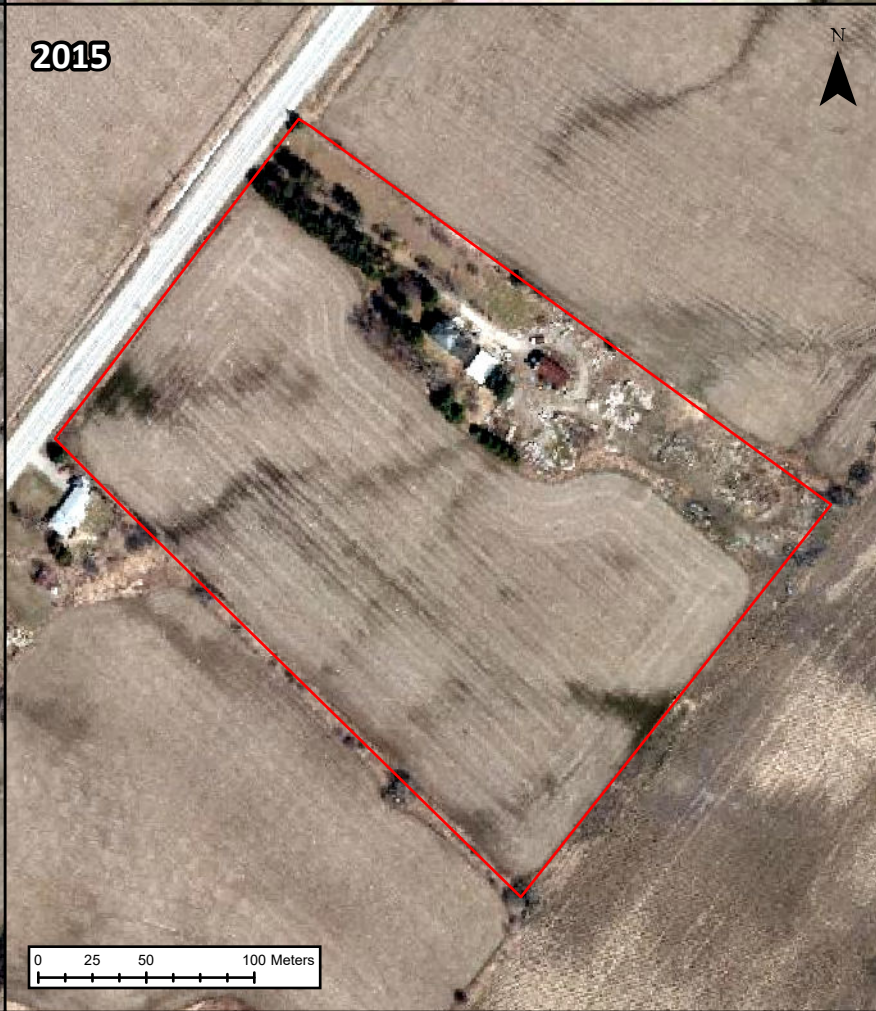
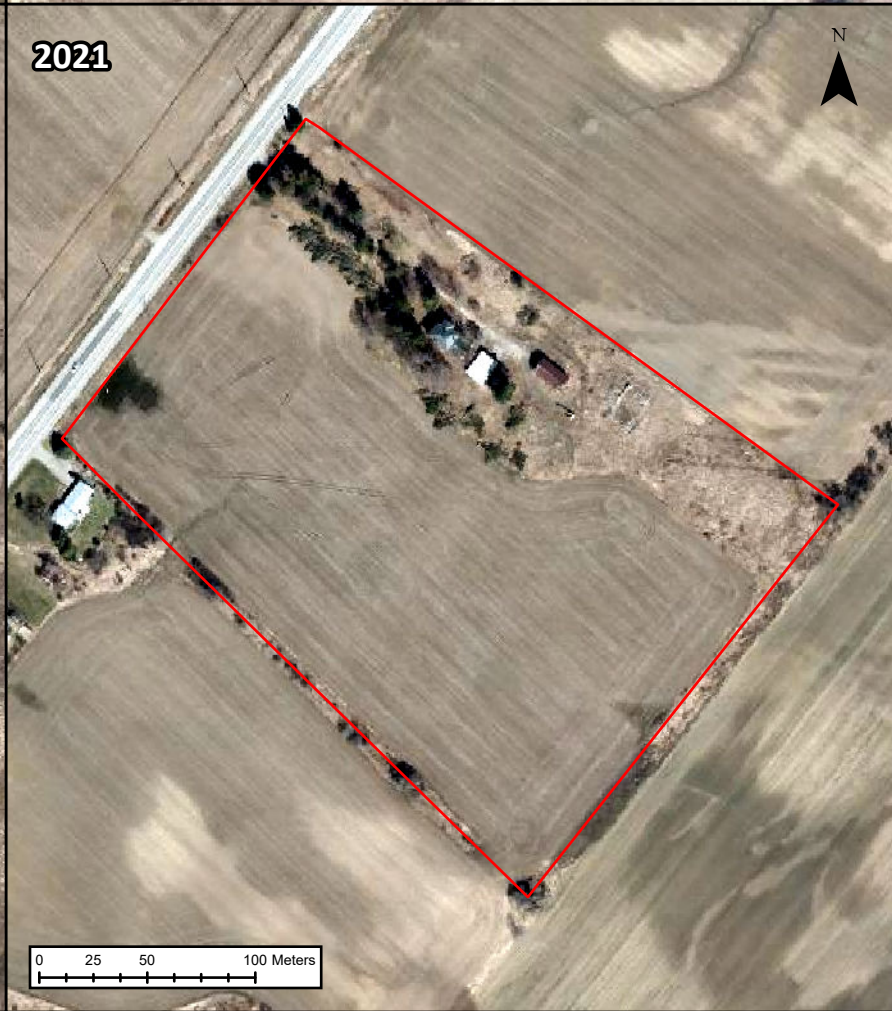
YYYY-MM-DD 4/3/2024
FIGURE #	5

- The barn is depicted again in the 1994 topographic map and in the 1999 aerial image. Two other small accessory buildings are depicted in the 1999 aerial image between the house and the barn (Figure 4 and Figure 5);

- By 2005, the barn is starting to be removed in sections with the barn completely removed by 2015 (Figure 5).
- The other two detached accessory buildings were removed between 2021 and 2023.

TITLE 1954, 1999, 2005, 2009, 2015, and 2021 Aerial Photographs Showing the Property	
CLIENT 1620076 Ontario Limited	
PROJECT Heritage Screening, 13552 10 Side Road, Halton Hills, Ontario	PROJECT NO. LHC0427
Legend <div><div></div>Property</div>	
NOTE(S) 1. All locations are approximate.	
REFERENCE(S) 1. University of Toronto, "1954 Air Photos of Southern Ontario, 435.794", (https://mdl.library.utoronto.ca/collections/air-photos/1954-air-photos-southern-ontario/index , accessed 28 March, 2024), 1954. 2. Town of Halton Hills, "Historic Ortho, Orth 1999", (https://map.haltonhills.ca/HT5/Index.html?viewer=p.HT5 , accessed 28 March, 2024), 1999. 3. Town of Halton Hills, "Historic Ortho, Orth 2005", (https://map.haltonhills.ca/HT5/Index.html?viewer=p.HT5 , accessed 28 March, 2024), 2005. 4. Town of Halton Hills, "Historic Ortho, Orth 2009", (https://map.haltonhills.ca/HT5/Index.html?viewer=p.HT5 , accessed 28 March, 2024), 2009. 5. Town of Halton Hills, "Historic Ortho, Orth 2015", (https://map.haltonhills.ca/HT5/Index.html?viewer=p.HT5 , accessed 28 March, 2024), 2015. 6. Town of Halton Hills, "Historic Ortho, Orth 2021", (https://map.haltonhills.ca/HT5/Index.html?viewer=p.HT5 , accessed 28 March, 2024), 2021. Portions of this document include intellectual property of Esri and its licensors and are used under license. Copyright (c) Esri and its licensors. All rights reserved.

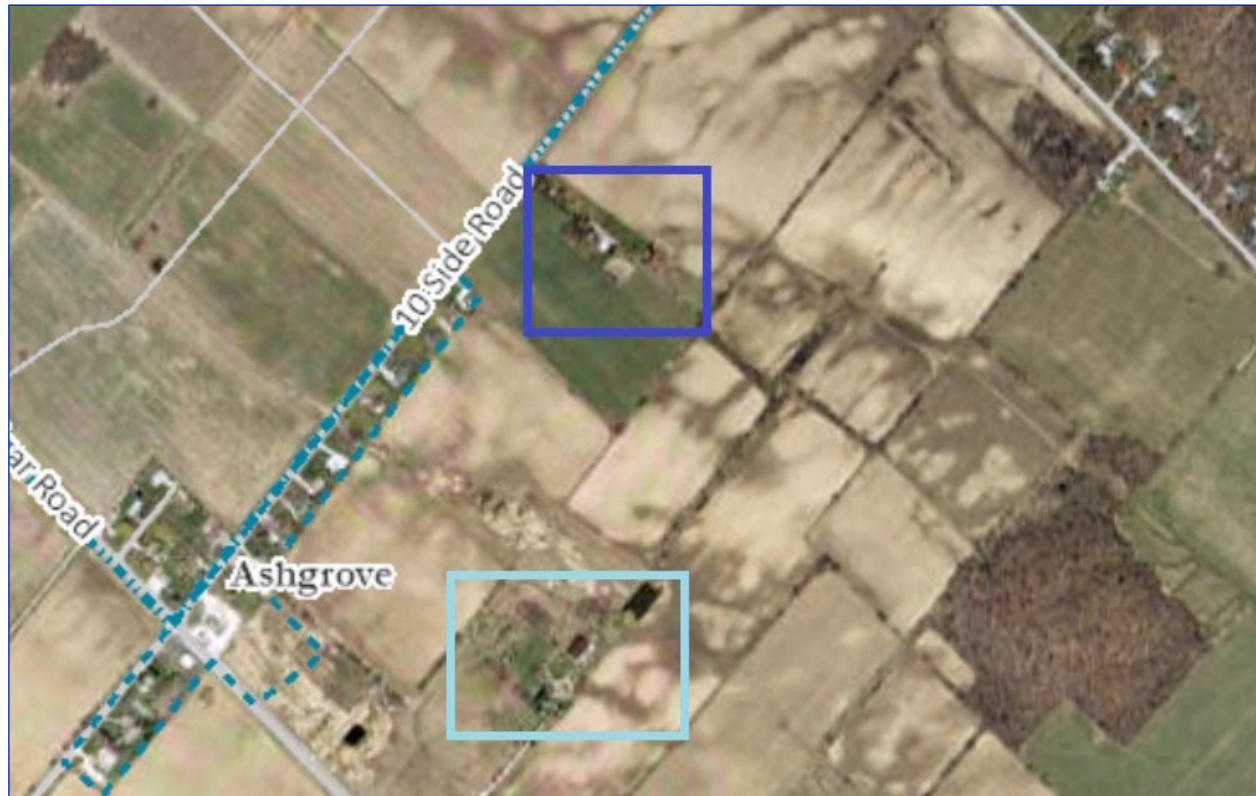
Figure 6: Relation of the Property in relation to the Wilson homestead in 1999

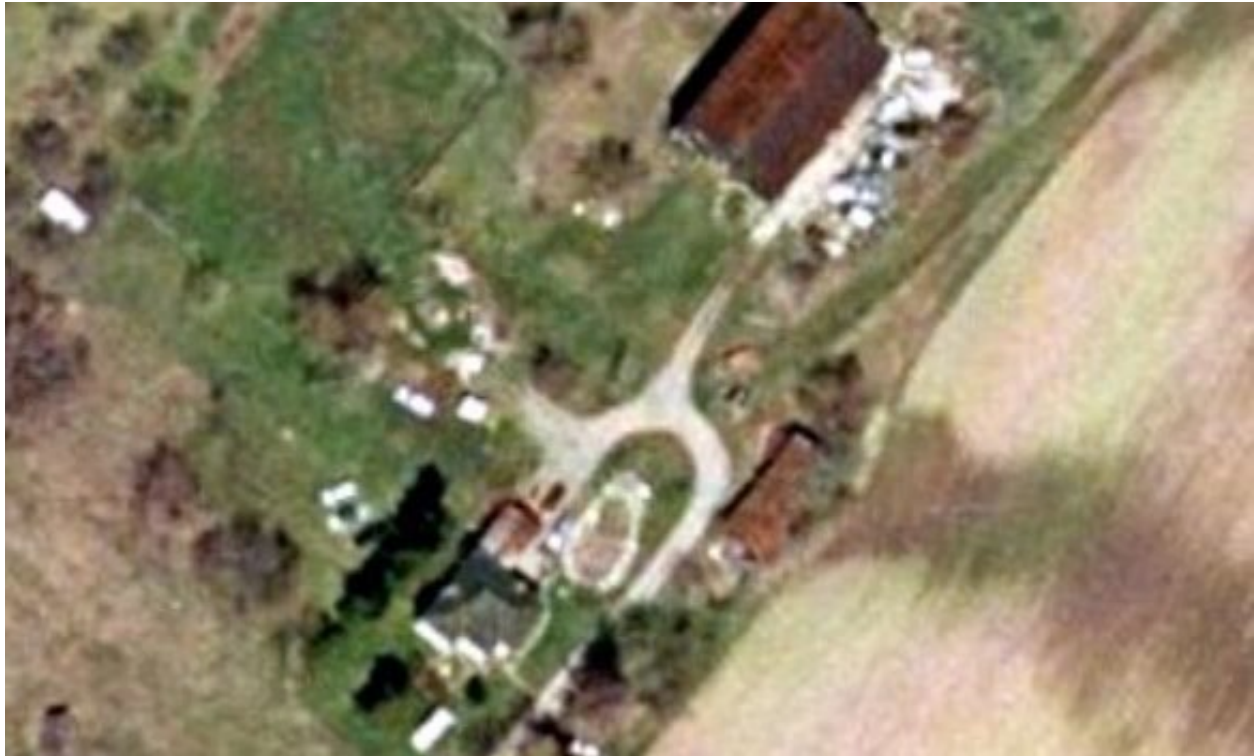
Figure 7: Close-up of the Wilson homestead in 1999
