# Research and Evaluation Report

## **Ligny School House**

7593 5 Side Road, Scotch Block, Town of Halton Hills

August 2024

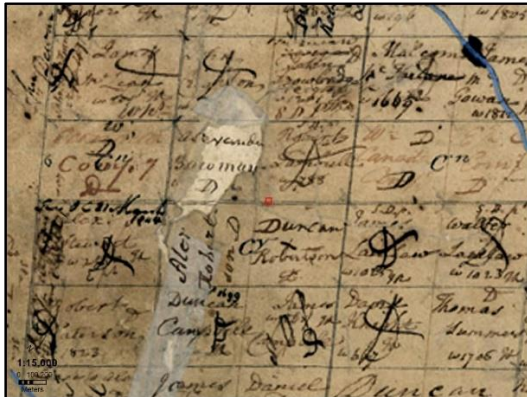
Figure 3: Subject property identified on the 1822 Patent Plan

In 1832, Robert Turnbull was granted 100 acres in Lot 6, Concession 2. The property was then sold to Alexander Duff in 1834 and was eventually willed to Thomas Duff in 1859. Shortly thereafter, the property was purchased by Thomas Aitken in 1863. By 1870, Thomas Chisholm oversaw ownership of the property. With the demand for a new location for the Ligny Schoolhouse, Thomas Chisholm sold 50 acres to the Trustees of S.S. No. 1 Log for £65 in 1874.

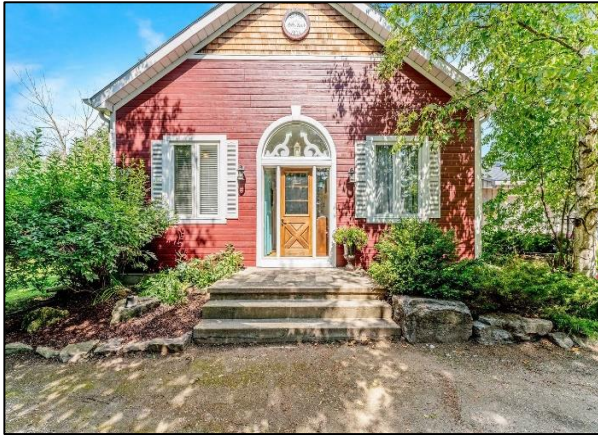
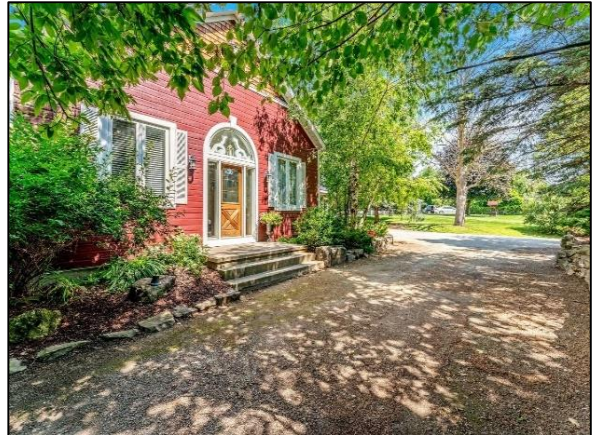
Figure 32: Front (southeast) elevation of the subject dwelling (HouseSigma 2021)

Figure 33: Front (southeast) elevation of the subject dwelling (HouseSigma 2021)

The front elevation features a symmetrical façade with two flatheaded window openings with vinyl window shutters on either side of the central entrance. The doorway features a semi-circular opening flanked by sidelights and a transom.

Along the second storey is a gable roof, with wooden shingles and a wooden date sign directly beneath the gable peak, which reads: “Ligny S.S. No.1 1874”. Directly above the roofline is a belfry, with a bell remaining.

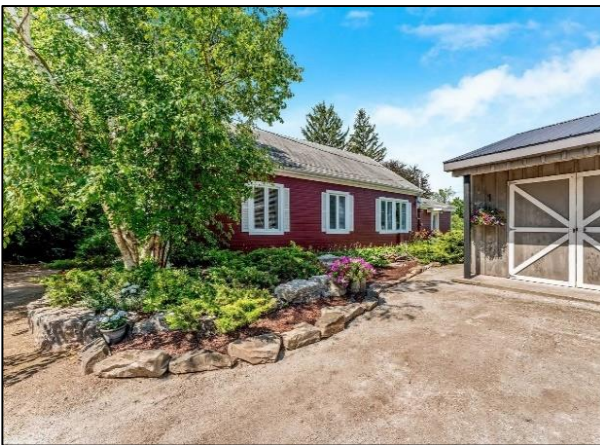
Figure 38: Side (northeast) elevation of the subject dwelling (HouseSigma 2021)

On the side (northeast) elevation are three flatheaded window openings. Adjacent to this elevation is a contemporary detached one-storey accessory structure. On the other side (southwest) elevation are three flatheaded window openings, along with a semi-circular window opening. Additionally, the side (southwest) elevation features an entrance to a storm cellar.

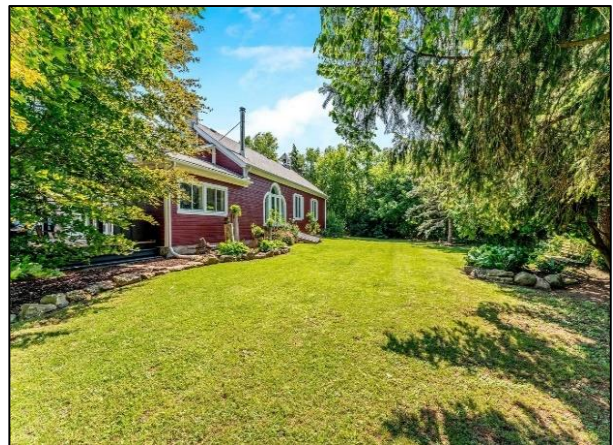
Figure 39: Side (southeast) elevation of the subject dwelling (HouseSigma 2021)

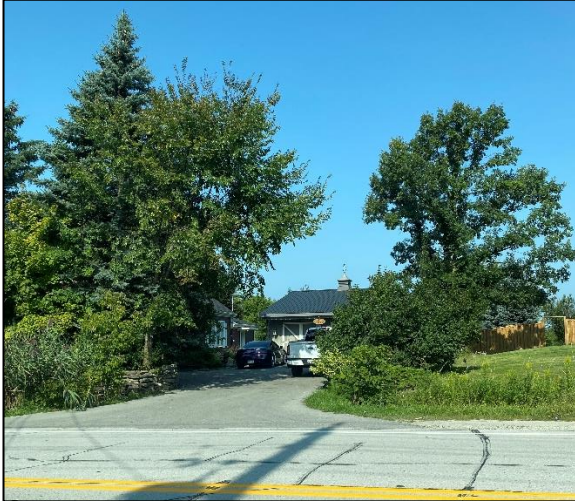
Figure 40: Partial side (northeast) elevation of the subject dwelling (Town of Halton Hills 2024)

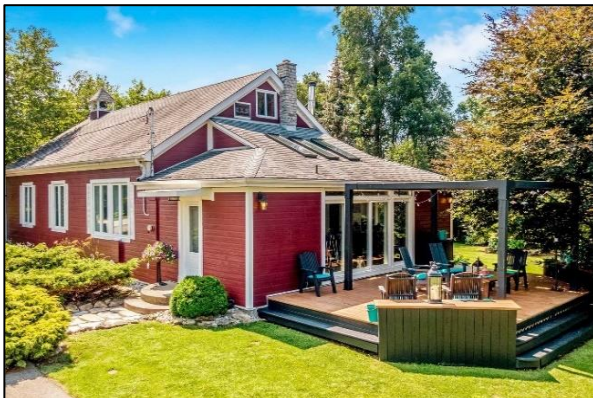
Towards the rear elevation is a contemporary one-storey addition with a flat-headed entryway containing a sliding door, flanked by two floor-to-ceiling windows, and transoms. Along the side (northeast) elevation of the addition is a flatheaded entryway. Above the addition roof peak is a stone chimney.

Figure 42: Partial rear (northwest) elevation of the subject dwelling (HouseSigma 2021)

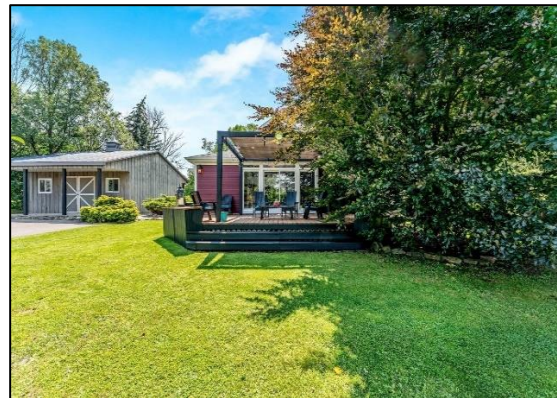
Figure 43: Rear elevation of the subject dwelling (HouseSigma 2021)

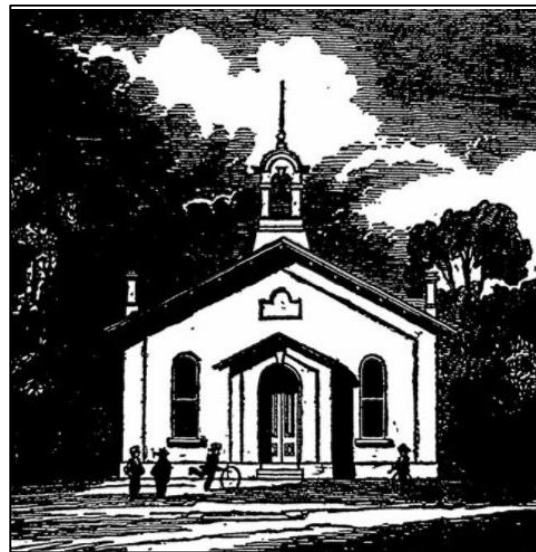
Figure 47: Prospective one-room schoolhouse design (*The School House, Its Architecture, External and Internal Arrangements*, p. 44)

Each rural schoolhouse design featured a gable roof, semi-circular window openings, a central semi-circular door opening with transom, date stone, as well as a belfry and bell directly above the gable peak. Materials recommended included brick, frame, and stone. The one-room schoolhouse was designed for sixty-four pupils and was intended to accommodate a small rural village or hamlet.

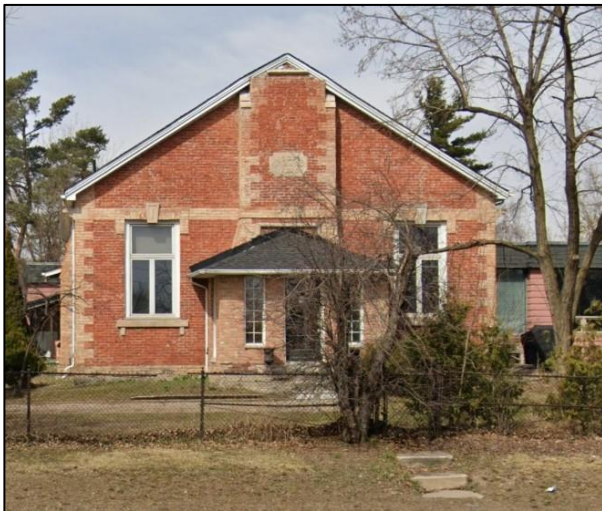
Figure 48: Former Hornby School along Steeles Avenue (Google Streetview, 2021)

Similar examples of the one-room schoolhouse exist in the Region of Halton, including the former Hornby School in Halton Hills (Figure 49) and Pinegrove School in Milton (Figure 50). Both Hornby and Pinegrove Schools were closed concurrently with Ligny School in 1962, following the opening of Pineview School. Hornby School features a symmetrical dichromatic brick façade with two window openings, one-and-a-half storey massing, a gable roof, date stone, and a central entrance. Pinegrove School consists of

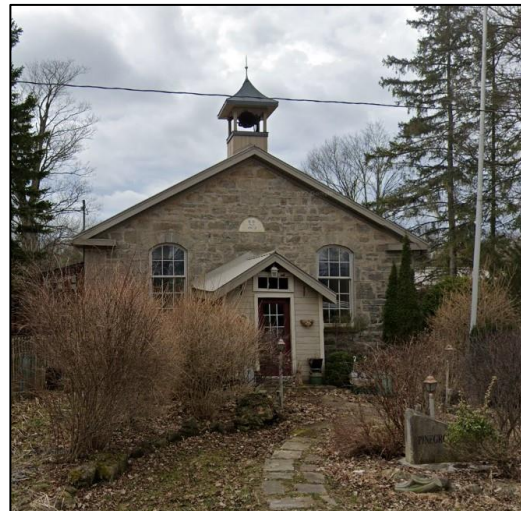
Figure 49: Former Pinegrove School located along Fifth Line (Google Streetview, 2022)

a more vernacular one-room schoolhouse design, with one-and-a-half storey massing, stone construction, two window openings with radiating voussoirs, a central entrance, a gable roof, date stone, along with a belfry and bell.
