Research and Evaluation Report

United Church Parsonage

29 Bower Street, Acton, Town of Halton Hills

May 2024

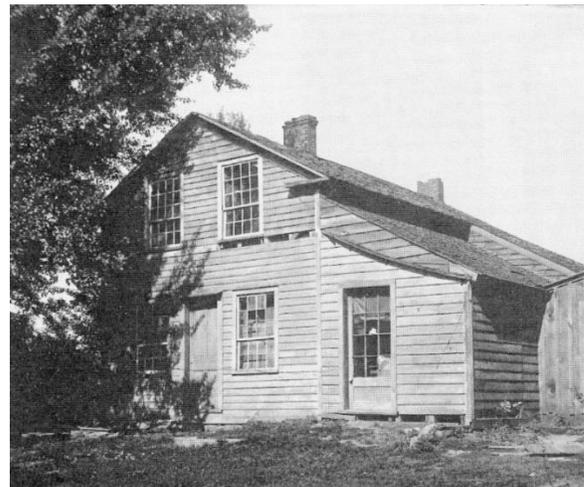
Figure 6: Frame farmhouse built c.1835 for Rufus Adams; the farm lane later became Bower Avenue. The house was demolished c.1900. (A.T. Brown/Dills Collection c.1899)

In 1829, Lot 28, Concession 3 was granted to the Canada Company. Three years later, Rufus Adams purchased the lot. The orchard lane within the property later became Bower Avenue. David Henderson purchased the old Adams farmhouse and surrounding property from Dr. Robert Morrow towards the end of the nineteenth century and created three properties from the land, including the subject property. Henderson divided the lands but kept 29 Bower Street for his own home.

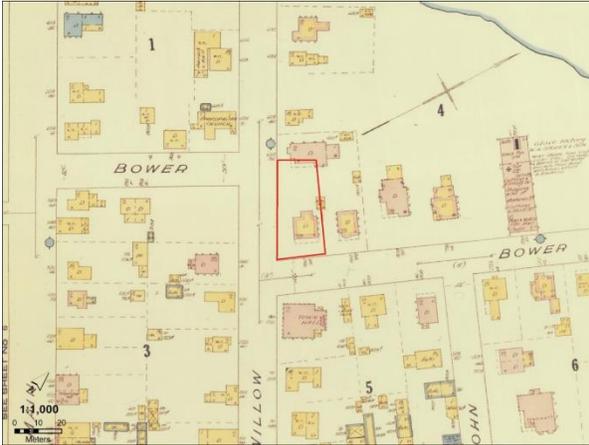
Figure 18: Subject property identified on the 1935 *Fire Insurance Plan of Acton* (detail)

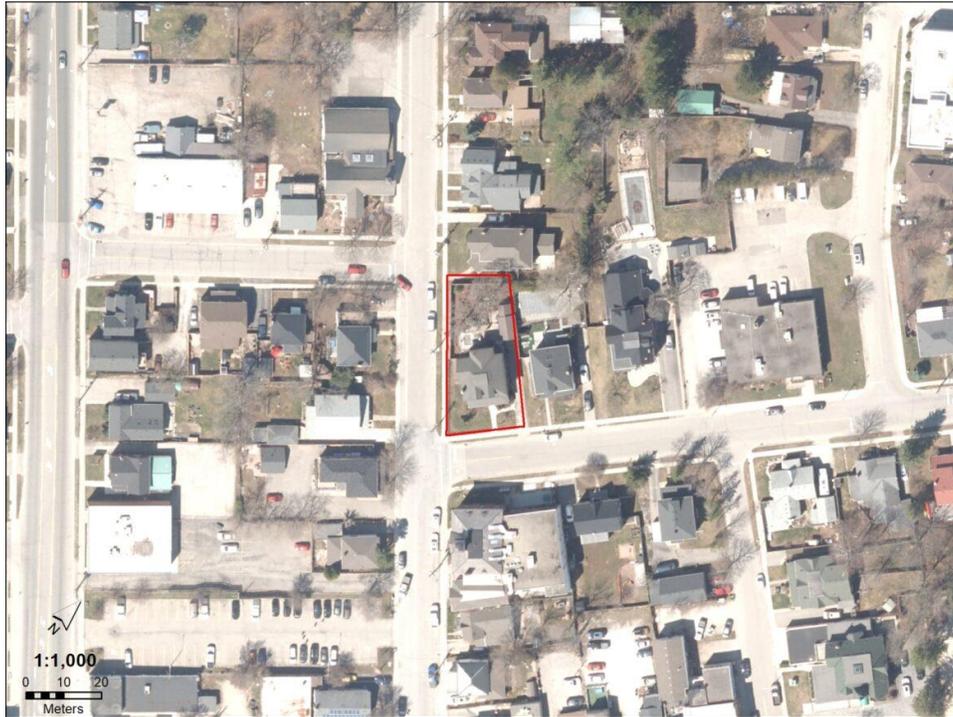
Figure 24: Subject property identified in 2023 aerial photography

The subject property is located along the north side of Bower Street in the community of Acton in the Town of Halton Hills. The existing residential building on the subject property is a two-and-a-half storey frame building with brick veneer, featuring a hipped roof with bracketed eaves and stone foundation.

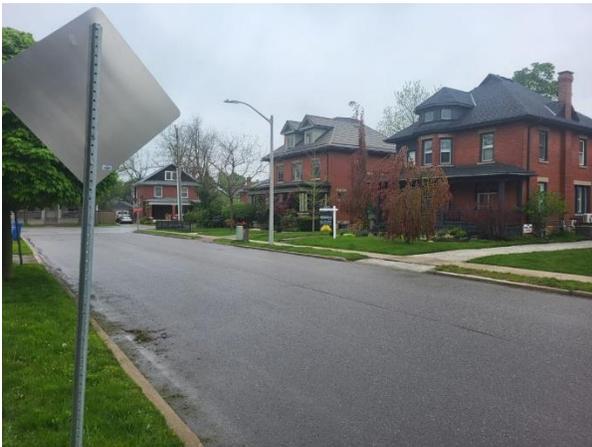
Figure 25: Looking towards the subject property along Bower Street (Town of Halton Hills 2024)

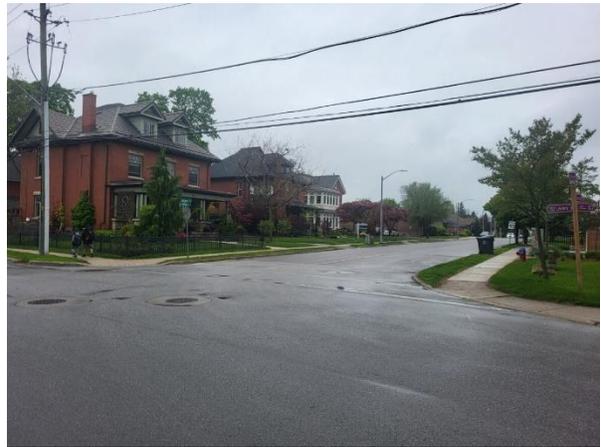
Figure 26: Looking along Bower Street, showing the existing two-and-a-half storey residential buildings at 29, 35, and 41 Bower Street (Town of Halton Hills 2024)

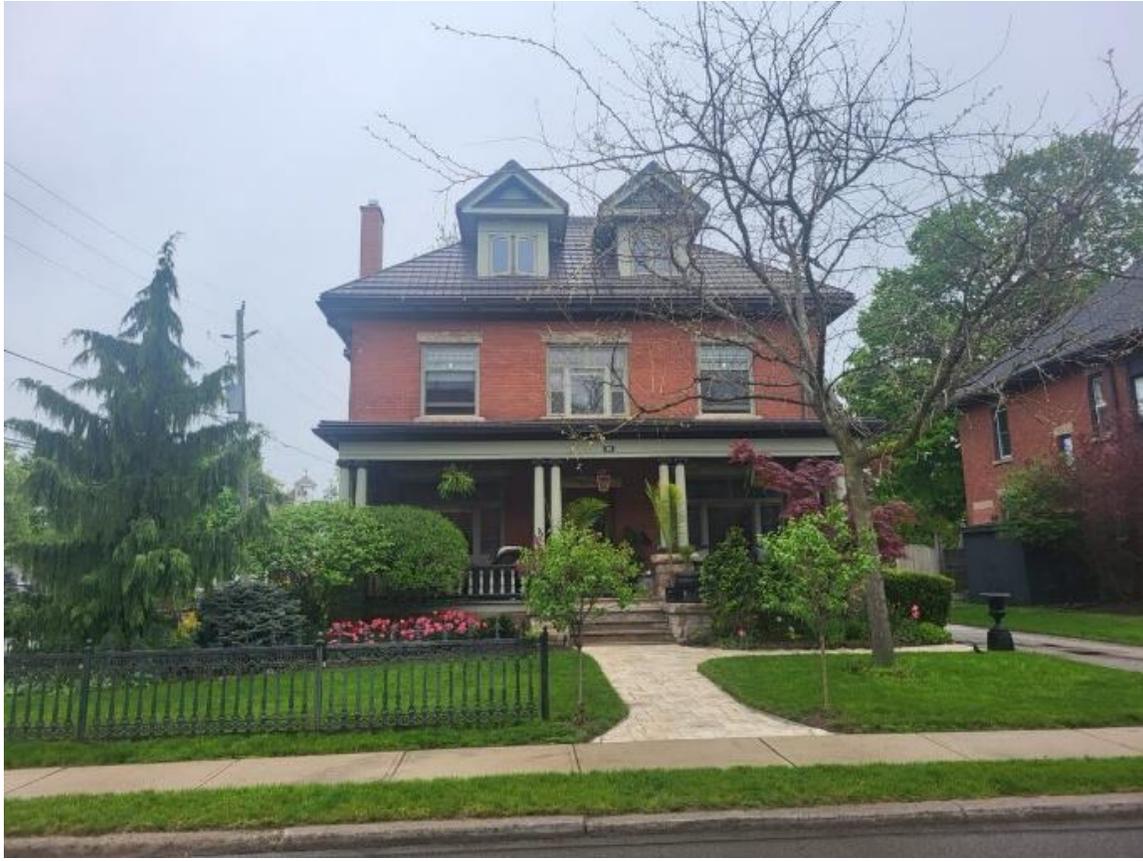
Figure 27: Looking towards the front elevation from Bower Street (Town of Halton Hills 2024)

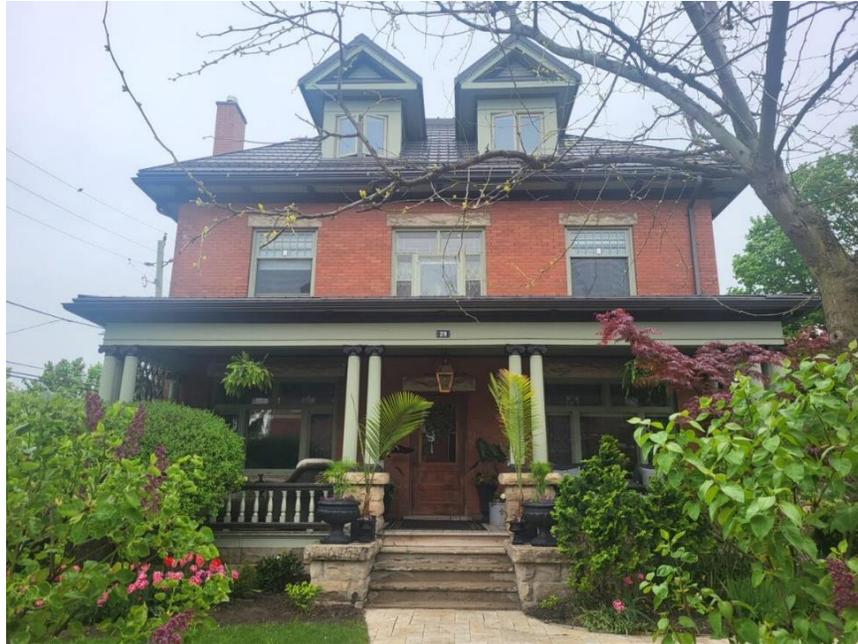
The front (southeast) elevation facing Bower Street features a symmetrical façade that is dominated by a covered wooden porch across the first storey. The porch is accessed via stone steps, however the porch floor is wooden. The stone piers support paired wooden Corinthian columns. The central entrance is located within a flatheaded opening with a heavy stone lintel above. On either side of the entrance at the first storey are two large window openings, featuring multiple divisions and leaded glass surrounding a large single pane, with stone lintels and sills. Three window openings are located above at the second storey. The central window features multi-divided lites and leaded windows on each side with a similar large single pane within. Smaller flatheaded window openings are located on either side of the central window and feature windows with multi-divided lites above a large single pane, both with stone lintels and sills. Two symmetrically placed gable-roofed dormers, featuring wooden architectural detailing and flatheaded window openings with casements are located in the roof above.

Figure 28: Front (southeast) elevation of the existing building at 29 Bower Street (Town of Halton Hills 2024)

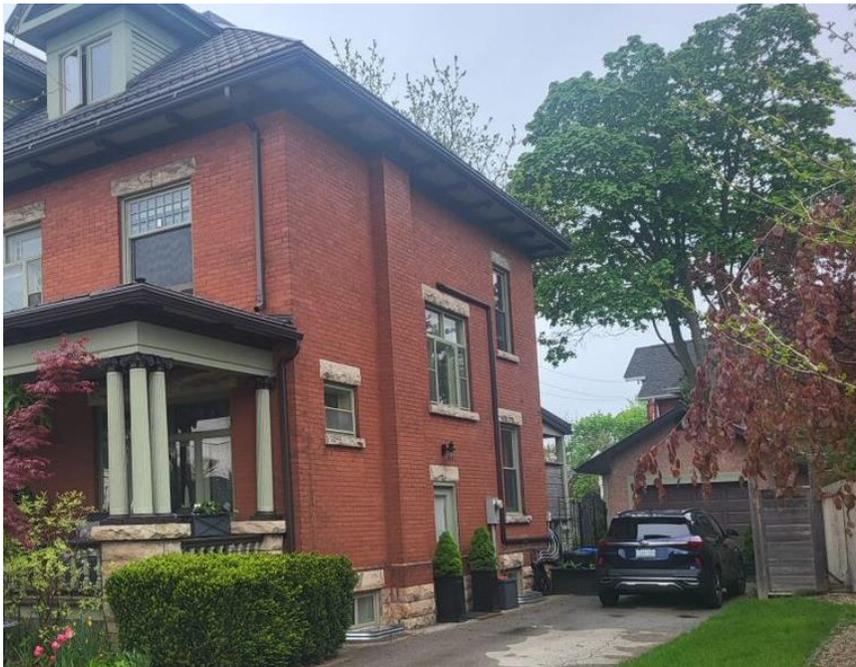
The side (northeast) elevation features a brick chimney that has been removed above the roofline. A single entrance with stone lintel is located at grade, with two flat-headed windows with stone lintels at the basement level within the stone foundation. This elevation features four flatheaded window openings of various sizes, with a smaller window towards the front elevation, two flatheaded windows in line with one another towards the rear elevation, and a larger window opening featuring a similar pattern to the central window on the front elevation, all with stone sills and lintels.

Figure 29: Side (northeast) elevation of the existing building at 29 Bower Street (Town of Halton Hills 2024)

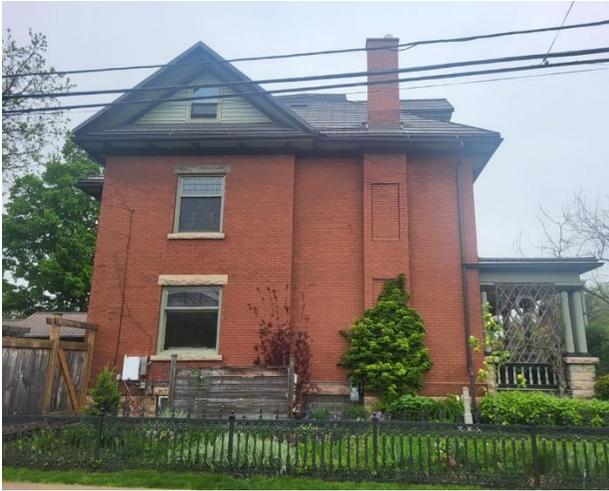
The side (southwest) elevation features another brick chimney, which is extant above the roofline, and which features detailing in the form of recessed panels along its height. The elevation features a slight projection beneath a gable which includes a small flatheaded window opening and siding. The first storey features a large flatheaded window opening with leaded glass transom and large single pane below, while the second storey features a smaller window opening with stone sill and lintel and a hung window with multi-divided lights above and a single pane below. Towards the rear of this elevation is a two-storey projection featuring smaller window openings with stone sills and lintels on the southwest side as well as on the rear elevation.

Figure 30: Side (southwest) elevation of the existing building at 29 Bower Street (Town of Halton Hills 2024)

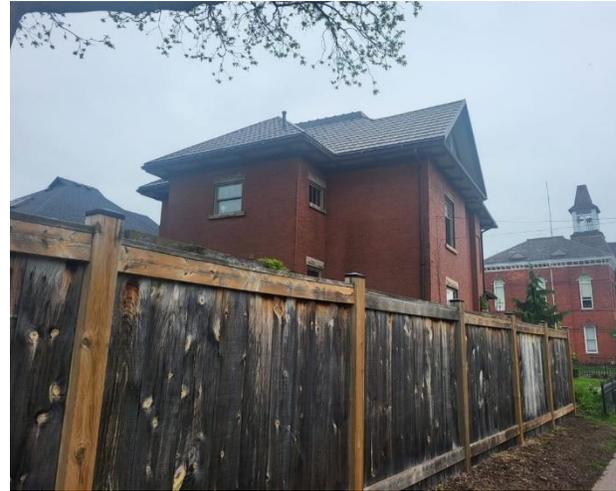
Figure 31: Rear (northwest) elevation of the existing building at 29 Bower Street (Town of Halton Hills 2024)
