Research and Evaluation Report

The Birches

75 Mill Street, Georgetown, Town of Halton Hills

August 2023

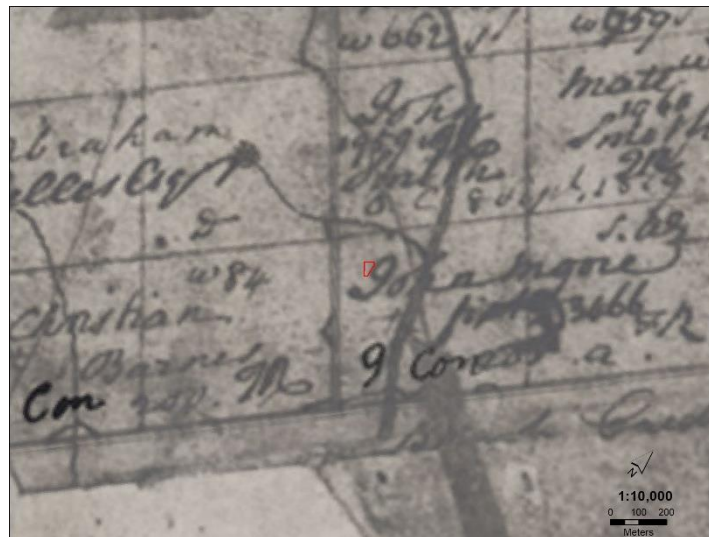
Figure 3: Excerpt from 1819 Patent Plan for Esquesing Township (Archives of Ontario RG 1-100-0-0-570)

Lot 18, Concession 9, Esquesing, which was designated as a mill seat, was granted by the Crown to John Moore in 1821 (Figure 3). In 1823, Moore sold the entire 200 acres to George Kennedy. Kennedy had also received a 100-acre grant (Lot 20) from the Crown for his service in the War of 1812, however he later sold it to his brother Morris and continued to subdivide and sell off lots.

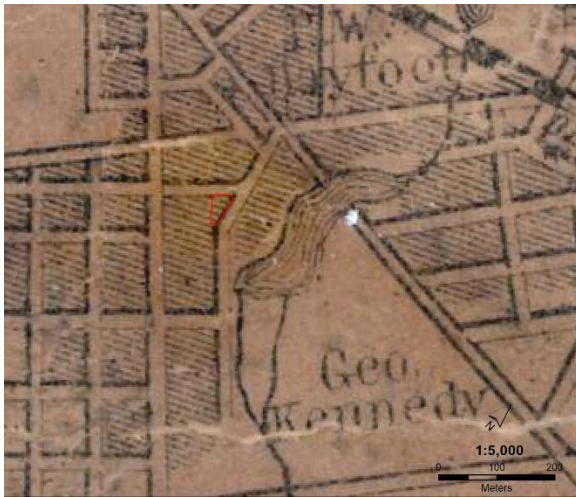
Figure 4: The subject property overlaid on 1858 *Tremain's Map of the County of Halton, Canada West*

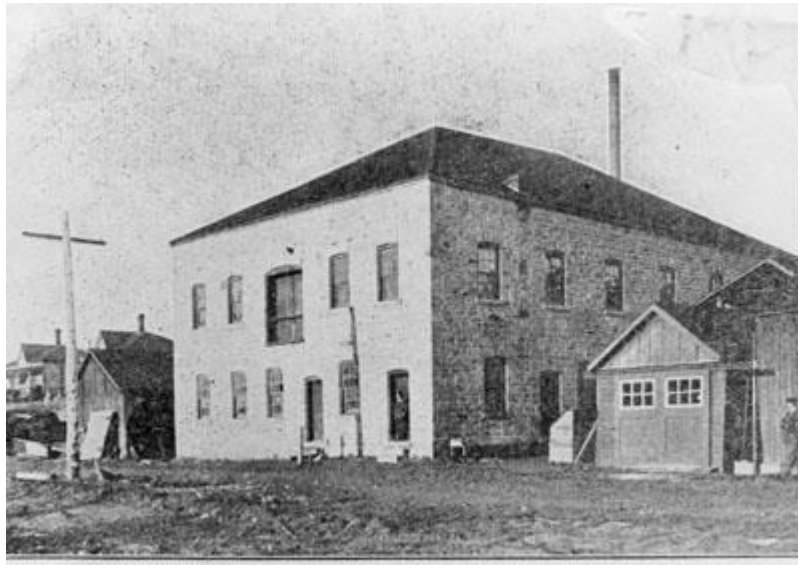
Figure 8: Stone building constructed by H.P. Lawson in 1897 and sold to J.B. Mackenzie in 1909 (Georgetown Herald, 17 Dec 1913, p. 4)

John Boyd Mackenzie (1876-1947) (Figure 6 and Figure 7) was born in Esquesing Township and attended Dublin School. He was trained in carpentry and opened his first shop in Acton. His interest in contracting led him to become a dealer in lumber, and the growth of his business resulted in him establishing a planing mill in Acton in 1900. In 1907, Mackenzie married Eliza McQueen, who taught classes in Acton. The couple resided at Church and Main Street in a block home Mackenzie had constructed prior to the marriage, before moving into The Birches in Georgetown in 1915. In 1909, Mackenzie bought contractor H. P. Lawson's planing mill (8 James Street) (Figure 8) in Georgetown. At only the age of 33, Mackenzie owned both the Acton and Georgetown mills.

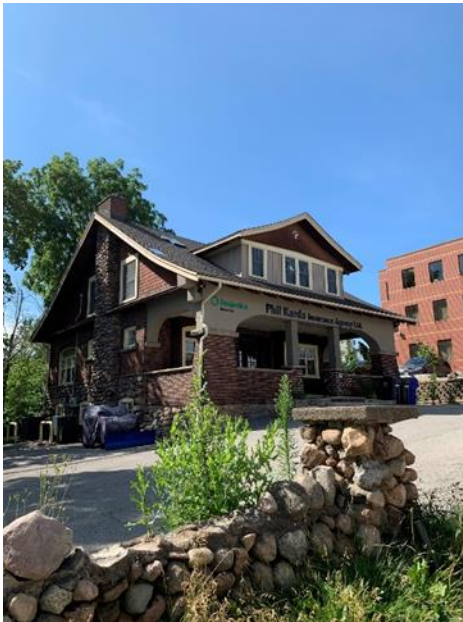
Figure 15: Looking southwest towards 75 Mill Street from Mill Street, Georgetown (Town of Halton Hills 2023)

The property is located at 75 Mill Street along the southeast side of Mill Street and to the southwest of Park Avenue. The triangular shaped lot is located just northeast of Main Street South within Downtown Georgetown. The existing property features a paved parking lot and drive along Mill Street with a one-and-a-half storey bungalow within the property (Figure 15 through Figure 17). Mature trees extend along the northeast/east property line along Park Avenue and to the rear along the southeast lot line.

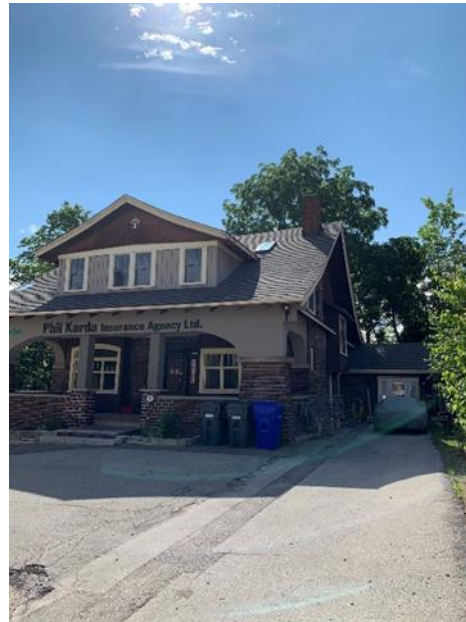
Figure 16: Looking southeast towards 75 Mill Street from Mill Street, Georgetown (Town of Halton Hills 2023)

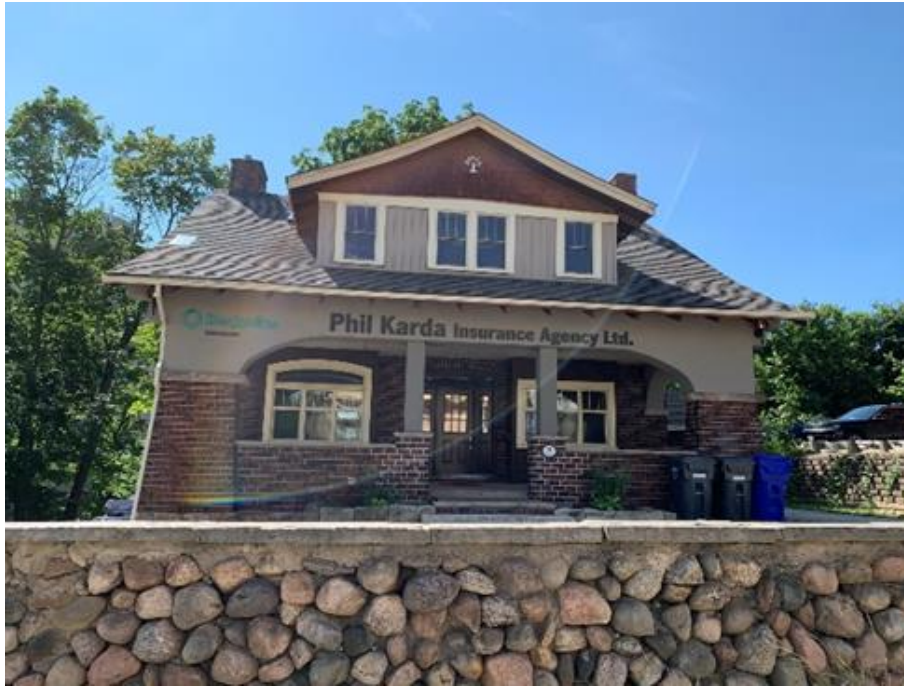
The front (northwest) elevation of The Birches (Figure 17) is dominated by its broad, low-pitched roof with an overhang over the front porch. The central columns have been replaced, however the wide columns on either end of the porch remain extant. The walls and columns at the base of the porch are brick, with stucco above and painted wooden columns were replaced on either side of the entrance. Beyond the porch on the front elevation, the main entrance features a segmentally arched opening with contemporary door and sidelights on either side of the door. A segmentally arched window opening with glass transom is located on the northeast side of the main entrance, featuring three three-over-one hung windows. A flat-headed window opening is located to the southwest of the main entrance and features three three-over-one windows with no transom window above. A large gable-roofed dormer is located on the front (northwest) slope of the roof, featuring a pair of window openings beneath the

gable peak with three-over-one windows, and on either end of the dormer's façade, single window opening with three-over-one windows. Brick chimneys are visible at the northeast and southwest ends of the roof.

Figure 17: Front elevation of The Birches at 75 Mill Street, showing the cobblestone wall along Mill Street (Town of Halton Hills 2023)

- The materials, including brick, cobblestone, stucco, and wood;
- The front (northwest) elevation, including:
 - The front porch, featuring a broad roof, brick columns, and cobblestone detailing;

- The central entrance, featuring a central door flanked by sidelights;
 - The extant window openings, including the segmentally-arched and flat-headed window openings at the first storey;

- The central dormer on the northwest roof slope, with gable roof and symmetrically placed openings;
- The side (southwest) elevation, including:
 - Small segmentally arched window with concrete sill and segmentally arched single door opening at the first storey;

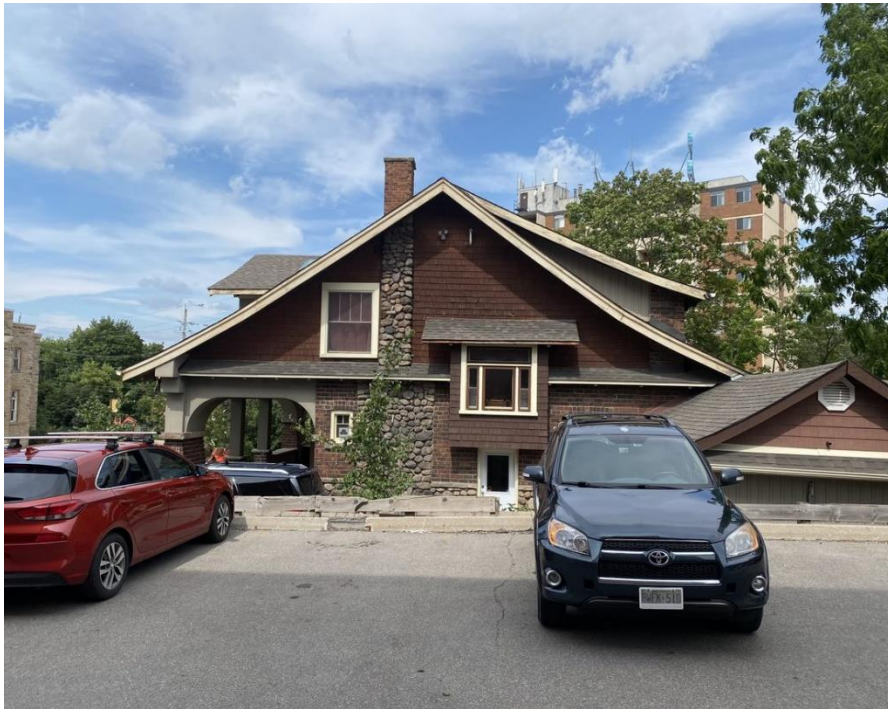
The southwest elevation of The Birches (Figure 18) reflects the mix of materials used within the exterior of the home, including the brick porch and façade, cobblestone chimney (beneath the roofline), shingled projecting bay with shed roof and small flat-headed window opening, small window tucked under the eaves, and one-storey addition with brick, wood shingles and contemporary entrance with glass door and sidelights.

Figure 18: Southwest elevation of The Birches (Town of Halton Hills 2023)

- Shed-roofed projecting bay with flatheaded window opening between the first and second storeys;
 - Flat-headed window opening at the second storey;;
 - Cobblestone at the foundation and within the chimney detailing extending up to the roofline, with brick above the roofline;

- Shallow projection above the first storey with bracketed eaves;
 - Brick cladding at the first storey; shingles within the projecting bay and at the second storey with brick at the rear;

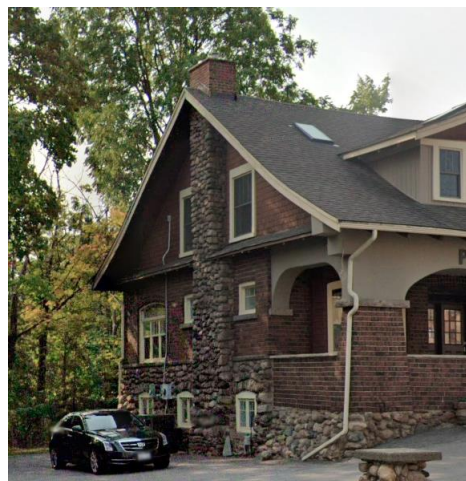
The northeast elevation of The Birches (Figure 19) takes advantage of the change in grade, with the basement, first and upper storeys visible. At the basement level, the façade features cobblestone to the base of the first storey window at the rear, with segmentally arched window openings on either side of the cobblestone chimney (beneath the roofline). At the first storey, a large segmentally arched window opening with glass transom and three-over-one openings are featured with two smaller windows with concrete sills on either side of the chimney. Above the first storey, two flat-headed window openings with four-over-one windows are extant on either side of the cobblestone chimney exterior.

Figure 19: Northeast elevation of The Birches at 75 Mill Street (Town of Halton Hills 2023)

- The side (northeast) elevation, including:
 - Segmentally arched window openings at the basement level;

- Large segmentally arched window opening with glass transom, and two small window openings on either side of the chimney;
- Cobblestone at the foundation and within the chimney extending up to the roofline, with brick above the roofline; and,
- Flat-headed window openings within the upper storey, flanking the chimney.

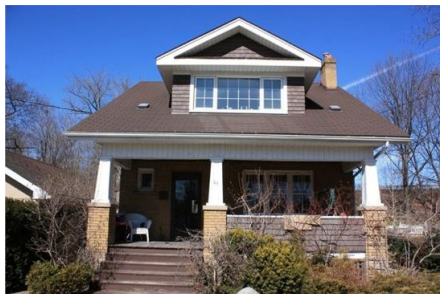
Figure 20: 25 King Street, Georgetown (Halton Hills Heritage Register 2010)

There are currently 19 properties on the Town's Heritage Register identified as Craftsman style that are currently listed, dating between 1910 and 1930. Of the Craftsman style buildings that are located within Georgetown, the most comparable in terms of scale, form, and design include the properties at 25 King Street (Figure 20) and 37 Charles Street (Figure 21), which are both located within residential streets, while The Birches is uniquely located within a primarily commercial area within Downtown Georgetown. All three of these buildings are excellent examples of the Craftsman style, however the use of cobblestone within the exterior of the house and within the stone wall along Mill Street and the side property line are unique to The Birches. Some features have been altered on the front elevation, including the central columns within the front porch, and the placement of windows in the central dormer, however the building has retained its integrity overall since its construction almost 100 years ago.
