Research and Evaluation Report

Hawkins House

7 Prince Street, Glen Williams, Town of Halton Hills

September 2024

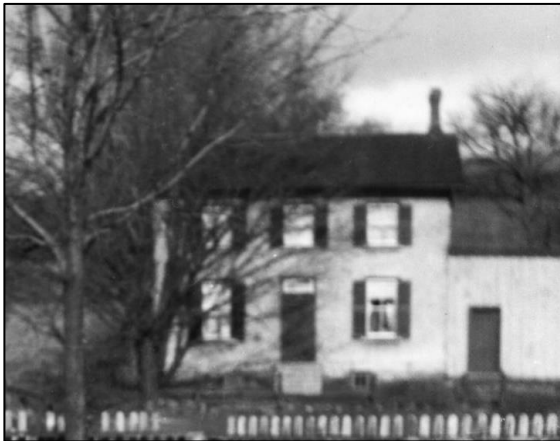
Figure 7: Front elevation of the extant dwelling at 7 Prince Street, c.1912 (Detail, EHS 20154)

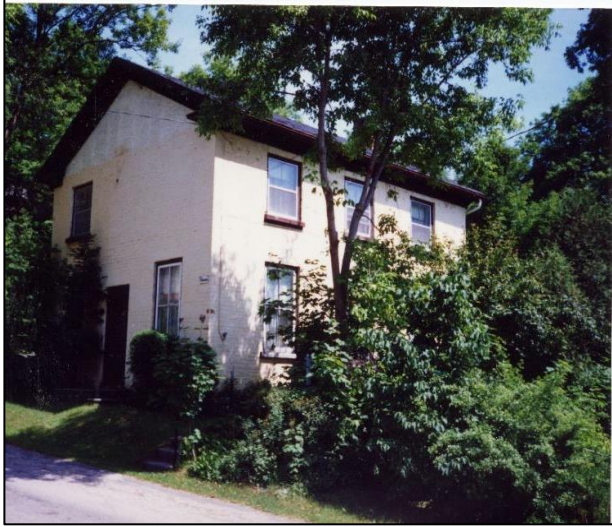
Figure 21: Partial front and side elevation of 7 Prince Street, c. 1990 (EHS942)

The current owners reside in #7 Prince Street. The painted brick was started by Roy Puckering, but the gable end was never completed since he had a heart attack during the work. The house at #5 Prince Street is a workshop today.

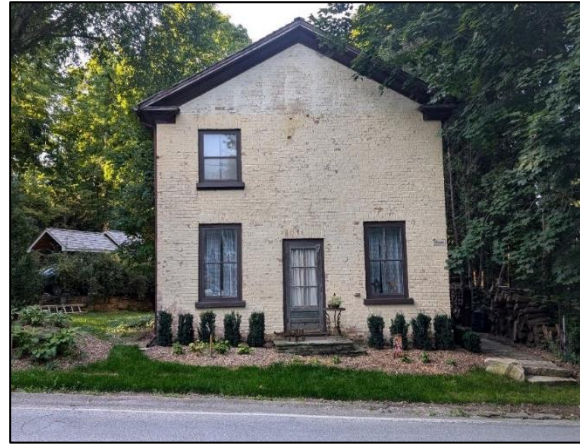
Figure 26: Side (north) elevation of the existing dwelling, fronting Prince Street (John Mark Rowe 2024)

The subject property contains a one-and-a-half-storey Georgian plan residential brick house building with moderately pitched cedar shake roof with gable returns on both facades and cedar shakes. It is situated near the western property line, demarcated by the drop in elevation to what was once a substantial raceway from the Credit River to the Williams sawmill and for a time, through a flume to the power plant and thence into the current ballpark. The front elevation faces west, at an angle matching the former raceway.

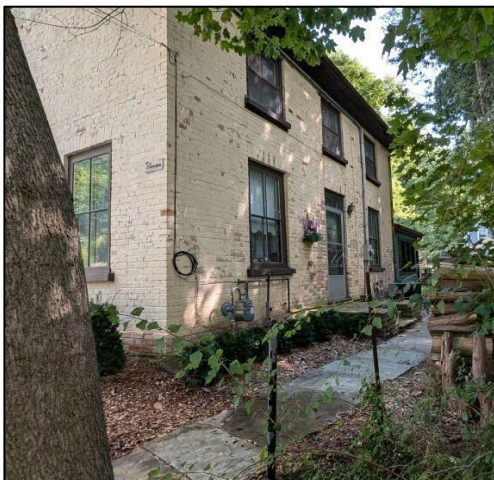
Figure 27: Front (west) elevation of the existing dwelling (John Mark Rowe 2024)

The existing building is currently obscured from view by a line of trees and bushes along the western property line. A concrete sidewalk leads from Prince Street across the front of the house, firstly to the

former front entrance, secondly to the kitchen door at the back of the frame single-storey addition and thirdly to the front door of the workshop, municipally known as #5 Prince Street. The wide gravel driveway at the rear of the house leads to a car port and shed. The angle of the drive mirrors the house angle and follows the steep embankment of the valley.

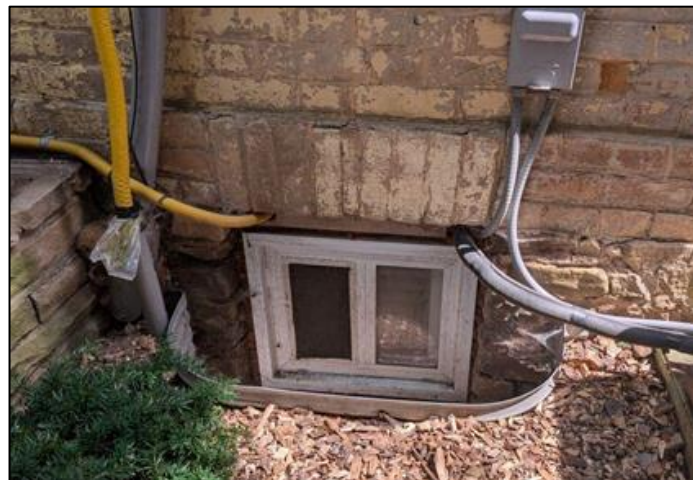
Figure 28: Basement windows on the extant dwelling (John Mark Rowe 2024)

The building features a rubble foundation that is six feet deep under the south end and features a three-foot crawl space on the north end of the house. A three-course brick plinth sits on top of the stone foundation. The five steps up to the front door, seen in historic photographs, are now replaced by three steps built into a flagstone landing.

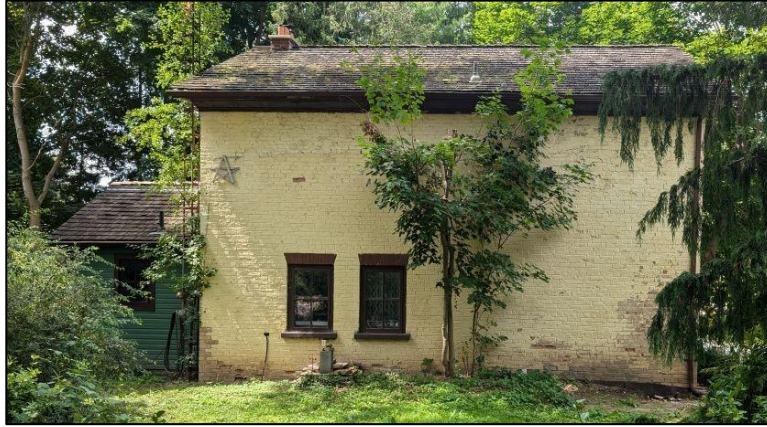
Figure 29: Side (east) elevation of the existing dwelling (John Mark Rowe 2024)

Hawkins House is a two-storey house constructed with locally made, compact red terra-cotta brick, laid in a common bond pattern, although the bond pattern does vary on the front of the house. The ground floor is triple-wythe construction with the second floor being double-wythe².

The rear (east) wall has only two close-set ground floor windows, corresponding to the placement of the original kitchen. The north wall, facing Prince Street, has two balanced windows on the ground floor

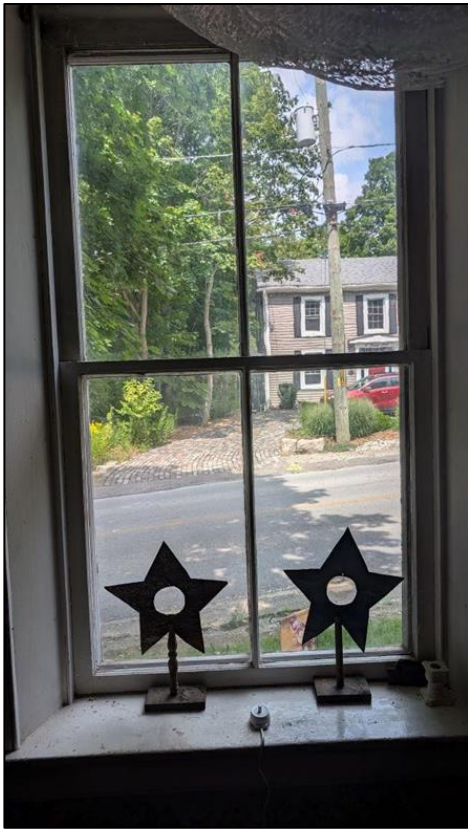
The window openings and door opening are supported by a flat soldier brick voussoir. Windows are framed in plain hemlock on the exterior and red pine internally. A solid hemlock lug sill supports the windows. Windows are two over two sashes, primarily featuring original glass, and are currently protected by a four-pane wooden storm window. The house has an asymmetrical window configuration on the other three walls.

Figure 30: Interior windows along the front (north) elevation of the extant dwelling, looking towards Prince Street (John Mark Rowe 2024)

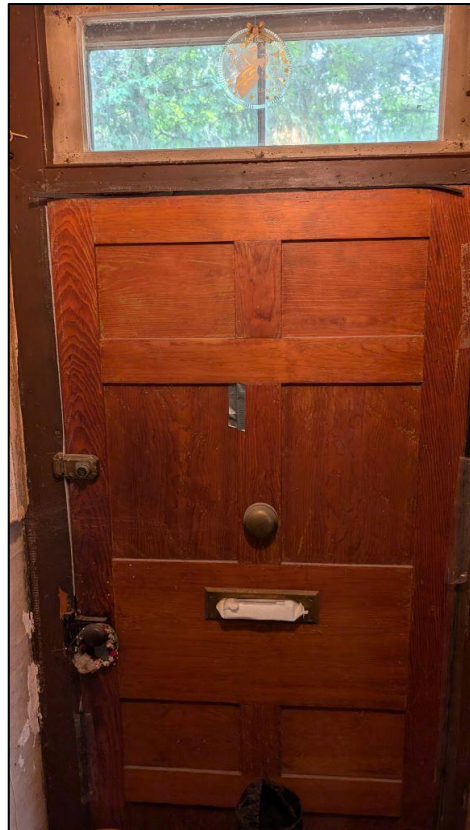
The original front door is a panelled framed door of either solid red pine or hemlock. It is in remarkable shape as it has been covered with storm doors over the years. A twist bell has been installed as well as a slot for mail delivery (installed in 1967). It has eight panels (six identical) with a wide lock rail. A secondary door facing Prince Street appears to be a replacement wood frame door (age unknown) with a six-pane window insert.

The transom is a single piece of glass in a painted wooden frame. It is protected by an exterior two pane storm window.

Figure 31: Wooden front door and transom found on the side (west) elevation of the existing dwelling (John Mark Rowe 2024)

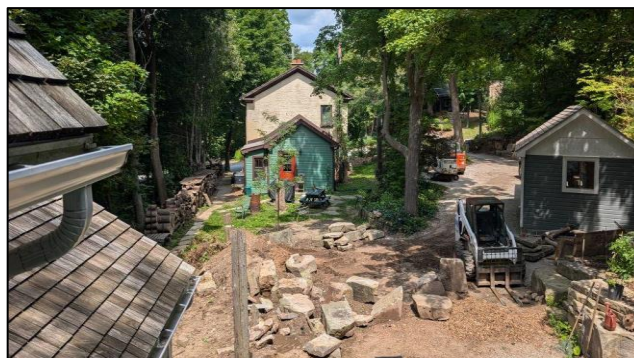
The medium pitch gable roof, with projecting eaves, is clad with cedar shakes, as it would have been originally. The simple flat fasciae are covered by aluminium eavestrough but like the gable ends may have a decorative narrower fascia board placed on the base board. The soffits are wide with three levels of overlapping boards, giving the roof trim a profile. A frieze board with molding finishes the top of the brick walls.

Figure 32: Rear (south) elevation of the subject dwelling (John Mark Rowe 2024)

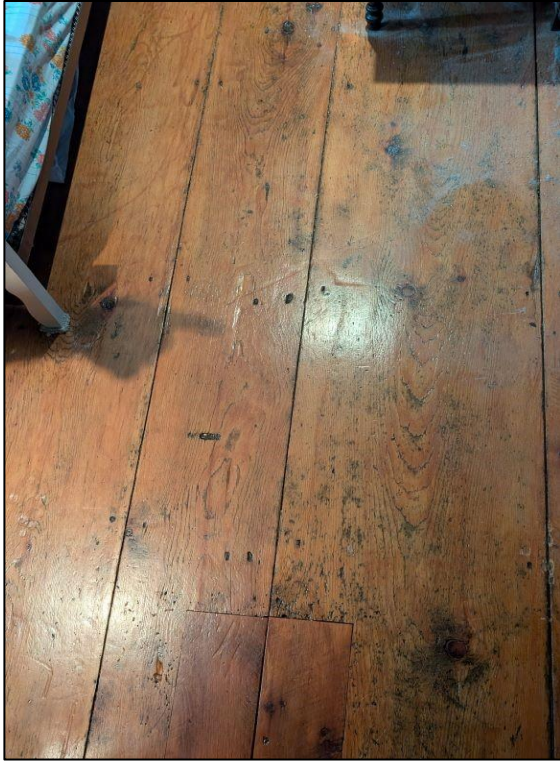
Figure 33: Existing pine floorboards found throughout the interior (John Mark Rowe 2024)

Rooms inside the house seem to remain true to the original layout, which census records mentioned as having 9 rooms. The floorboards are wide pine boards and all door moldings, window casings and baseboards are original. The staircase is steep and is made of the original red pine treads. The simple brick hearth (with modern insert) features a stepped-back brick mantle.

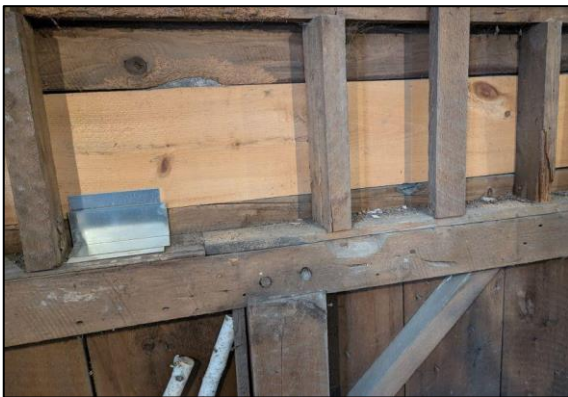
Attached to the south wall is a frame summer kitchen that is currently sided, visible in all historic photographs. The door has been moved to the south end of the structure and accommodates a contemporary kitchen. The roof features shake shingles to match the house and simple flat fascia ends in short eaves return to echo the original returns found on the brick house.

Figure 35: Interior of the framed summer kitchen (John Mark Rowe 2024)

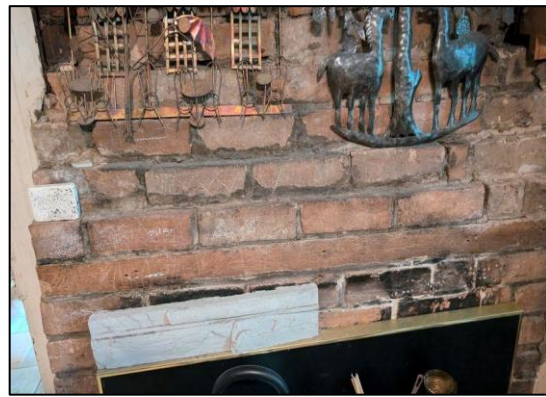
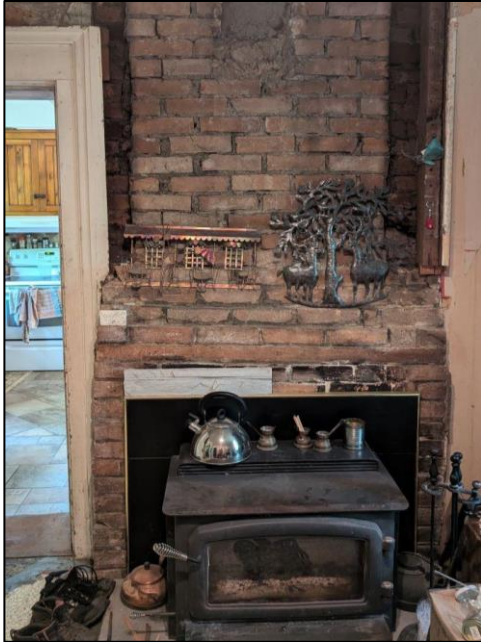
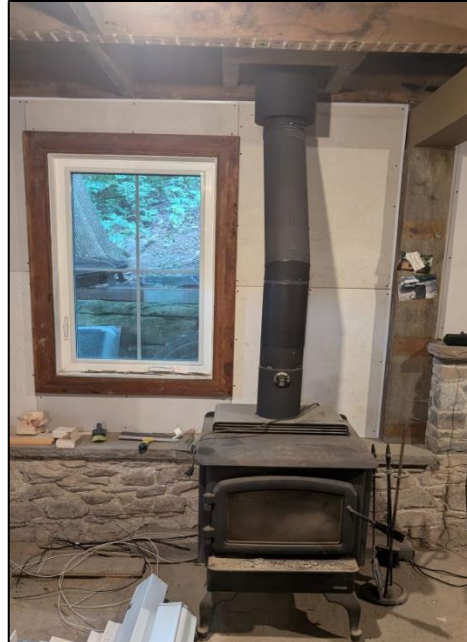
Figure 36: Existing fireplace in the extant dwelling (John Mark Rowe 2024)

Figure 37: Existing fireplace in the extant dwelling (John Mark Rowe 2024)

Figure 38: Existing fireplace in the extant dwelling (John Mark Rowe 2024)

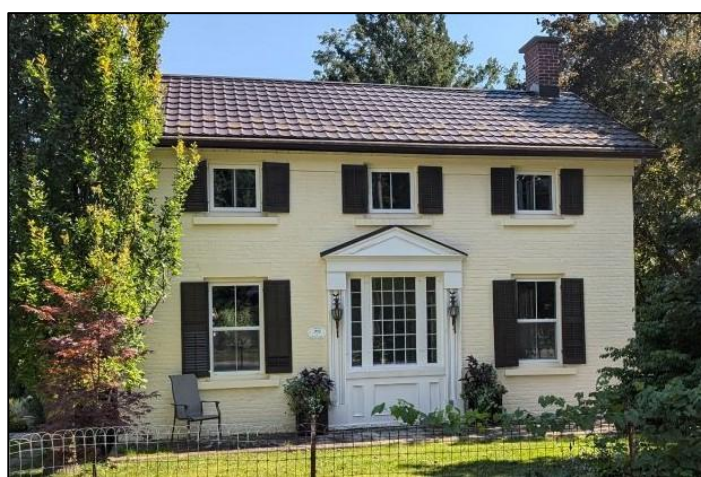
Figure 40: Example of a Georgian House at 15 Mountain Street, Glen Williams (John Mark Rowe 2024)

Balanced and symmetrical facades are a hallmark of Georgian houses, and this building boasts three bays across the front with the centre door topped with a transom. A chimney is located at each gable end and originally all window openings featured shutters. The original heavy solid plank door is still extant and would have been opens outwards and hooked open during the good weather. The door stop and hook are still in place on the front façade.
