Research and Evaluation Report

Hornby School

13029 Steeles Avenue, Town of Halton Hills

April 2025

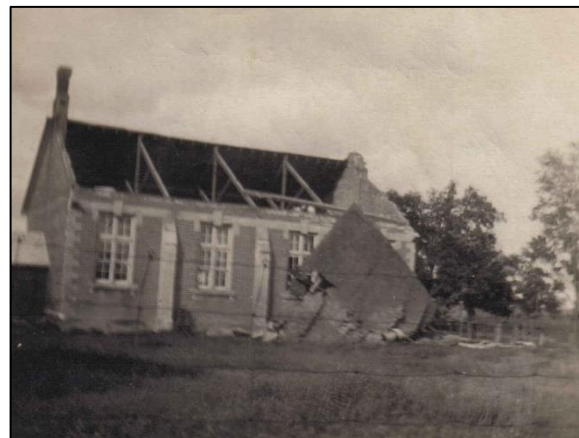
Figure 11: Damage to the Hornby Schoolhouse following a Tornado in 1923 (MHS 5518)

In 1923, the Hornby Schoolhouse was substantially damaged by a tornado, which tore off its roof, destroyed its bell tower, and damaged the school grounds. The community quickly rallied together to repair the school, and by 1924, the building had been restored. However, the bell tower was never fully rebuilt.

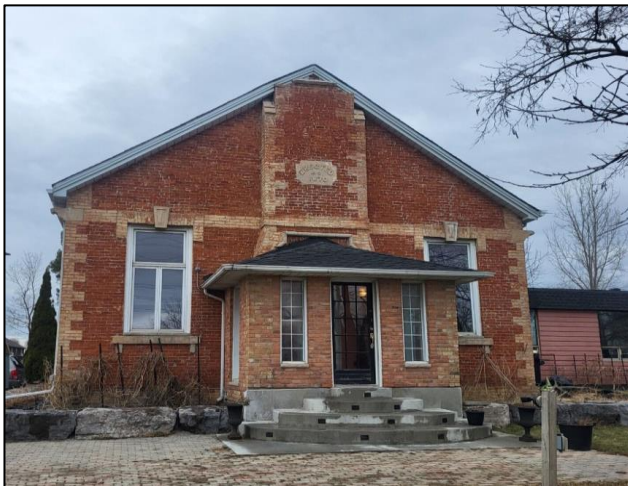
Figure 28: Front (southeast) elevation of the existing building at 13029 Steeles Avenue (Town of Halton Hills 2025)

The southeast (front) elevation of the Hornby Schoolhouse is constructed of red brick laid in a running bond pattern, featuring dichromatic brick detailing with buff-brick quoining framing the building's corners and the slightly projecting former bell tower. A running band of buff brick also extends around the perimeter of the first storey. The central entrance, now obscured by a modern vestibule, is centrally positioned within a slightly projecting wall that once formed the base of the bell tower. This frontispiece

rises to the peak of the gable end and is inset with a date stone inscribed “Erected A.D. 1870.” The entrance is flanked by large, flatheaded rectangular window openings, each featuring a limestone keystone, soldier course lintel, and a projecting limestone sill.

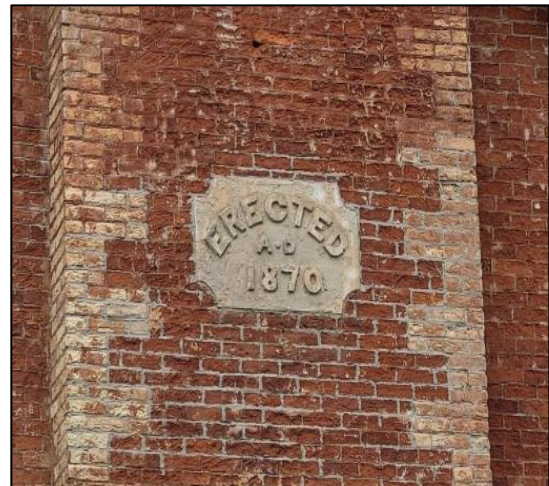
Figure 29: Datestone inscribed "Erected A.D. 1870" on schoolhouse frontispiece (Town of Halton Hills 2025)

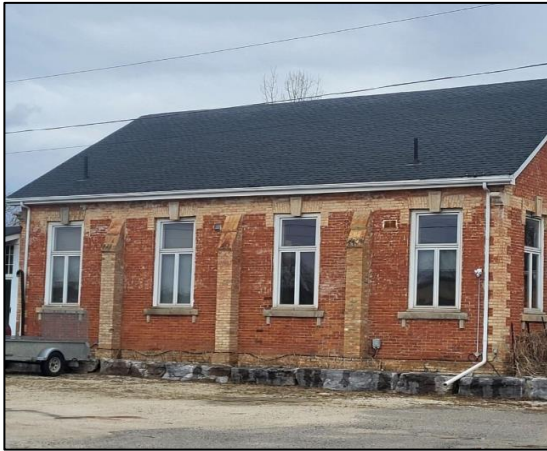
Figure 30: 13029 Steeles Avenue side (southwest) elevation (Town of Halton Hills 2025)

The southwest (side) elevation of the Hornby Schoolhouse is constructed of red brick laid in a running bond, framed by buff-brick quoining. A buff-brick band runs continuously around the perimeter of the first storey, just beneath the gable eaves. This elevation showcases a four-bay design divided by three buff-brick buttresses. Each bay contains a large, flatheaded rectangular window opening, accented by a limestone keystone, soldier course lintel, and a projecting limestone sill.

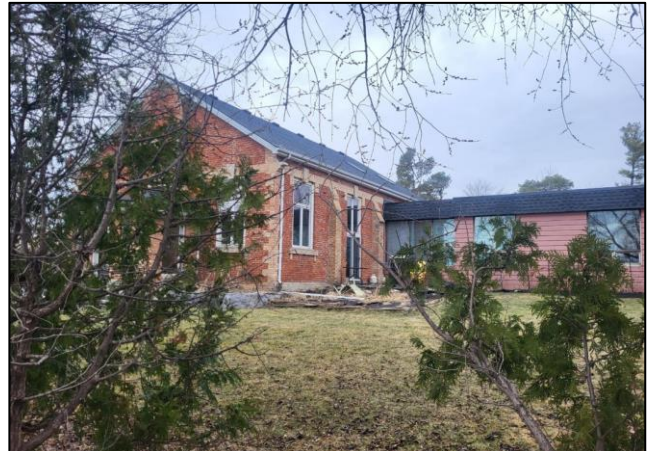
Figure 31: 13029 Steeles Avenue side (northeast) elevation (Town of Halton Hills 2025)

The southwest (side) elevation of the Hornby Schoolhouse is constructed of red brick laid in a running bond and framed by buff-brick quoining. A continuous buff-brick band runs around the perimeter of the first storey, just beneath the gable eaves. This elevation has been partially obscured or altered by a large, single-storey modern addition, which affects two of the original window openings. However, two buff-brick buttresses and one rectangular window opening featuring a limestone sill, a soldier course buff-brick lintel, and a limestone keystone remain extant. A second window opening has been converted into an entrance; however, the limestone keystone and soldier course lintel have been preserved.

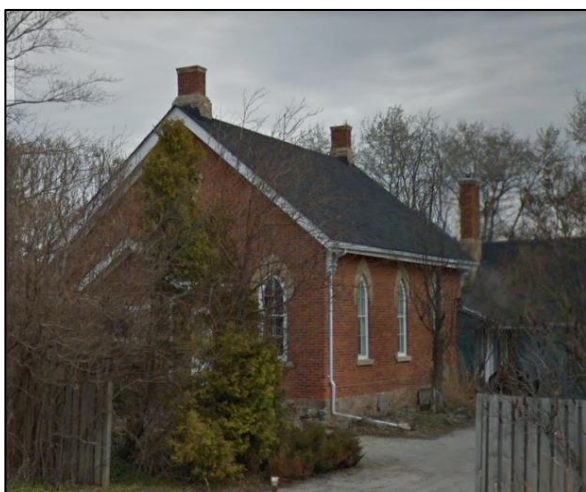
Figure 36: Lorne Schoolhouse, S.S. No. 12 (Town of Halton Hills)

Similar examples are extant throughout Halton Hills, such as the former Lorne Schoolhouse, which is a representative example of an Ontario rural one-room schoolhouse in the Gothic Revival architectural style, featuring dichromatic brickwork, lancet window openings, buff brick drip moulds, a gable roof, and central vestibule entrance. Blue Mountain Schoolhouse also displays similar details such as dichromatic brickwork, buff-brick quoining, flatheaded window openings with soldier-course lintels and limestone sills, and a gable roof. Over time, Hornby School has been modified, including the destruction of the front bell tower, the construction of the front vestibule, and the alteration to the existing window openings. However, historic documentary evidence provides opportunities to restore the original elements of the schoolhouse, should any future owner(s) choose to do so.
