Research and Evaluation Report

Moore-Creelman House

44 Main Street North, Georgetown, Town of Halton Hills

March 2026

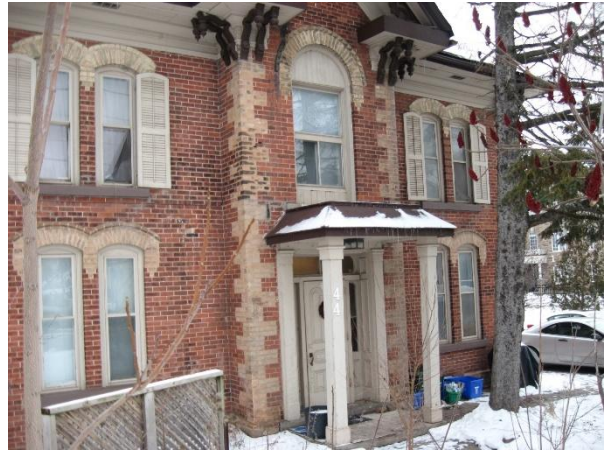
Figure 28: Detail of the front facade of Moore-Creelman House, c.2016 (EHS 23169)

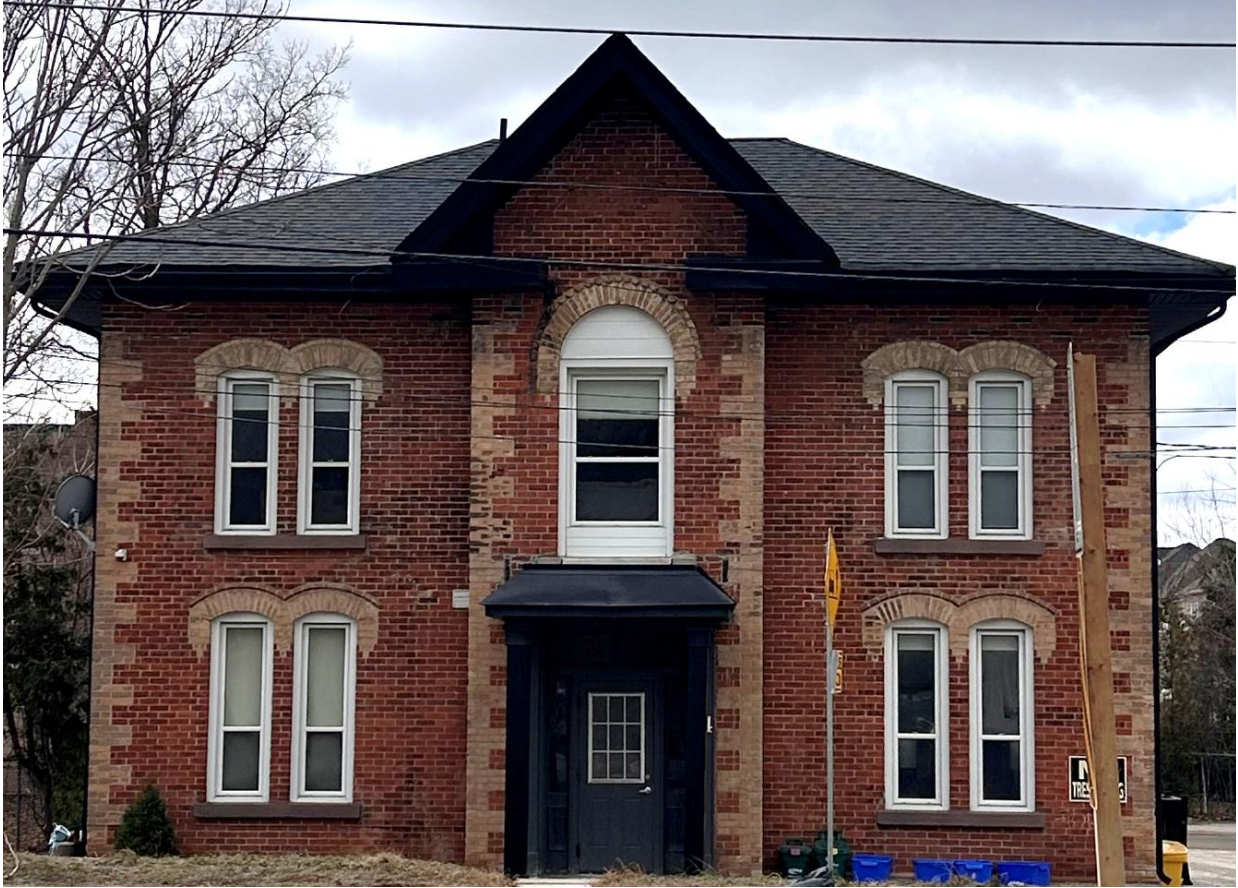
The front (northeast) elevation of the existing building features a three-bay, symmetrical layout, with the central bay projecting slightly from the rest of the elevation featuring buff brick quoining within the red brick facade. The central entrance features a flatheaded opening with sidelights and transom above, beneath a shallow hipped roof porch with simple squared columns. Paired segmentally arched window openings featuring buff brick hood moulds and a shared stone sill are extant on either side of the central entrance at the first storey, and buff brick quoining extends from the first storey to the eaves at each corner of the front elevation. The cut stone foundation is visible at grade.

At the second storey of the front (northeast) elevation, each side bay features identical paired window openings as the first storey. Within the second storey of the central bay is a round-arched door opening with buff brick hood mould above, extended into a door opening. Early photos of the building show a covered front porch at the first storey with a balcony with railing accessed by the second storey opening. Above this window opening, the eaves return to meet the buff brick hood mould at each side beneath the central gable peak.

Figure 33: Front (northeast) elevation of the existing building at 44 Main Street North (Town of Halton Hills 2026)

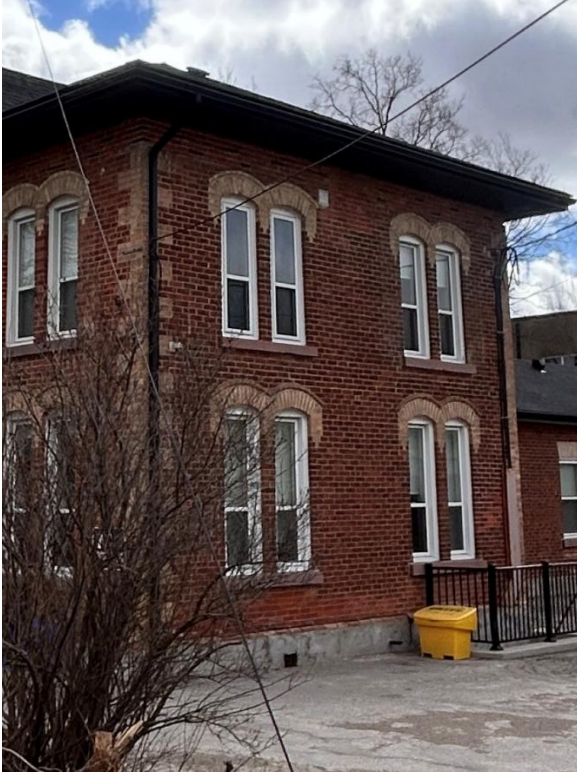
The side (northwest) elevation of the original two-storey building features the cut-stone foundation at grade with small contemporary basement entrance towards the rear of the elevation. Paired, segmentally arched window openings with shared stone sills are extant at both the first and second storeys. More modest buff brick quoining is extant at the rear corner of the elevation. The side (southeast) elevation of the existing building mirrors the northwest elevation.

Figure 34: Looking south towards the northwest elevation of the existing building at 44 Main Street North (Town of Halton Hills 2026)

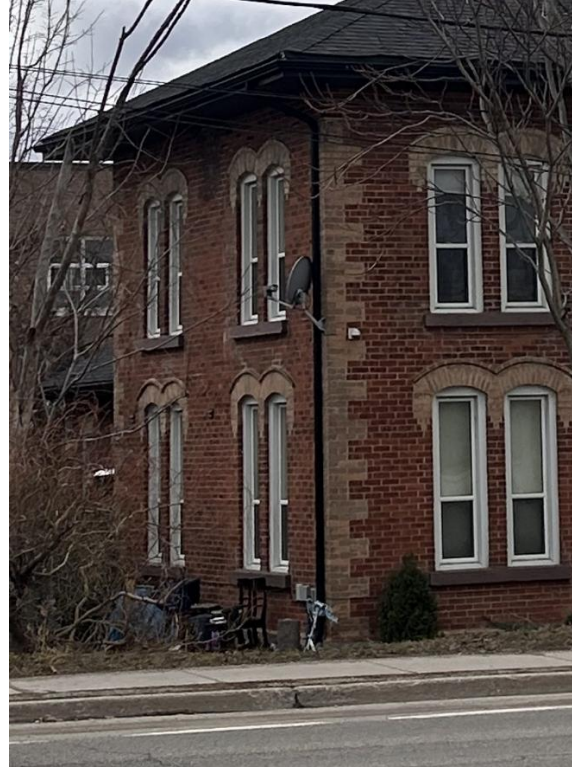
Figure 35: Looking towards the southeast elevation of the existing building at 44 Main Street North (Town of Halton Hills 2026)

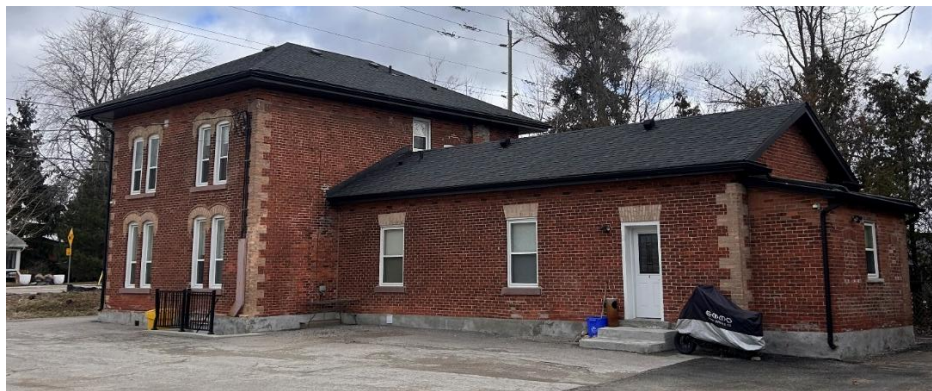
The rear (southwest) elevation of the original two-storey building is partially obscured by the one-storey brick addition extant at the rear of the original building, which is shown in the 1960 Fire Insurance Map of Georgetown. The gable-roofed addition is red brick construction, features flat-headed window openings with buff brick voussoirs and concrete sills, a flatheaded entrance featuring buff brick voussoirs, and simplified buff brick quoining at the corners. Above the rear addition is a small rectangular window opening directly under the eaves and a smaller segmentally arched window opening adjacent to a truncated chimney. The visible rear façade shows evidence of infilled bricks and some alterations over time.

Figure 36: Looking northeast towards the rear (southwest) elevation of the existing building with one-storey addition at 44 Main Street North (Town of Halton Hills 2026)

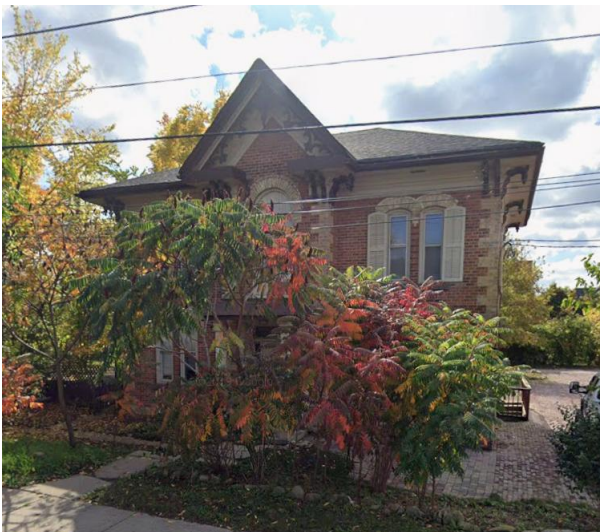
Although now no longer extant, until 2018 the home featured decorative wooden brackets beneath the wooden soffit and fascia at each corner and at the corners of the central bay on the front elevation, a wooden cornice beneath the eaves, and decorative bargeboard within the central gable peak on the front elevation. Paired bracketed eaves and the wooden cornice were also extant on the side and rear elevations, and some window openings featured wooden shutters. The dual chimneys above each side elevation were also removed at an unknown date. Photograph evidence of these lost features provides a significant opportunity to restore the decorative elements that once contributed to the building's Italianate style.

Figure 37: Google Streetview of the front elevation of the Moore-Creelman House (Google Streetview 2018)

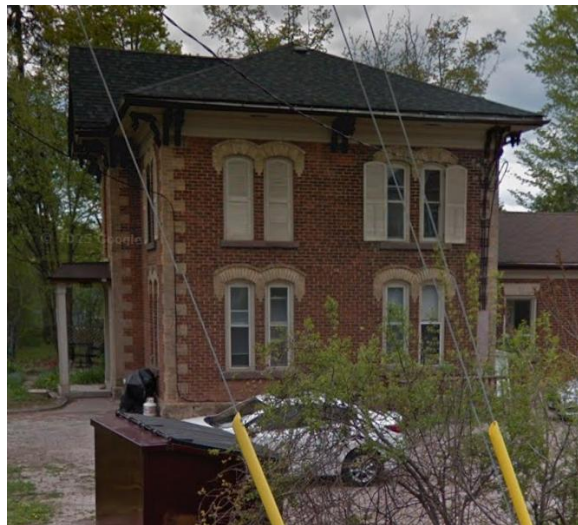
Figure 38: Google Streetview of the side elevation of the Moore-Creelman House (Google Streetview 2016)
