## Research and Evaluation Report

**St. Joseph's Patron of Canada Catholic Church**  
64 Church Street East, Acton, Town of Halton Hills

March 2026

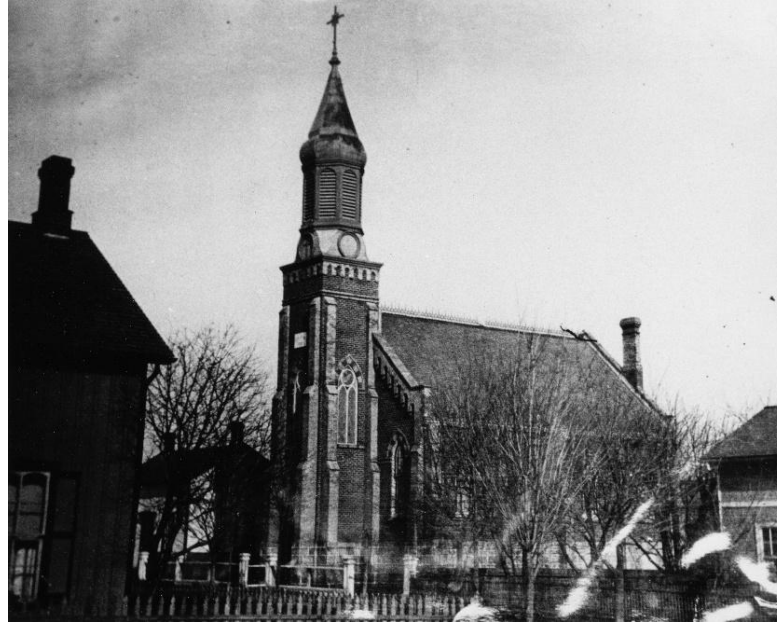
Figure 8: St. Joseph's Roman Catholic Church, c.1919; the church's original steeple is prominent in this photograph (EHS 00065)

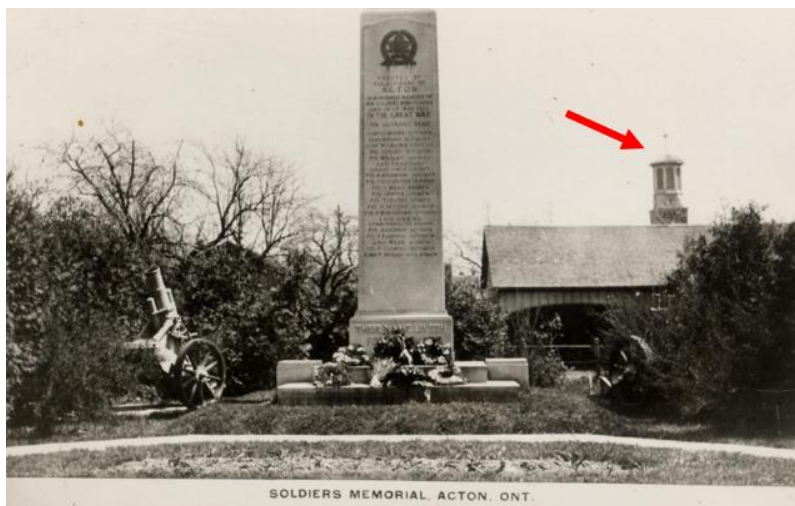
Figure 9: Steeple for St. Joseph's Roman Catholic Church identified behind the Cenotaph on Mill Street in Acton, c.1920 (EHS 11337)

The first Catholic wedding ever consummated in Acton was at St. Joseph's in 1886. In 1893, Acton was established as a parish by Bishop Thomas J. Dowling, with the first resident priest being Father Patrick Haley. The original steeple was destroyed by lightning in 1895, following which it was rebuilt. In 1899, Father Feeny purchased a brick dwelling and lots at John Street South and Agnes Street to be used as a parsonage for the church; the former parsonage is no longer extant.

During the mid-twentieth century, the basement was renovated to make additional meeting room space. Work was undertaken on the building's exterior during the 1960s, which is likely when the original steeple at the top of the tower was removed, however an exact date of its removal has not been confirmed. During the 1970s, a new heating system and hall kitchen were also introduced within the church.

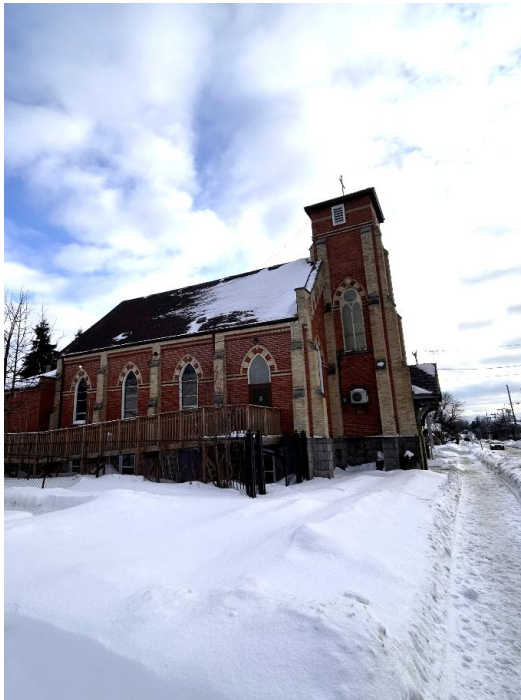
Figure 27: Looking southwest towards the subject property along Church Street East (Town of Halton Hills 2026)

The subject property at 64 Church Street East is located along the southeast side of Church Street East in the community of Acton in the Town of Halton Hills. The property is a rectangular lot and abuts a parking lot on the southeast side, also owned by the Roman Catholic Diocese but not part of the subject property. Residential properties surround the church property on all sides. The existing church building is a rectangular plan dominated by a central tower on the front (northwest) elevation. The exterior is red brick with buff brick detailing throughout.

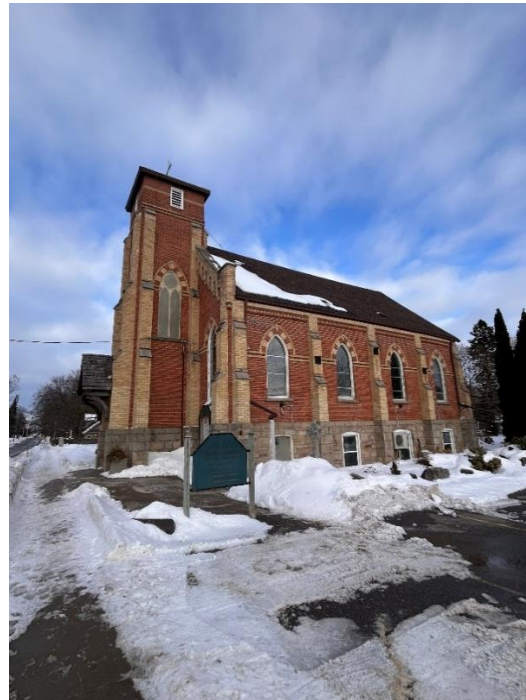
Figure 28: Looking northeast towards the subject property along Church Street East (Town of Halton Hills 2026)

The front (northwest) elevation features three bays with a central tower dominating the façade. The entrance is centered within the tower and features double wooden doors within a lancet arched opening featuring glass transom above. A wooden portico with a gable-roof supported by wooden brackets is extant above the central entrance. Stepped buff brick buttresses extend upwards along the tower at each corner. Above the central entrance is a lancet arched window opening with stone sill and dichromatic brick voussoir above the window which features decorative tracery. A datestone reading “SAINT JOSEPHS CHURCH” is located above the window opening. A decorative “string course” featuring projecting buff brick and red brick is located above the buttresses on the tower. A rectangular louvered opening is extant above the flat roof and is intersected with a buff brick string course.

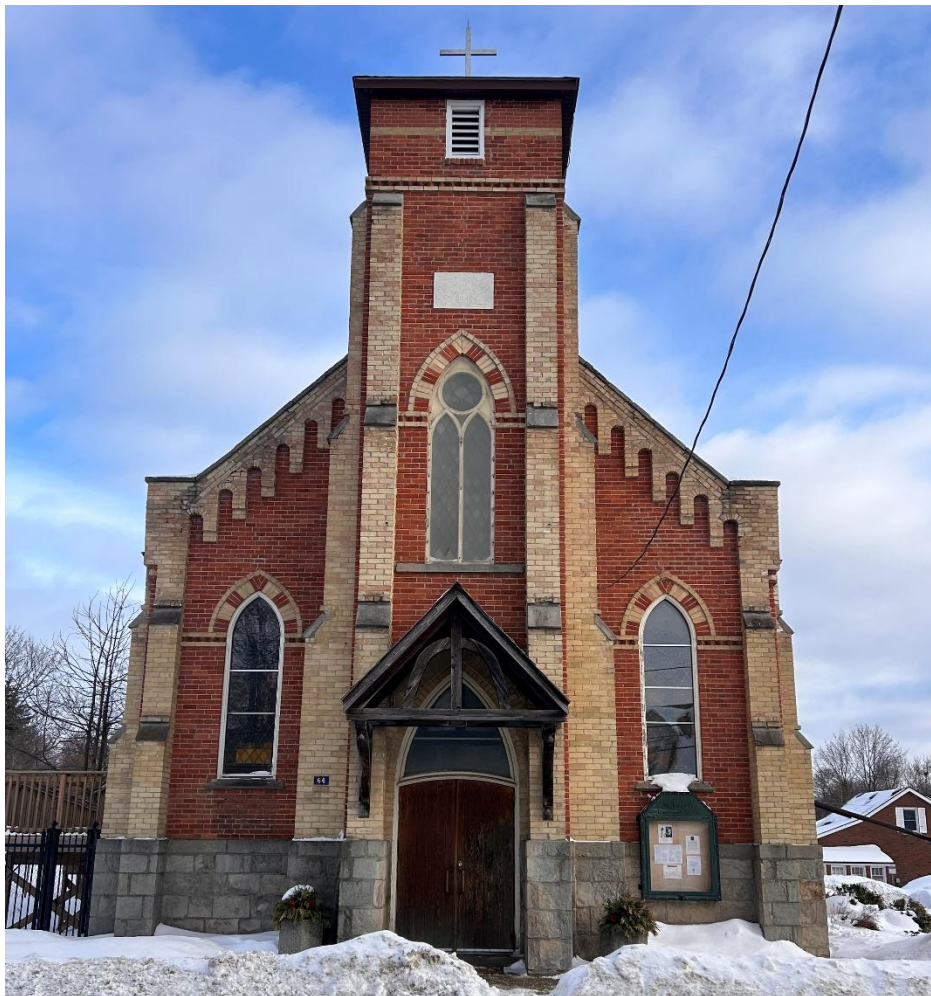
Figure 29: Front (northwest) elevation of the existing building at 64 Church Street East (Town of Halton Hills 2026)

A single lancet arched window opening is extant on either side of the central tower, each featuring a stone sill and dichromatic brick voussoirs, with a double-buff brick string course with the same decorative brick detail between extending on either side of the window opening within its upper portion. Buff brick detailing is featured along the roofline on either side of the gable roof as it extends from the tower.

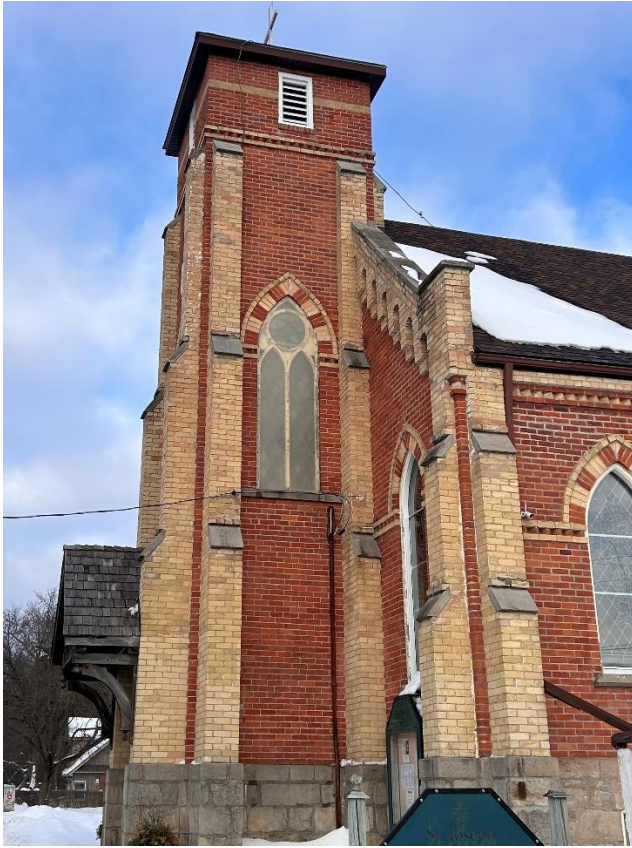
Figure 30: Southwest corner of the existing building at 64 Church Street East (Town of Halton Hills 2026)

The side elevations of the central tower feature similar details to its front (northwest) elevation, including stepped buff brick buttresses capped with stone, lancet-arched window openings featuring stone sills and dichromatic brick voussoirs above the windows which feature decorative tracery, and the same rectangular louvered opening surrounded by decorative brickwork below the roofline. A cross spire is located above the roofline of the tower.

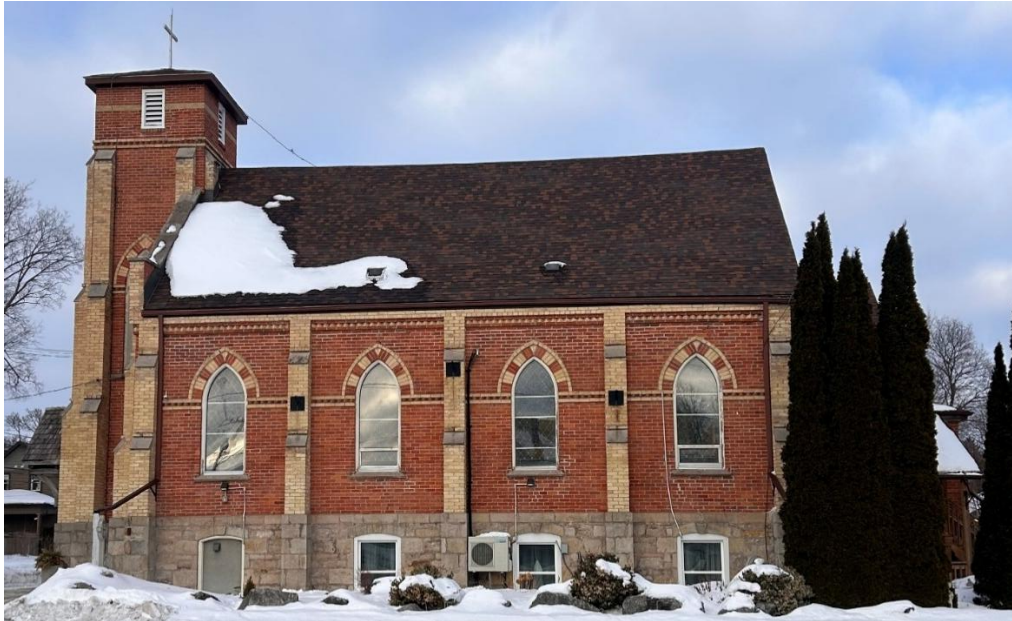
Figure 32: Side (southwest) elevation of the existing building at 64 Church Street East (Town of Halton Hills 2026)

The side (southwest) elevation of the existing building beyond the tower at the front features four symmetrically placed bays, divided by buff brick buttresses that extend from the existing foundation to the roofline of the gable roof. Segmentally arched window openings are extant at the basement level within each bay. Single lancet arched window openings are extant between each buttress and feature stone sills, dichromatic brick voussoirs, and are connected by the same detailed buff and red brick detailed string course that extends along the front (northwest) elevation. Additional dichromatic brick detailing is extant beneath the eaves of the gable roof and is topped by a course of buff brick that extends from the buff brick buttresses along the elevation.

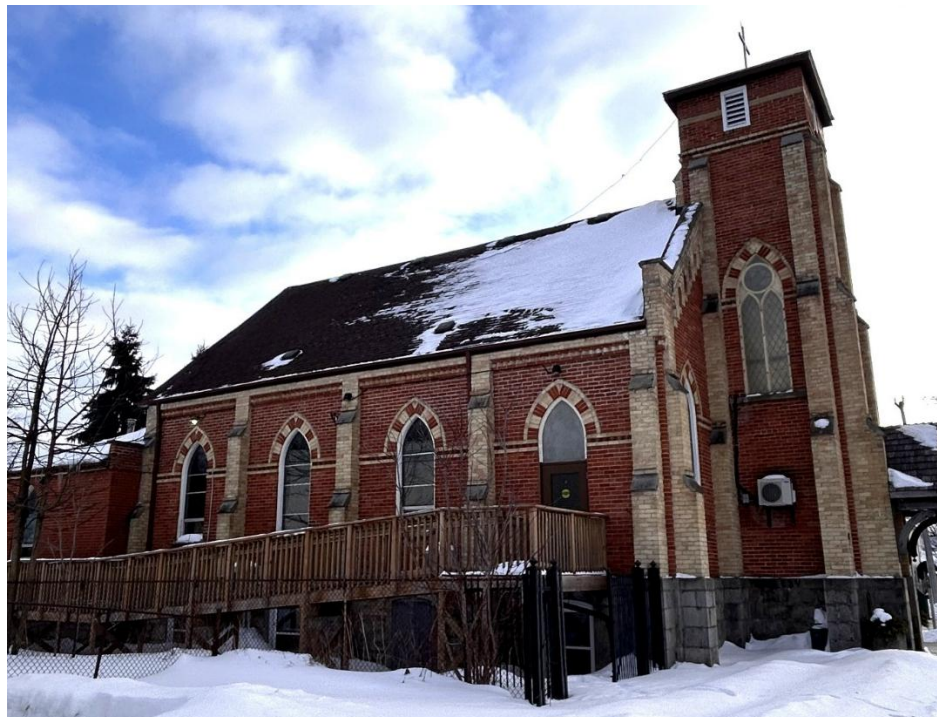
Figure 33: Side (northeast) elevation of the existing building at 64 Church Street East (Town of Halton Hills 2026)

The other side (northeast) elevation of the existing building mirrors the southwest side, however, is partially obscured at grade by a wooden ramp and porch. The northernmost window opening on this elevation has been modified to serve as an entrance to the existing building.

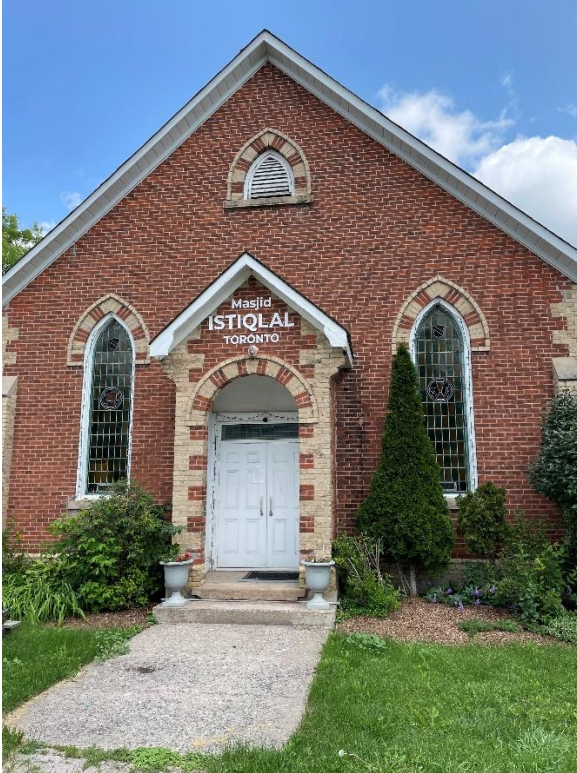
Figure 35: Photograph of 14369 Trafalgar Road (Town of Halton Hills 2024)

Similar examples are extant within Halton Hills, such as 14369 Trafalgar Road (Figure 35) and 499 Guelph Street (Figure 36). The building at 14369 Trafalgar Road features a modest Gothic Revival design, with dichromatic brickwork, a central vestibule with a semi-circular arch opening, buff brick quoining, lancet arched windows, and dichromatic voussoirs. In comparison, the building at 499 Guelph Street consists of red brick, buttresses, a central lancet arched entryway, lancet arched windows, hood moulds, string courses, and a tall tower. Brick turrets on squared bases are located at each corner of the tower; the turret tent roofs have octagonal bases with steeply pitched slopes rising to a peak. The steeple features wooden louvered openings with pointed roofs featuring trefoils and terminates in a finial. In comparison, St. Joseph's Church features dichromatic brickwork and features a distinctive composition of Gothic Revival elements, making it a unique example in Halton Hills.
