LES SALLAY
PROJECT NUMBER: 221-07745-00

HERITAGE IMPACT ASSESSMENT 152 CONFEDERATION STREET, TOWN OF HALTON HILLS

SEPTEMBER 07, 2022

FINAL

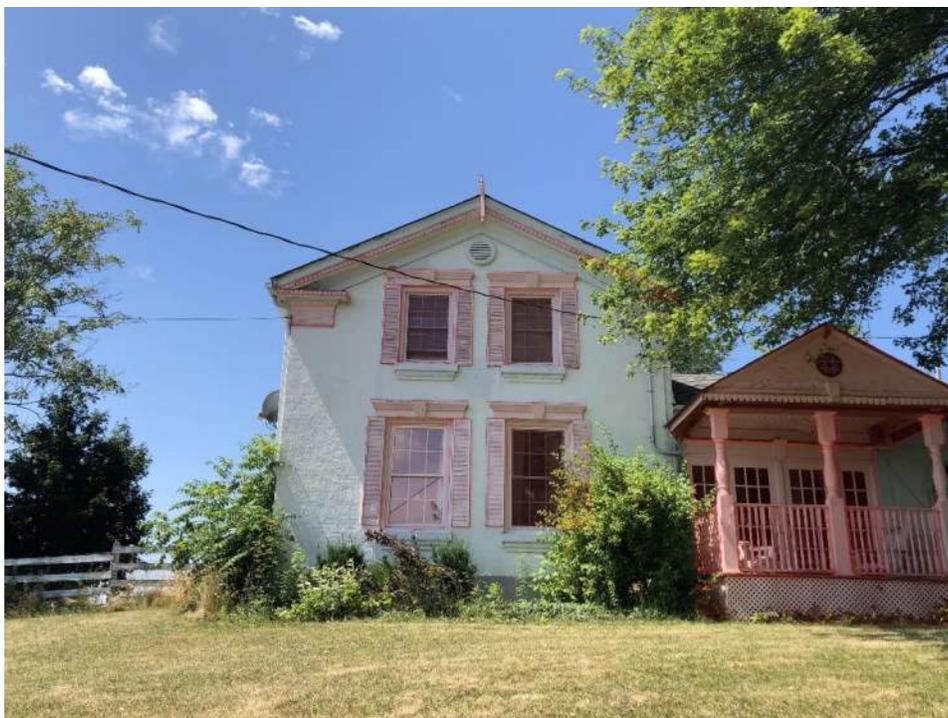
Image 96: Annotated photograph of the east elevation of the original part of the house and north wing ((pink shaded areas depict alterations completed since 1983).

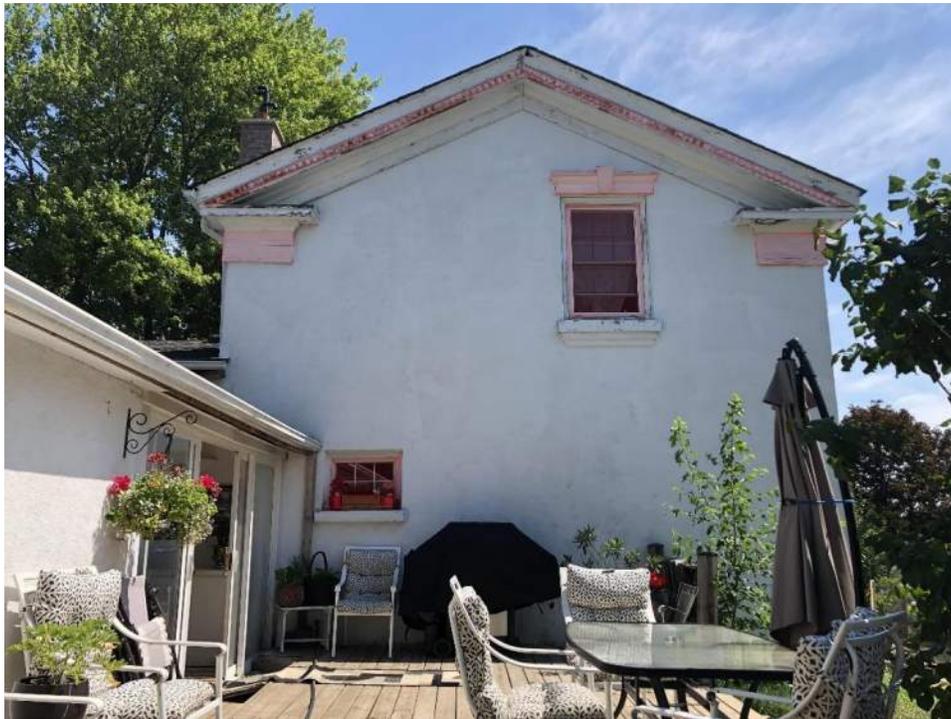
Image 97: Annotated photograph of the west elevation of the original part of the house (pink shaded areas depict alterations completed since 1983).

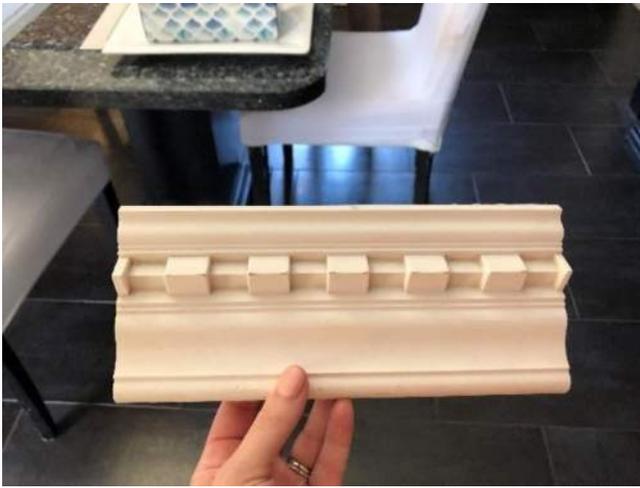
Photographs of the farmhouse have been annotated to visually identify the most recent changes to the structure (Image 95-Image 98). Samples of the exterior moulding were also provided and upon close inspection the cornice and dentil detailing do not display the typical deterioration one would expect from wood details dating to 1857 and some areas reveal the polyurethane material where the coating has worn away

Image 99: View of a sample of the smaller dentil detailing used on some part of the house.

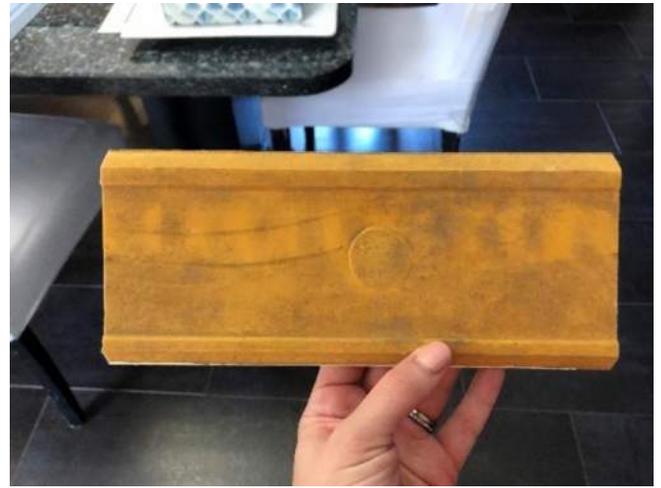
Image 100: View of the back of the dentil detailing revealing the polyurethane material.

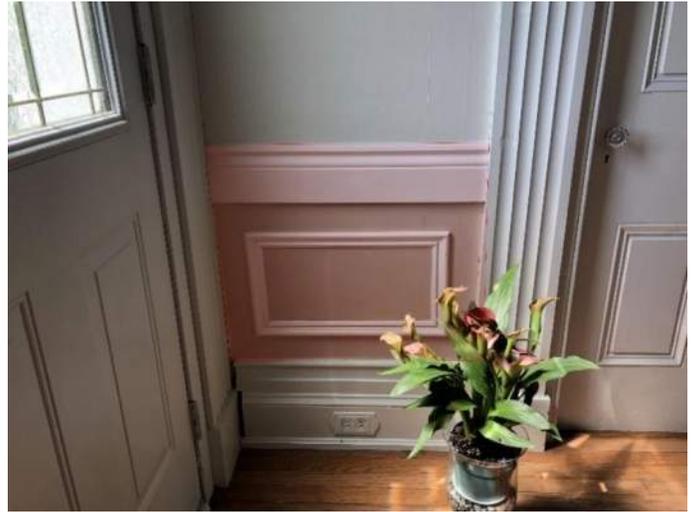
Image 103: Annotated photograph of the woodwork in the large room of the original part of the house (pink shaded areas depict alterations completed since 1983).

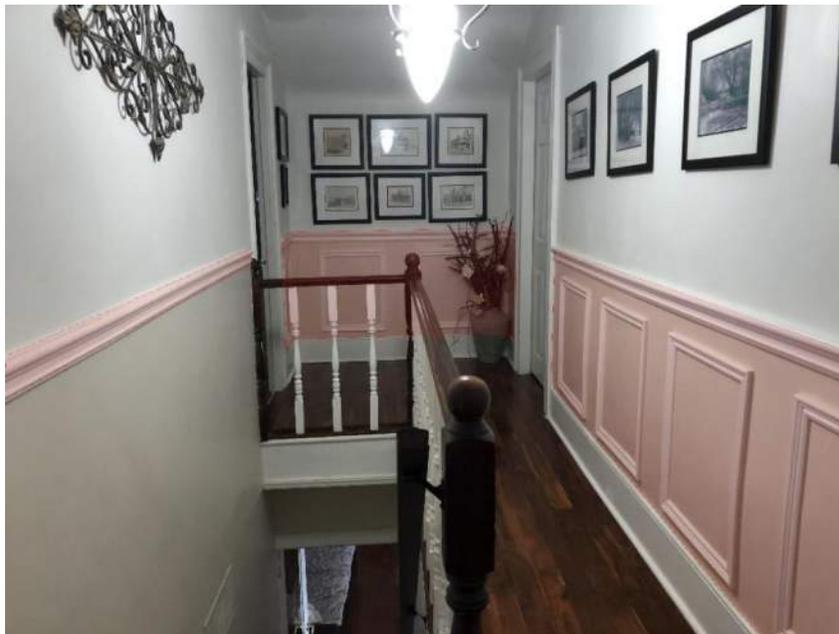
Image 104: Annotated photograph of the second storey hallway (pink shaded areas depict alterations completed since 1983).
