## Cultural Heritage Evaluation Report

9259 Fifth Line  
Town of Halton Hills, Ontario

# Hardy Farm Residence Structural Condition Assessment

9259 Fifth Line  
Georgetown Ontario

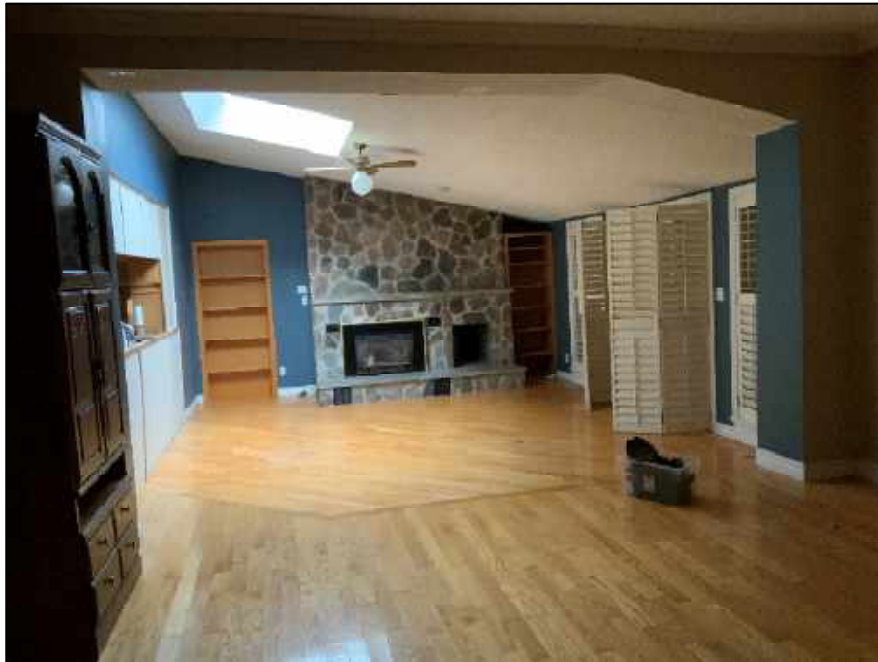
In the living room addition, water damage was noted on the ceiling around the skylight. Water damage was also noted around the door and windows in the east exterior wall of the living room addition. An overview of the living room can be seen in Photograph 3.

Photograph 3: Overview of living room addition.

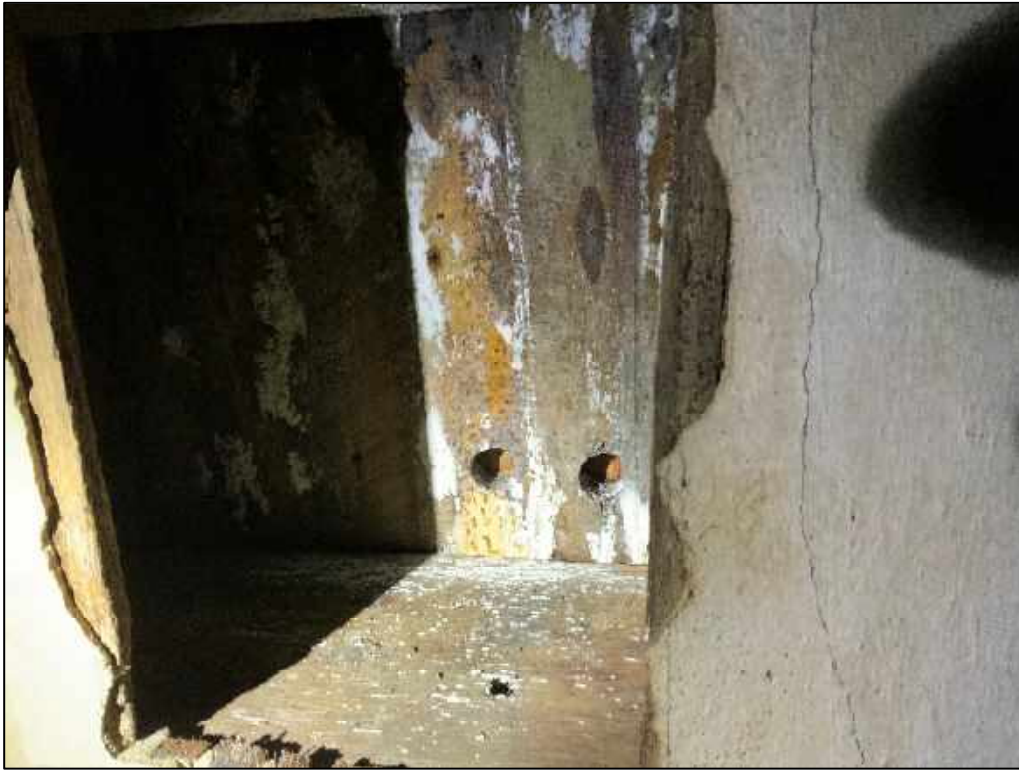
In the northwest room, one of the props in the intermediate bearing line had buckled, as seen in Photograph 6. Water damage was noted on the floorboards and floor joists above and significant amounts of mold were present (Photograph 7). Evidence of water ingress was present from above and staining was noted on the foundation walls at the northeast corner of the room (Photograph 8). The source of the water could not be determined at the time of review. This area of the basement was notably humid, and corrosion was noted on the exterior of a steel pipe (Photograph 9). Deteriorated areas of foundation wall were noted near the door at the south end of the room (Photograph 10). Generally, the foundation walls were otherwise in fair condition.

**Photograph 7: Mold on floorboards/joists above.**
