Research and Evaluation Report

Perryman-Mainprize Building

46 Mill Street East, Acton, Town of Halton Hills

December 2023

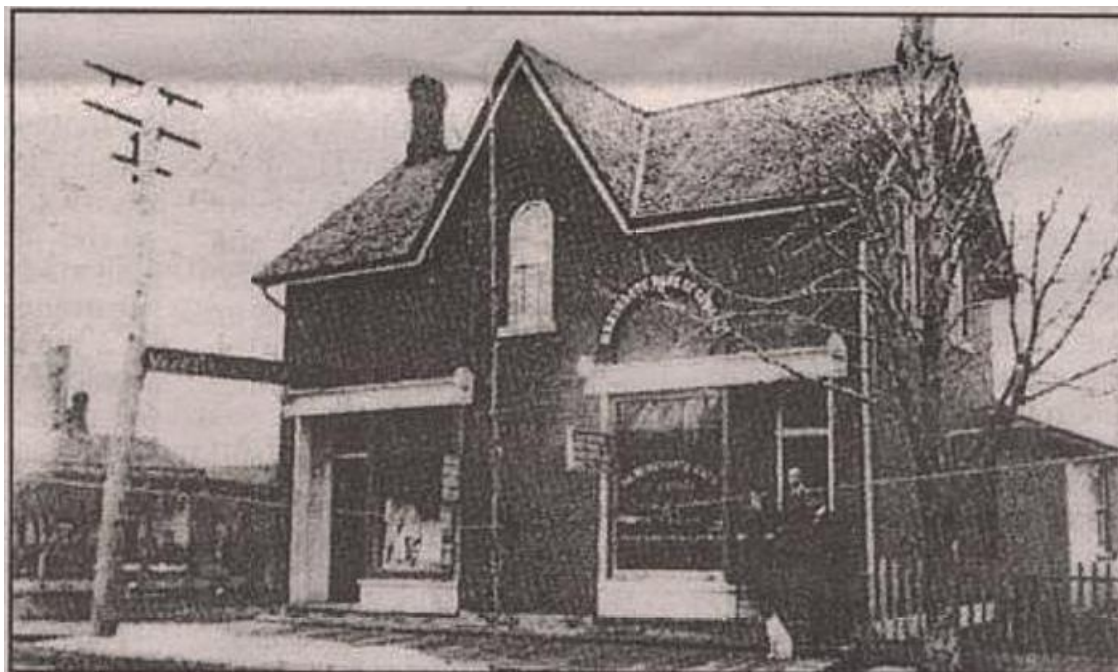
The Merchant's Bank was first established in Montreal in 1817. At the turn of the century, the Acton Branch of the Merchant's Bank was opened at the subject location. However, it was located there for only a year before it was moved to the northeast corner of Mill Street East and Willow Street in Acton. The first bank manager was Mr. Gentiles, and his assistant was Reuben McNabb. Note the purpose-built dual storefronts on the front elevation in Figure 8 for commercial purposes, Merchant's Bank of Canada identified on the right, with living quarters above.

Figure 8: Acton Merchants' Bank (Acton's first bank) at the corner of Mill and John Streets -- April 6th, 1900 (EHS)

The modified first storey of the front elevation has not been identified as an attribute, however photographic evidence of the building c.1900 provides an opportunity to restore the original configuration in future. The interiors, rear elevation of the original one-and-a-half storey building, and rear additions are not identified as heritage attributes as part of this report.

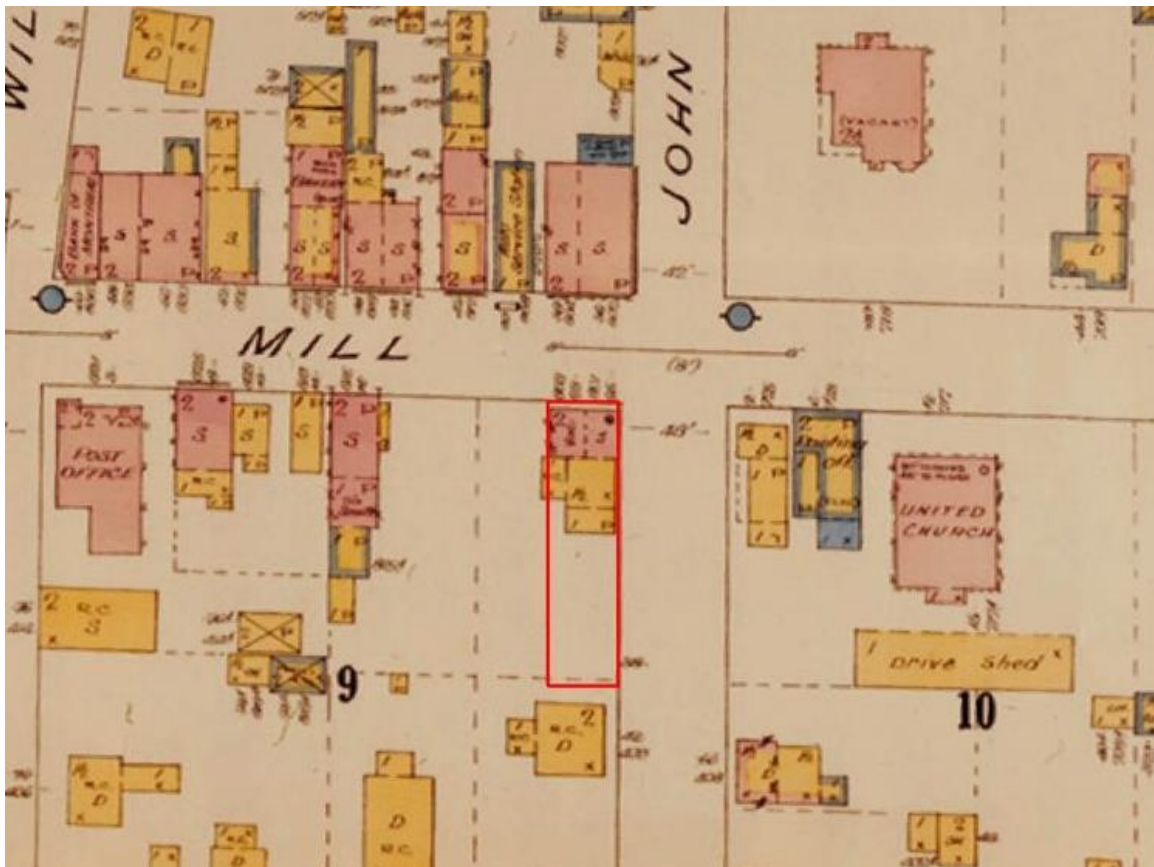
Figure 12: Subject property identified on the 1934 Fire Insurance Plan, showing the two units within the brick building and rear 1 ½ and 1-storey additions. The YMCA, for which construction began in 1934, is not yet identified.

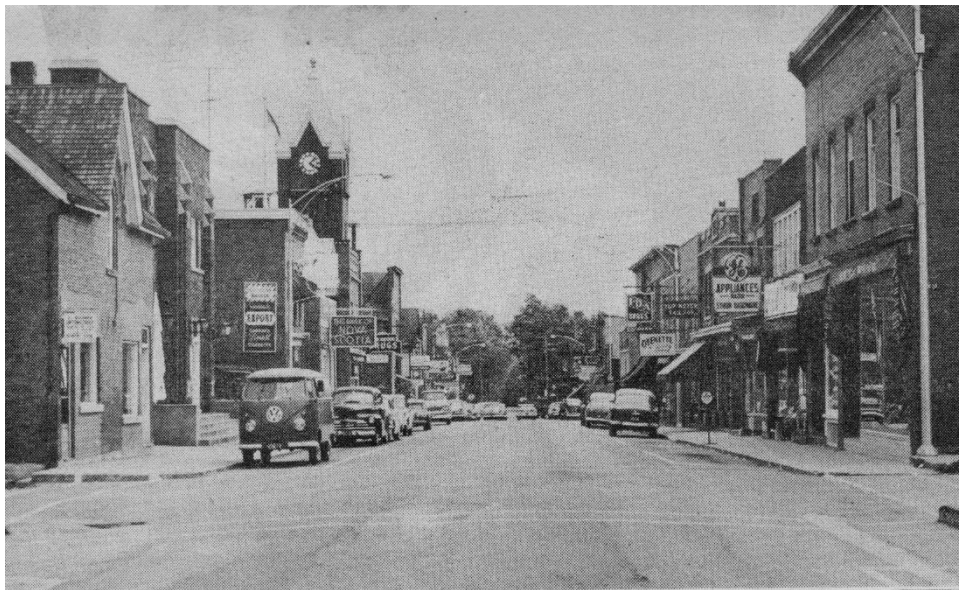
Figure 14: Mill Street East in Acton c.1960s, subject property on the far left; the dual storefronts are extant in this photograph however appear modified based on earlier photographs (Dills Collection Courtesy of Vintage Acton)

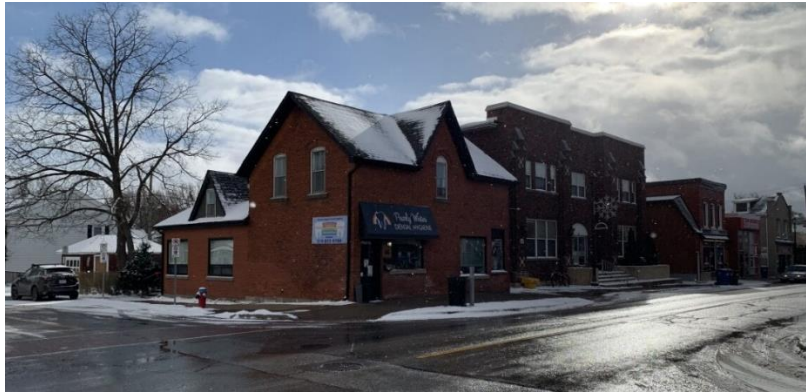
The property is located at 46 Mill Street East along the south side of the roadway in Halton Hills and contains a one-and-a-half storey brick residential building with rear addition (Figure 17). The property is legally known as PT LT 13, BLK 13, PL 31, AS IN 352765, S/T 352765; HALTON HILLS.

Figure 17: Looking towards the subject property along Mill Street East in Acton (Town of Halton Hills 2023)

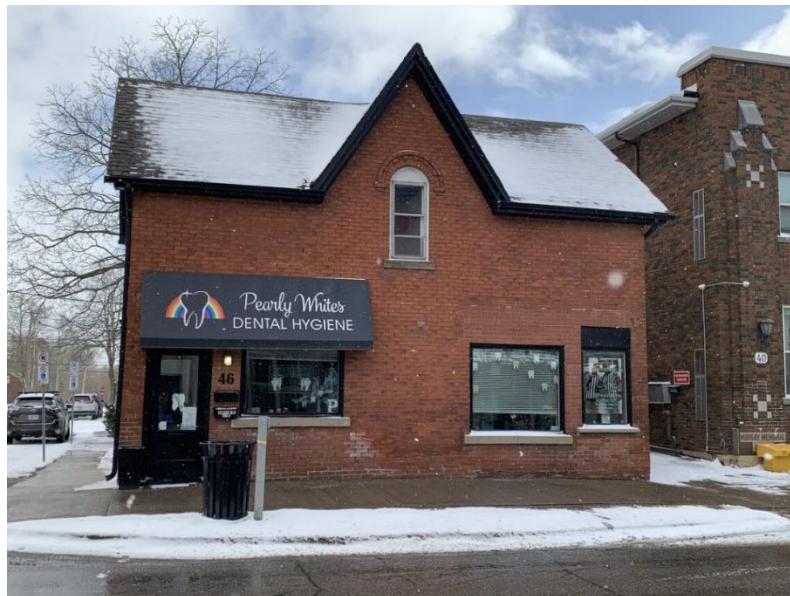
The front (northwest) elevation of the existing one-and-a-half storey building (Figure 18 through Figure 20) faces Mill Street East and features a red-brick façade. Evidence of the original openings pictured in 1900 is extant. One flat-headed entrance remains at the east end of the façade beside a wider single window opening with concrete sill. A wider rectangular window opening with a concrete sill and narrower window beside it sit in the same location as the west side entrance pictured in 1900. A round-headed window opening with stone sill and brick arch above is located at the upper storey beneath the centre gable peak. The stone foundation is not visible at the front elevation due to the existing sidewalk.

Figure 18: Front (northwest) elevation of 46 Mill Street East (Town of Halton Hills 2023)

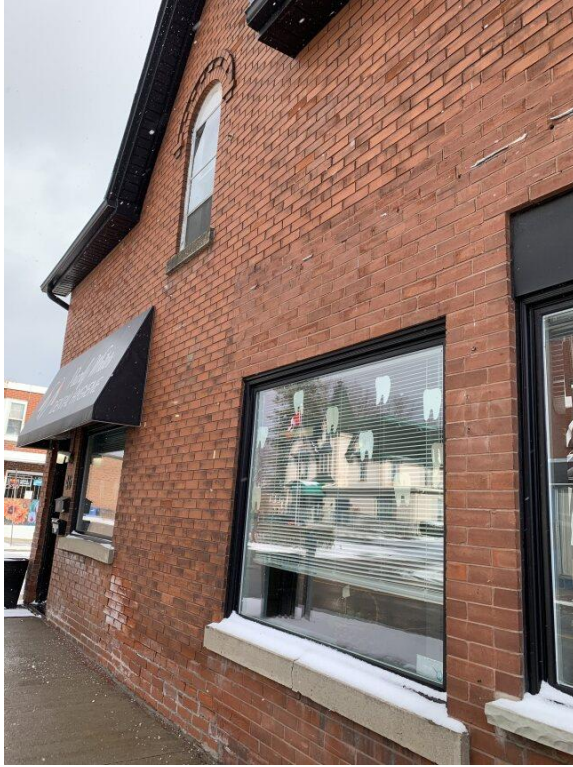
Figure 19: Detail of the front (northwest) elevation of 46 Mill Street East (Town of Halton Hills 2023)

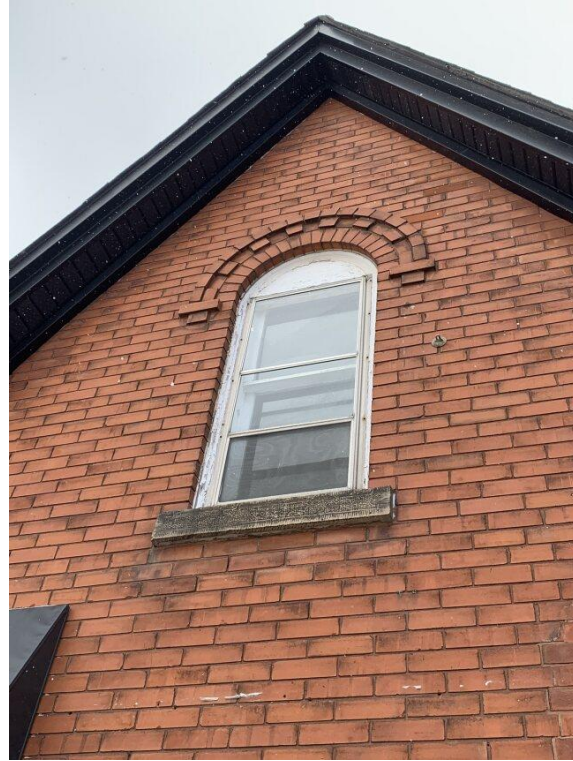
Figure 20: Detail of the front (northwest) elevation of 46 Mill Street East (Town of Halton Hills 2023)

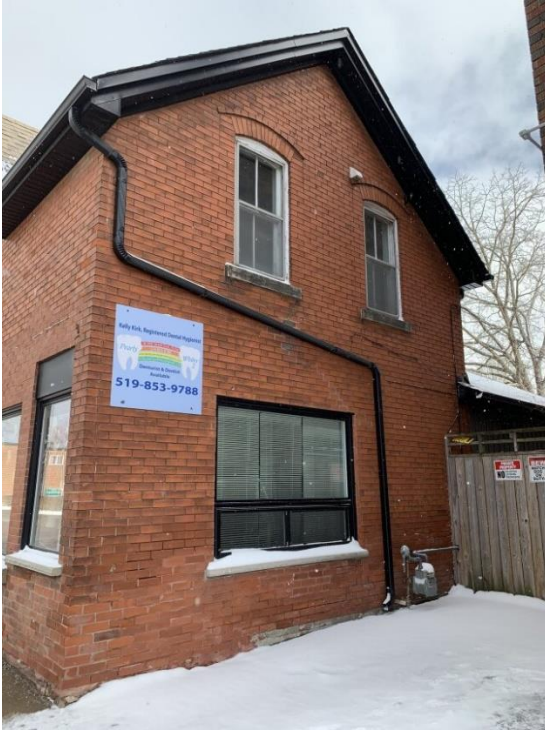
The side (southwest) elevation of the existing building (Figure 21 and Figure 22) features a contemporary window opening at the first storey. At the second storey are two symmetrically placed, segmentally arched window openings with stone sills below and brick voussoirs above.

Figure 21: Side (southwest) elevation of 46 Mill Street East (Town of Halton Hills 2023)

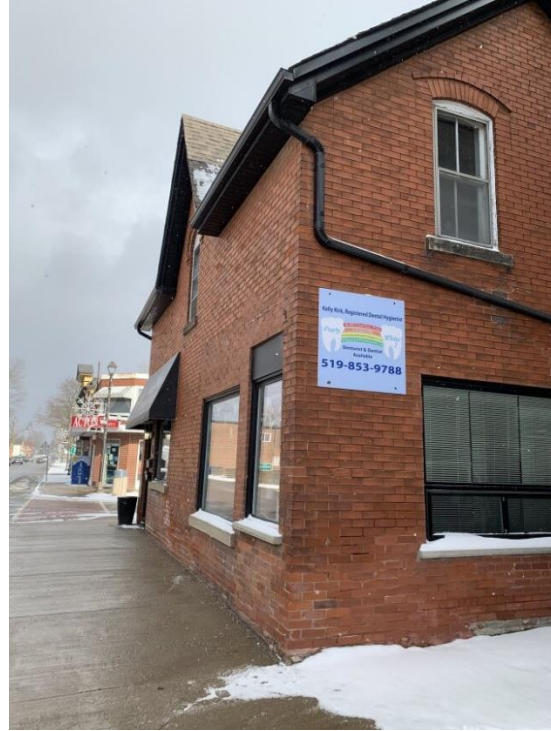
Figure 22: Northwest corner of 46 Mill Street East (Town of Halton Hills 2023)

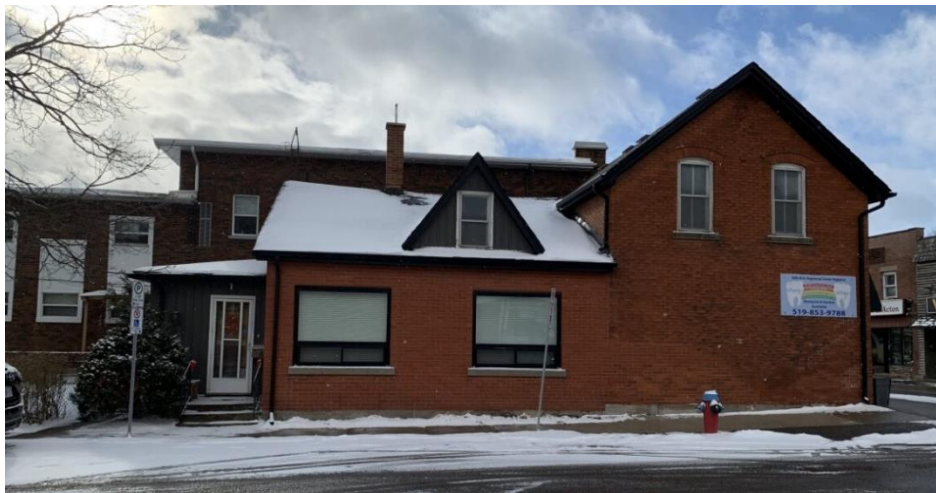
The side (northeast) elevation along John Street South (Figure 23 and Figure 24) includes both the original one-and-a-half storey building as well as a rear one-storey brick exterior addition and one-storey sun porch and entrance at the rear. The stone foundation is partially visible along this elevation. The side elevation of the one-and-a-half storey original building has no openings at the first storey and two window openings at the upper storey, as can be observed on the southwest elevation on the other side of the building. Two contemporary rectangular window openings are located within the rear one-storey portion of the addition with a gable dormer and small brick chimney above.

Figure 23: Side (northeast) elevation of 46 Mill Street East (Town of Halton Hills 2023)

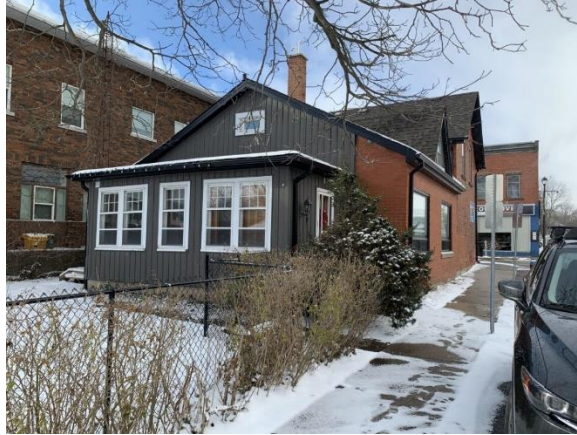
Figure 24: Southeast elevation of 46 Mill Street East (Town of Halton Hills 2023)

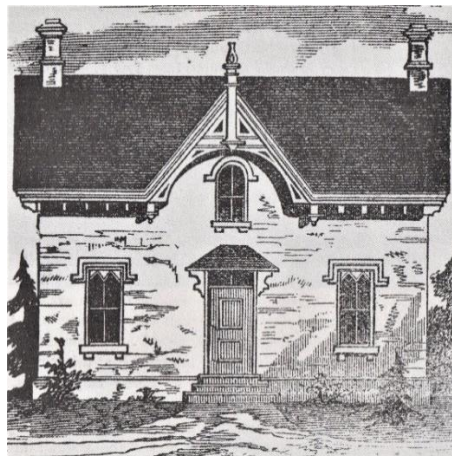
The existing one-and-a-half storey building at 46 Mill Street East can best be described as a vernacular variation of the Gothic Revival, or Ontario Cottage form, modified for commercial use at grade with residential use in the upper storey. Gothic Revival architecture was immensely popular in Ontario in the 19th century (it was promoted in *The Canadian Farmer* in the 1860s; see Figure 25) and can be found in communities throughout the province, likely in part due to the cheaper tax rates for one-and-a-half storey structures as opposed to two storeys once constructed.

Early photographic evidence of the existing building reveals a symmetrical front elevation with dual storefronts that reflects the symmetry of more typical examples of this style (namely a central entrance with symmetrically placed window openings on either side). The existing composition, although modified from its original configuration, reflects the original division of the front elevation into two bays at grade. The materials, as well as the scale, form, and massing of the building reflects the characteristics typical of the style (demonstrated in *The Canadian Farmer* in 1865). The extant side gable roof, centre gable with window beneath the gable peak, round-arched and segmentally arched window openings are also typical of this style.

Figure 25: Illustration from *The Canadian Farmer*, vol. 2, 1865, p.244
