## Cultural Heritage Evaluation Report

9259 Fifth Line  
Town of Halton Hills, Ontario

# Hardy Farm Residence Structural Condition Assessment

9259 Fifth Line  
Georgetown Ontario

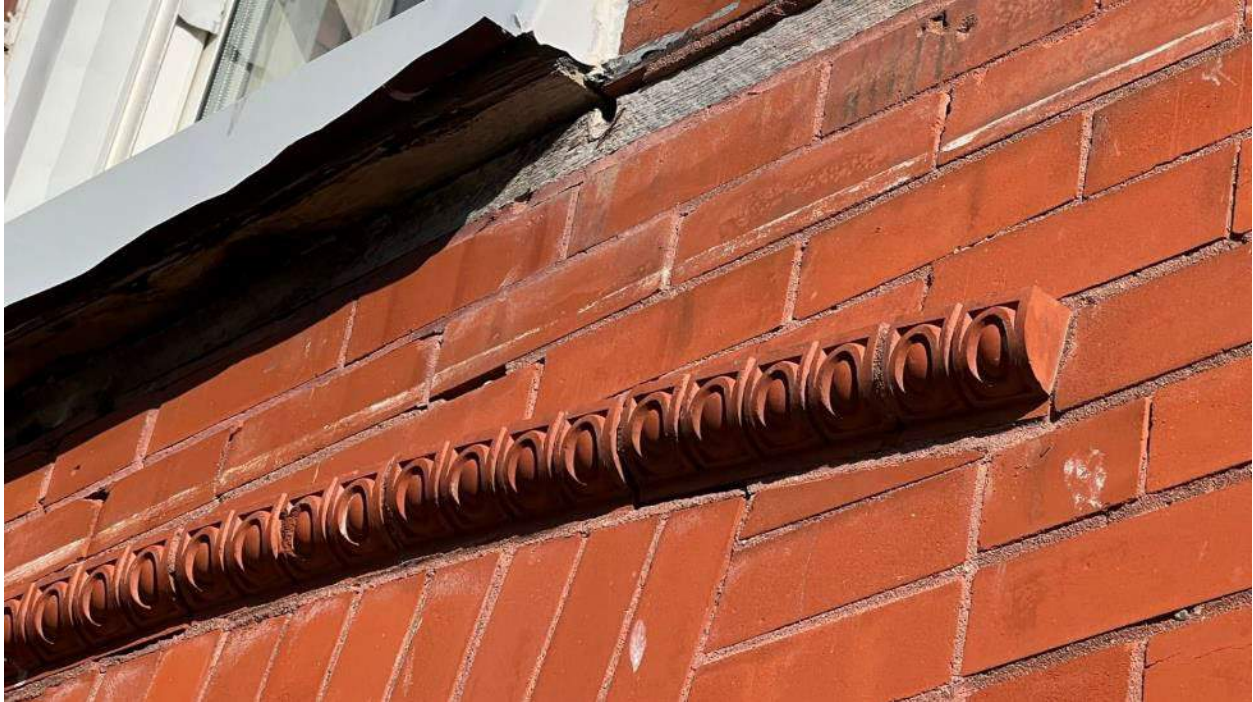
*South (Front) Façade Dentils above Brick Voussoirs above Arched Central Doorway*

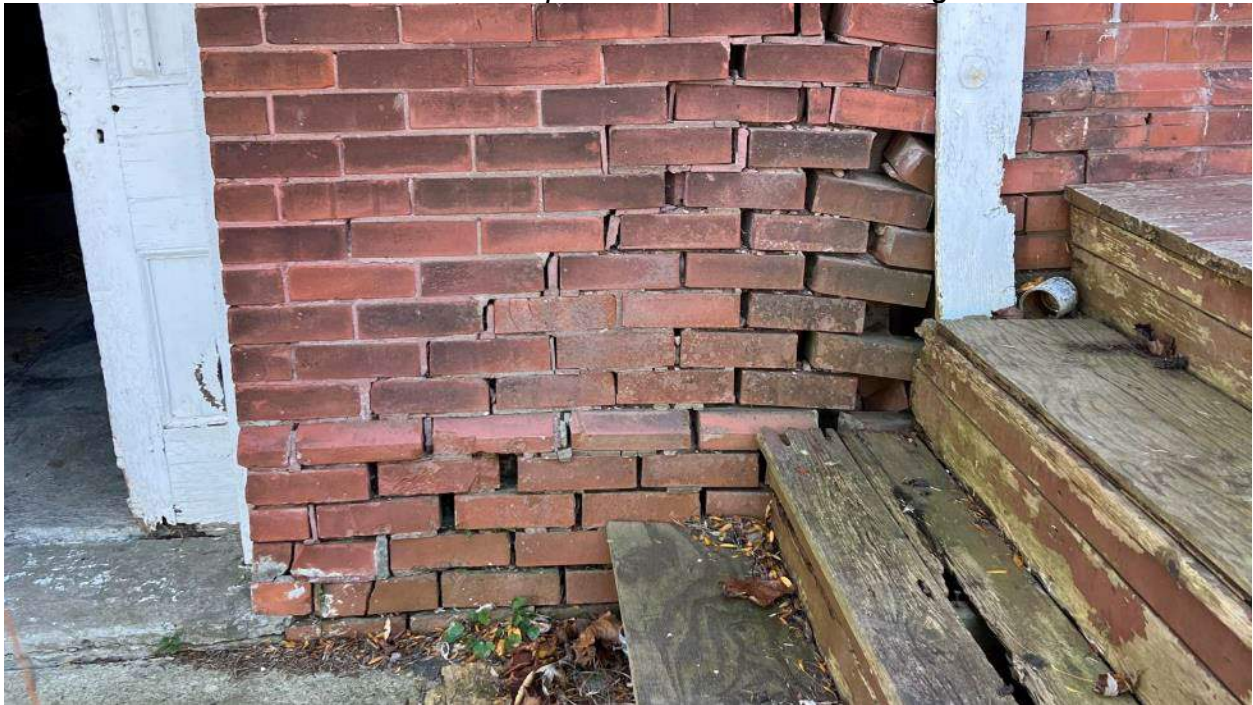
This facade displays evidence of both superficial and structural damage, including brick and mortar damage, brick buckling and collapse, and sagging. Deterioration in both head joints and bed joints, along with spalled bricks, is found throughout the building, but is, especially on this facade. Open, skyward-facing joints and spalled bricks are evident in several locations, including the brick water table. Various openings in the foundation walls and at the base of the ground floor walls, where mortar had deteriorated, have been filled with spray foam. The images below showcase this description.

*Buckled and Collapsed Brick Veneer on Garage*

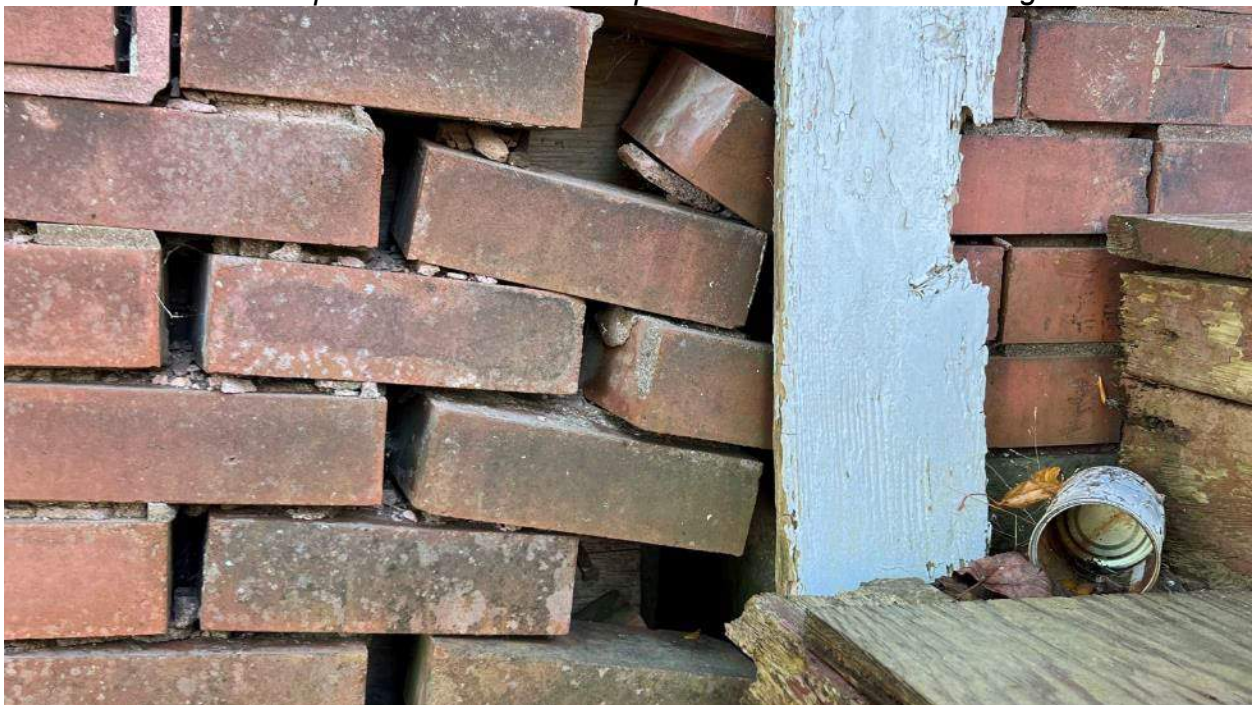
*Close Up of Buckled and Collapsed Brick Veneer on Garage*

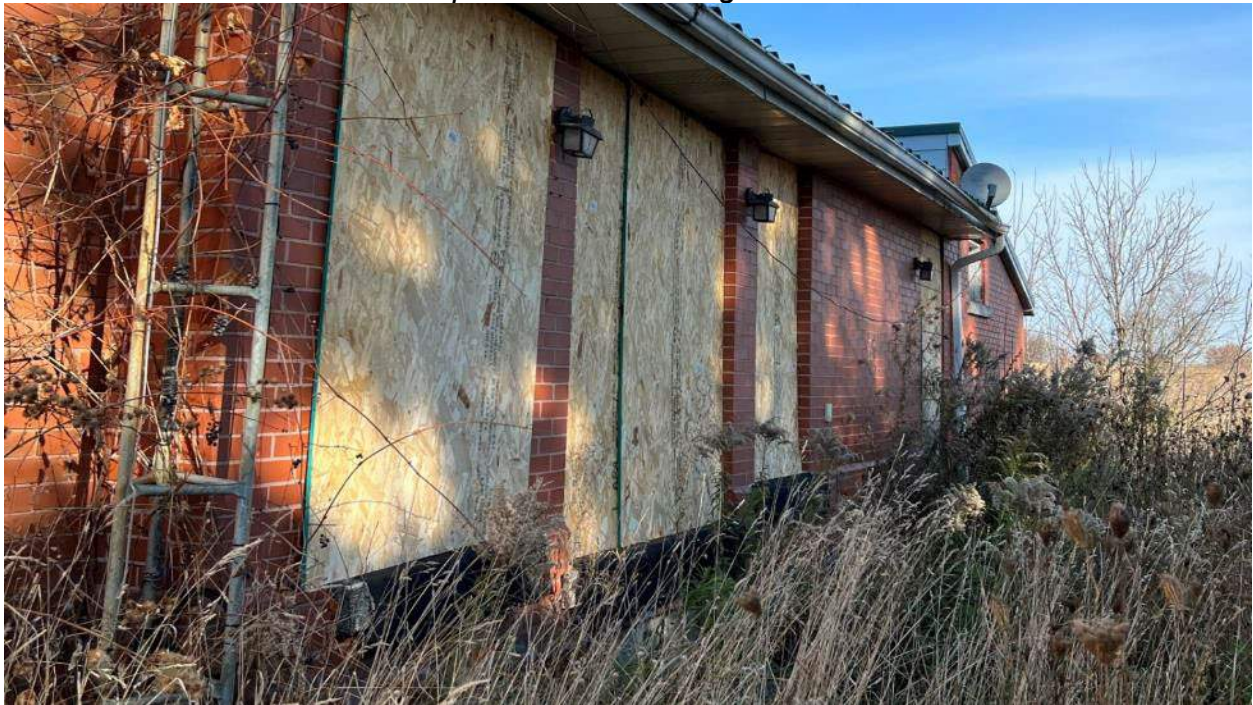
*Boarded Up Windows of Living Room Addition*

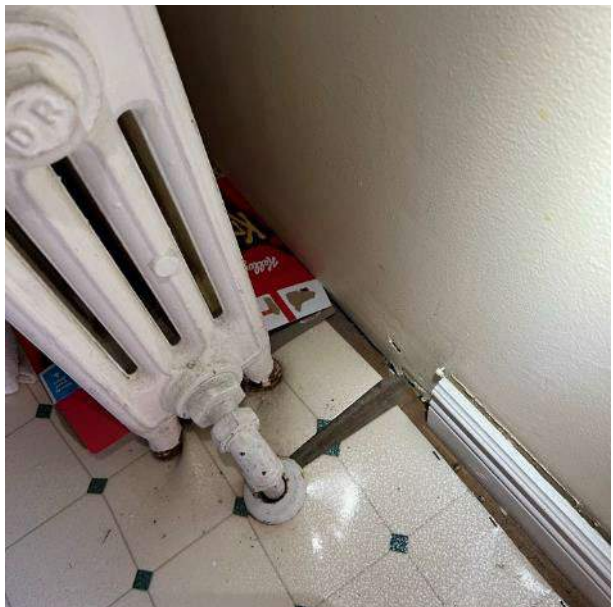
*Radiator and Peeling Linoleum Flooring*

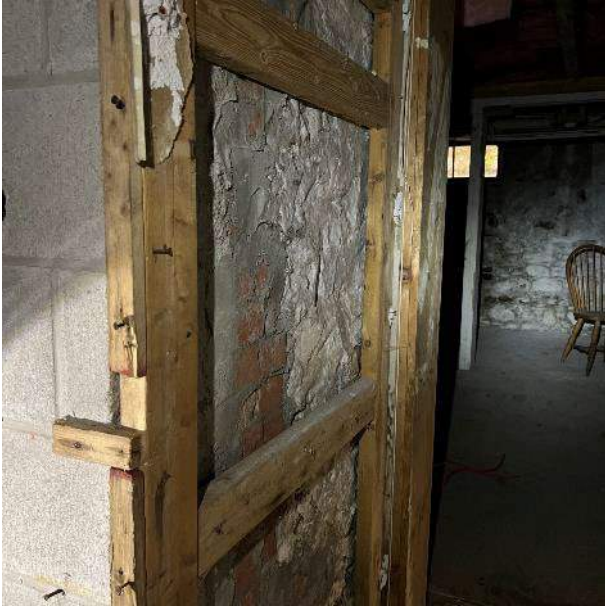
*Transition between Concrete Block and Rubble Stone Foundations*

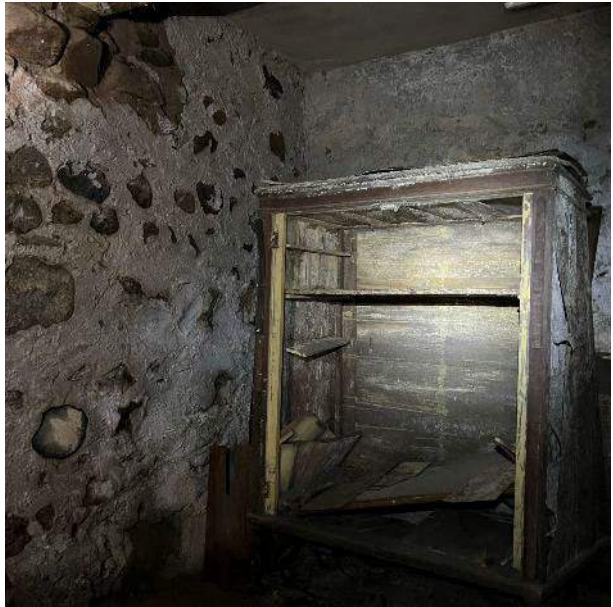
The basement is divided into four distinct areas, each characterized by unique ground-floor framing above. There is a southeast room, which has ground-floor framing comprised of 3.5 inch by 11 inch true-cut joists at 24 inches on center. A modern 3-ply 2x6 beam spans between foundation walls and intermediate posts, effectively reducing the span of the joists. Moving to the southwest room, the ground-floor framing consists of 4 inch by 8-inch rough-hewn joists at 24 inches on center. Notably, the joists were notched at their bearing points on the foundation walls. In the northwest room, ground-floor framing features 2.5 inches by 10 inches true-cut joists, and an intermediate bearing line is present, effectively reducing the span of the joists. The foundation walls in these three areas are constructed of rubble stone.

*Rubblestone Foundation*

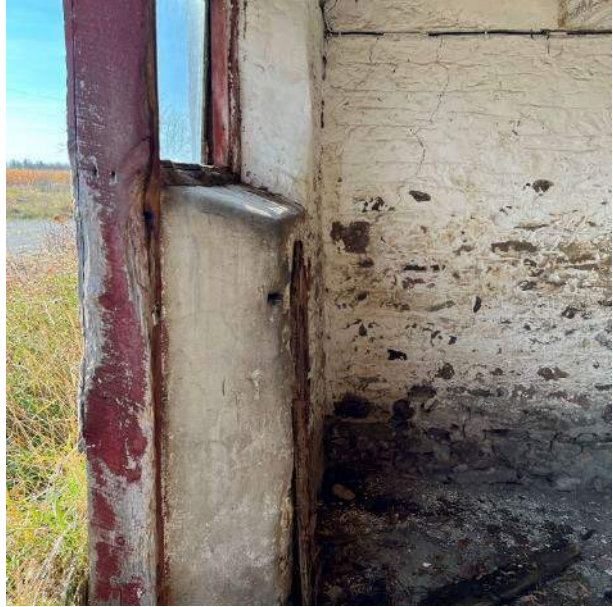
Some parts of the stone foundation have been parged with concrete. Much of the lower-level interior is coated in flaking or peeling white paint, with small wooden staircases providing access to the upper levels. Livestock, equipment, or storage likely occupied the lower levels, while the upper levels likely served as storage or haylofts. Notably, one section of the larger barn's lower level contains a series of horse stalls, remnants of riding equipment included.

*Concrete Parging*

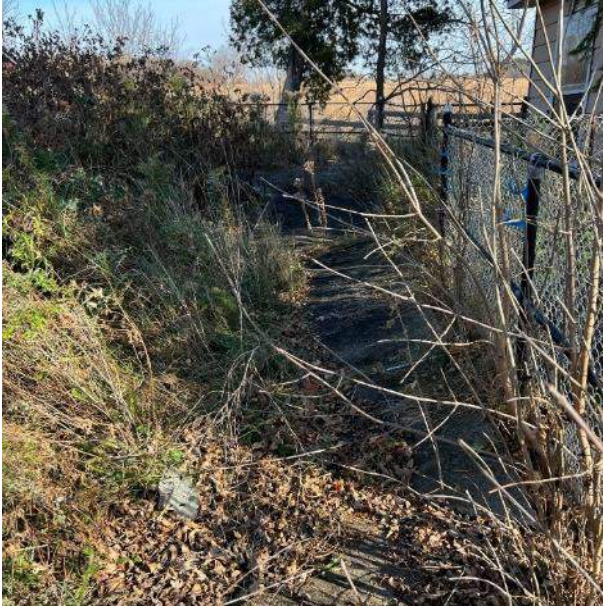
The subject site contains a pool to the west of the residence. The pool is oval shaped and has been filled in dirt and is now overgrown with weeds and shrubs. The pool is encircled by a chest height chain-link fence. The pool surround / patio area is made of concrete.

*Pool Filled In with Dirt and Overgrown*

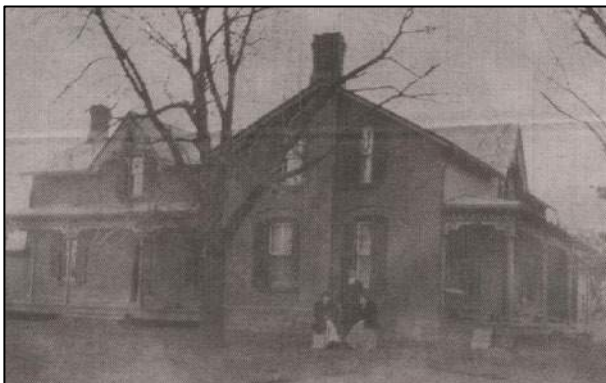
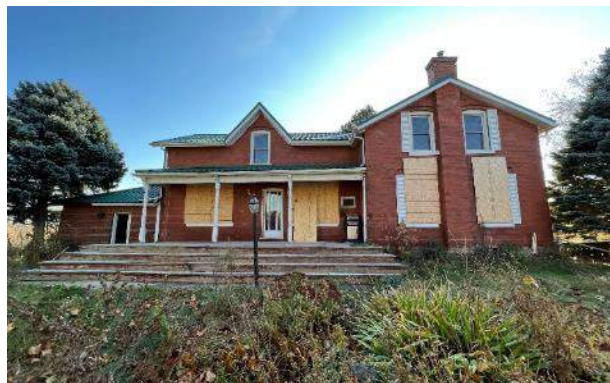
- Cut openings into brick for air conditioning and other appurtenances.
- Modern window and door inserts (rectangular in shape) retrofit into mildly arched window and door openings.

- Removal of chimneys.
- Bricking over of some windows.
- Removal of front porch roof, and replacement of west side porch roof.
- Removal of vergeboard / bargeboard.

In addition, there are also several signs structural, water, and exterior brick damage including floor and wall bulging and unevenness, collapsing concrete block wall in basement (portion only), brick-and-mortar damage and spalling brick, buckled and collapsed brick veneer, and more. `` `
